# TOTAL FIRE GROUP LTD

## Fire Risk Assessment

25-82 Brownley Court  
Wythenshawe  
Manchester  
Greater Manchester  
M22 4QH

01 June 2026

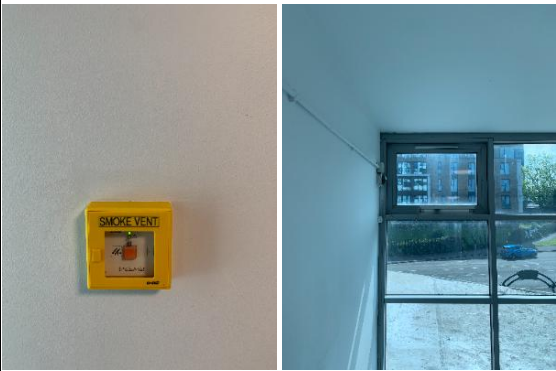
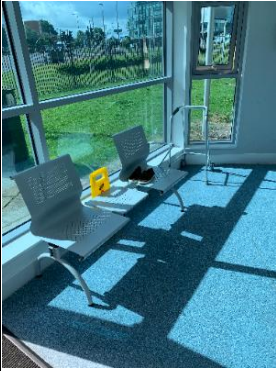
| 8.7 | <p>A single metal bench is provided at the base of the alternative stair serving only the ground and first floor. The presence of this item is not considered to significantly increase the risk to the life of the residents, however, close attention should be paid with regard to the prevention of any additional items being placed in the area.</p> |

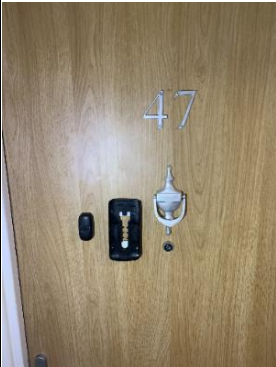
| Ref | FINDINGS |
|---|---|
| 9.1, 9.5 | There was a doorbell holder screwed into the door of flat 47. These holes may have breached the fire resistance of the door, potentially placing persons at risk of harm. |

| Ref | FINDINGS |
|---|---|
| 9.1, 9.5 | It is recommended that the door be inspected to ensure that these holes do not affect the level of fire resistance. If the fire resistance is affected, the holes should be repaired. |

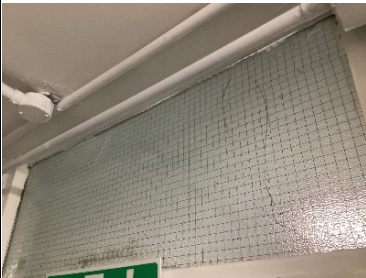
| Ref | FINDINGS |
|---|---|
| 9.1, 9.5 | The glazing to the lobby on the 8th floor is cracked; this may void the 30 minutes of fire resistance, placing persons at risk of harm. |

| Ref | FINDINGS |
|---|---|
| 9.1, 9.5 | It is recommended that the Georgian wire glazing be replaced. |

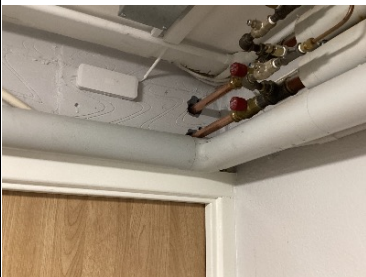
| Ref | FINDINGS |
|---|---|
| 9.1, 9.8 | There appeared to be potential breaches around the pipes leading into flat 78. Where there are breaches in fire-resistant construction, this may allow for the spread of smoke/products of combustion, placing persons at risk of harm. |

| Ref | FINDINGS |
|---|---|
| 9.1, 9.8 | It is recommended that the breaches be fire-stopped to a minimum of 60 minutes of fire resistance. |

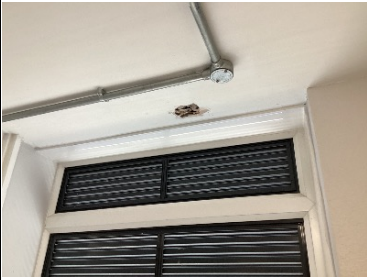
| Ref | RECOMMENDATIONS |
|---|---|
| 9.1, 9.8 | There was damage observed to the ceiling outside of the bin store on the 2nd floor. |

| Ref | RECOMMENDATIONS |
|---|---|
| 9.1, 9.8 | It is recommended that the ceiling be repaired to the same level of fire resistance as the surrounding area. |

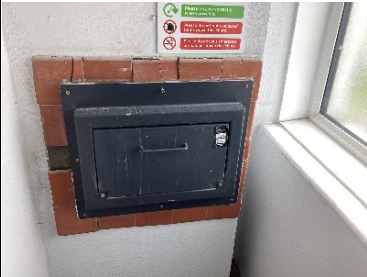
| Ref | RECOMMENDATIONS |
|---|---|
| 9.17 | There was damage observed around the edges of the bin chute on the 10th floor, a bolt was also missing. |

| Ref | RECOMMENDATIONS |
|---|---|
| 9.17 | The bin chute should be repaired to ensure that it continues to function. In the event that the chute breaks, residents may pile rubbish in the communal areas or within the bin store area. |

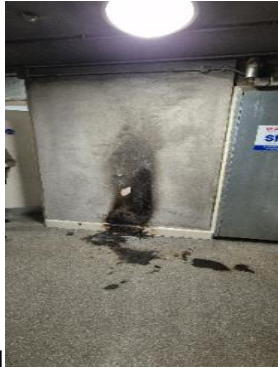
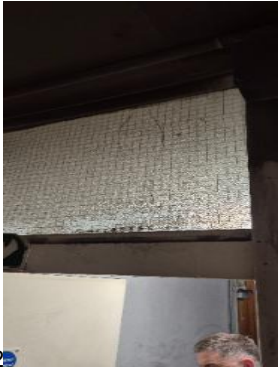
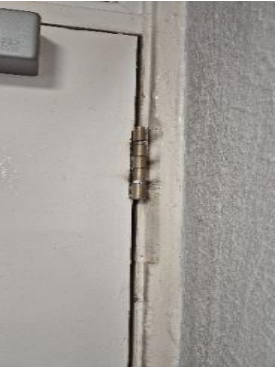
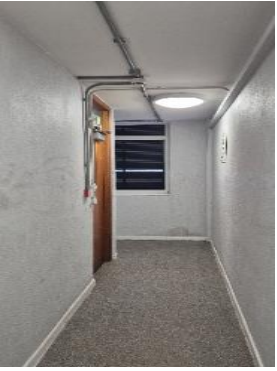
| 9.1, 9.5-9.6 | <p><b>Retained for historical information and to explain smoke marks within cupboards on the 8th floor. 12/11/2025.</b></p> <p>The fire on the 8th floor has been confined to the lift lobby. Some heat damage is visible to Georgian wired glazing (2) with some smoke leakage around the hinge (3) into the ventilated lobby separating the lift lobby from the staircase (4). There was no evidence observed to indicate that smoke had entered the staircase; therefore, the lobby fire doors and the ventilated lobby appear to have performed as required, keeping the staircase free of any smoke throughout the incident. The assessor has been advised by WCHG the glazing will be replaced as soon as possible.</p> <div data-bbox="245 365 523 734"> <p>1</p> </div> <div data-bbox="547 365 825 734"> <p>2</p> </div> <div data-bbox="849 365 1126 734"> <p>3</p> </div> <div data-bbox="1150 365 1428 734"> <p>4</p> </div> |

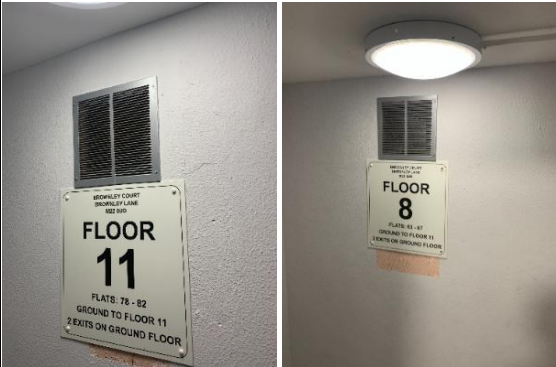
| Ref | FINDINGS |
|---|---|
| 13.15-13.16 | Wayfinding signage that has the floor number and directional signage to the flats, including flat numbers, is displayed in the lift lobbies and on the stairway landings. They appear to be mounted at the recommended height as per ABD and are all visible and in good condition. Supplementary signage is also present, with signage outside the lift areas to show which flats are on each floor and which floors the two lifts access. However see finding. |
