# TOTAL FIRE GROUP LTD

## Fire Risk Assessment

1-58 Hollyhedge Court  
223 Hollyhedge Road  
Manchester  
Greater Manchester  
M22 4QD

01 June 2026

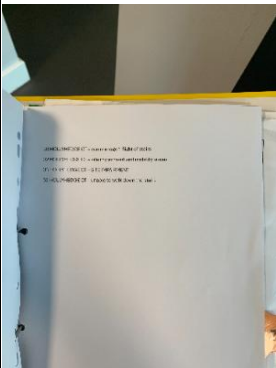
| 7.0 Persons at Risk: Finding(s) | |
|---|---|
| 7.5 | <p>A vulnerable tenants list was noted within the folder within the SIB at the time of the fire risk assessment.</p> |

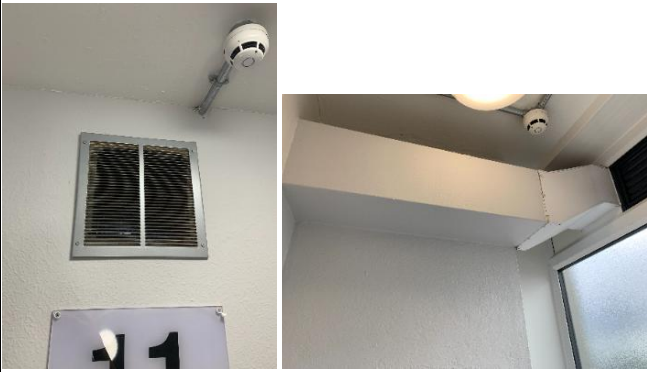
| Ref | COMMENTARY |
|---|---|
| 8.2 | <p>The below photographs show an example of the means of smoke ventilation in the stairway of the premises. The layout is the same on all floors from the first floor upwards. The vent on the stairs leads into the metal ducting which in turn vents direct to outside, passing through the refuse chute room on its way. The previous FRA confirmed that WCHG have engaged third parties to confirm that this method of smoke ventilation is adequate. Smoke modelling calculations have been provided by a fire engineer who concluded that provided new grilles were fitted and the ducting was cleaned the existing provisions for smoke ventilation are satisfactory. In addition, the ducting has been inspected by another third party who confirmed that they were fit for purpose. Although not viewed on this assessment, it is understood that WCHG have documentary evidence available issued by the third parties.</p> <div data-bbox="236 443 885 813"> </div> |

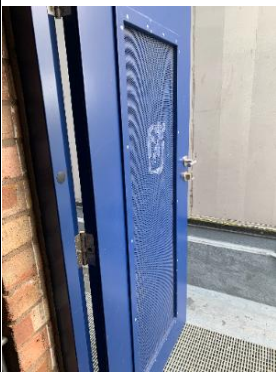
| Ref | COMMENTARY |
|---|---|
| 8.2 | <p><b>Noted during the previous fire risk assessment:</b> A louvred door provides a means of permanent ventilation to the lift motor room.</p> <div data-bbox="236 891 512 1261"> </div> |

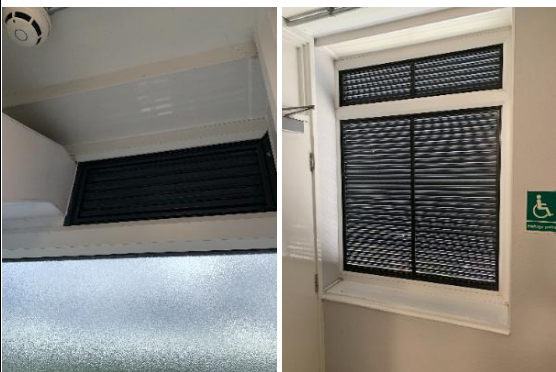
| Ref | COMMENTARY |
|---|---|
| 8.2 | <p>The corridor between the lobby serving flats and the staircase is provided with permanent ventilation, as is the refuse chute room.</p> <div data-bbox="236 1339 794 1709"> </div> |

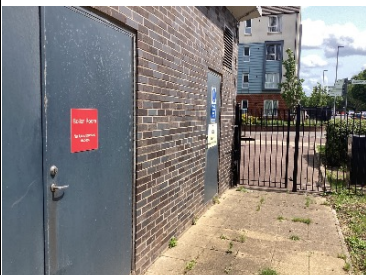
| Ref | COMMENTARY |
|---|---|
| 8.6 | <p>It was observed at the time of the assessment that the gated area has not been provided with an emergency override. This area is for authorised persons only; they would not be working in this area for long periods of time, and there is a choice of direction within the plant rooms.</p> <div data-bbox="236 1816 603 2089"> </div> |

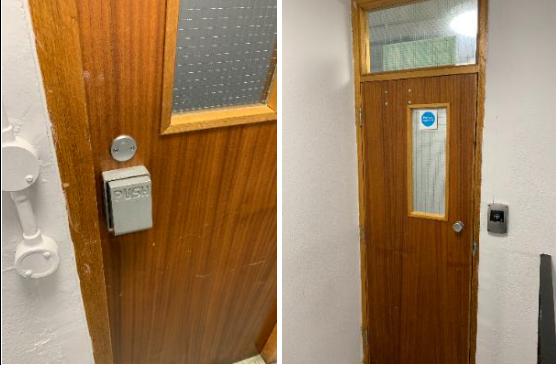
| 8.17 | Electromechanically secured doors separate the staircase from the corridors serving flats and these require fob access in the direction towards the flats. In the direction of escape, a suitable push pad device is provided leading into the stair.<br> |

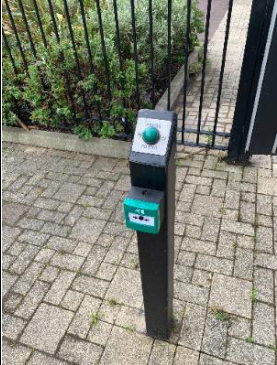
| 8.18 | Onsite observations showed an override has now been installed to one of the gates to allow for full evacuation away from the building.<br> |

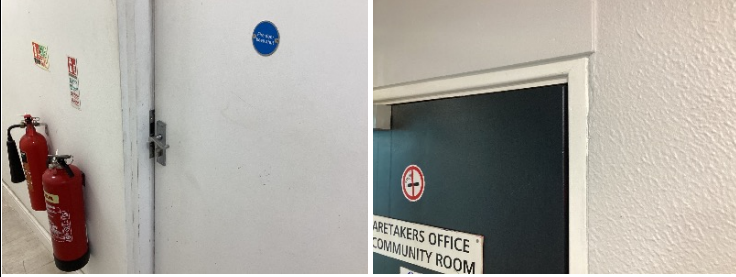
| Ref | FINDINGS |
|---|---|
| 9.1, 9.5 | <p>It was observed that the door to the ground floor kitchen and the door to the caretaker's area were both unable to self-close fully into the frame. Where fire doors cannot self-close fully into the frame, they may allow for the spread of fire and products of combustion throughout the communal areas, placing persons at risk of harm.</p> |

| Ref | FINDINGS |
|---|---|
| 9.1, 9.5 | It is recommended that the doors be adjusted so that they are able to close fully and unaided into the doorframe. |

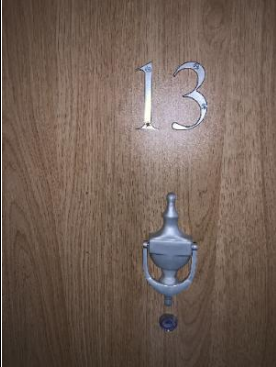
| Ref | FINDINGS |
|---|---|
| 9.5 | <p>It was observed that there were small holes in the entrance door to flat 13. These holes may have breached the fire resistance of the door, potentially placing persons at risk of harm.</p> |

| Ref | FINDINGS |
|---|---|
| 9.5 | It is recommended that the door be inspected to ensure that these holes do not affect the level of fire resistance. If the fire resistance is affected, the holes should be repaired. |

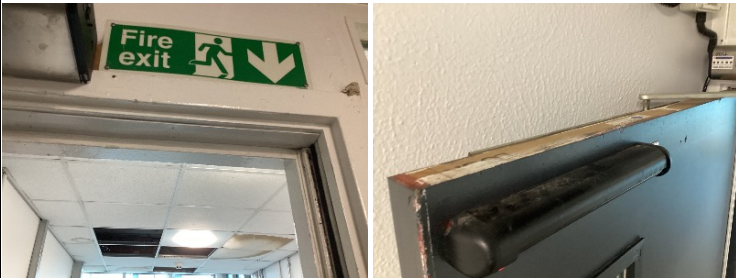
| Ref | FINDINGS |
|---|---|
| 9.6 | <p>It was observed that the automatic door on the ground floor does not have intumescent strips or smoke seals to the top of the frame. Where fire doors are missing strips and seals, it will allow for the spread of smoke and products of combustion, placing persons at risk of harm.</p> |

| Ref | FINDINGS |
|---|---|
| 9.6 | It is recommended that the door be provided with intumescent strips and smoke seals to the top of the frame. |

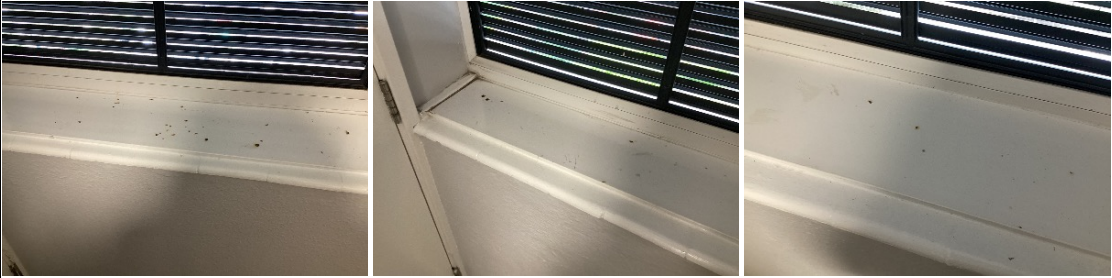
| 9.16 | <p>It was observed at the time of the fire risk assessment that there was evidence of smoking and fire starting within the communal areas on a number of floors. Where there is evidence of fire starting and malicious ignition attempts, this could potentially result in a fire occurring, placing persons at risk of harm.</p> |

| 9.16 | <p>It is recommended that these areas be monitored frequently and are subject to weekly checks with findings recorded. In the event that more damage is observed, consider installing CCTV or No Smoking signage in the affected areas as a deterrent.</p> |

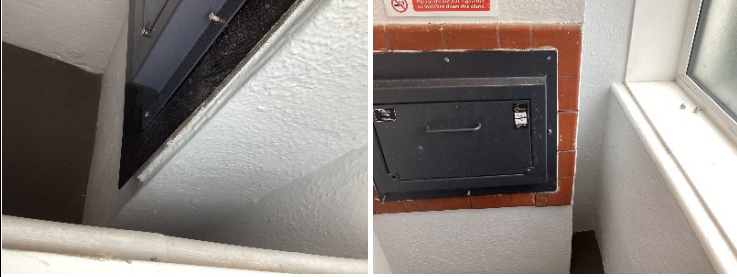
| 9.16 | <p>It was observed at the time of the fire risk assessment that the bin chute hatches on the 3rd and 5th floors were coming away from the wall, if these hatches were not functional, there may be a pileup of rubbish in the bin rooms and communal areas.</p> |

| 9.16 | <p>The bin chutes should be repaired.</p> |

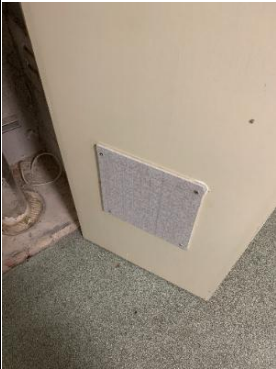
| Ref | COMMENTARY |
|---|---|
| 9.1 | <p>The previous fire risk assessment noted that the gas service riser cupboard adjacent to flat 7 (first floor) is provided with an intumescent grille. Intumescent grilles would not prevent the spread of products of combustion prior to reaching the temperature required to seal, meaning that some products of combustion may be able to enter the escape route and place persons at risk of harm. At the time of the fire risk assessment, it was observed that the vent had been sealed from the interior side of the door.</p> |

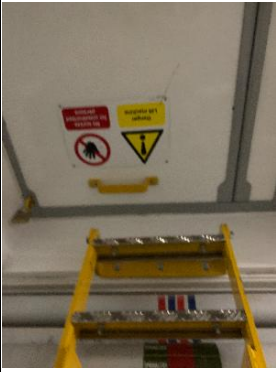
| Ref | COMMENTARY |
|---|---|
| 9.1 | <p>As previously noted, a fire resisting hatch appears to have been installed between the eleventh floor and the lift motor room.</p> |

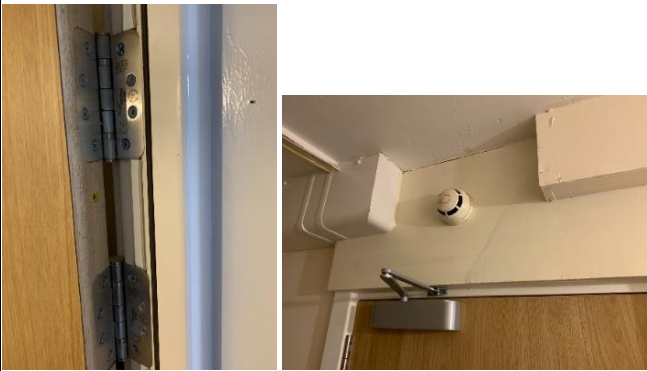
| Ref | COMMENTARY |
|---|---|
| 9.1, 9.5-9.6 | <p>A sample of flat entrance doors were accessed and visually inspected. The entrance doors appeared to be robust timber doors certified to FD30, and installed with intumescent fire and cold smoke seals, and a self-closer. A label was provided on the top door edge, and BM Trada door plugs were also installed on the door edges. It is reasonable to assume that the remaining flat entrance doors are of the same door assembly and furniture, as they all visually appeared to be the same. Test evidence of each fire door's performance was not available, however, one was observed as part of a previous action.</p> |

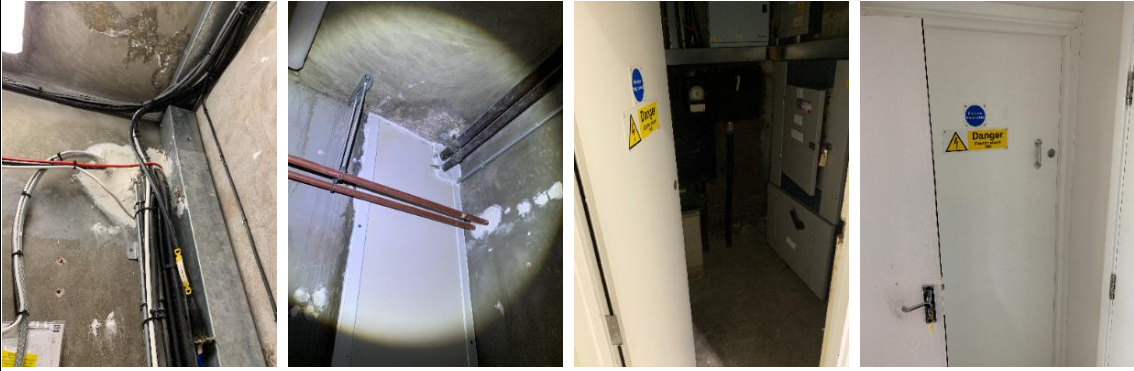
| 9.1, 9.5-9.6 | <p><b>Extract from previous fire risk assessment:</b> The previous FRA raised an action in relation to several cupboards adjoining the corridor serving the community areas/server room that could not be accessed be fitted with FD30s doorsets and fire stopped within. The previous FRA action has been signed off as complete on 23/09/2022 by Mike Holt. Access was gained into 2 out of 3 cupboards in this area to show that the doors are robust timber doors with intumescent fire and cold smoke seals installed, and fire door signage on the doors. Also within the cupboards accessed, fire stopping was undertaken. It is reasonable to assume the same in the none accessed cupboard.</p> |

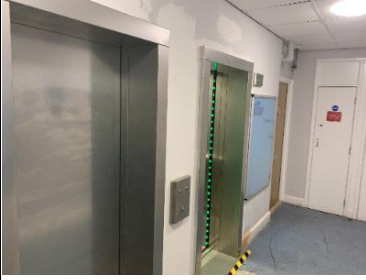
| 9.1, 9.8 | <p><b>Historical information:</b> It was observed during the previous fire risk assessment that there were breaches in the lift shaft wall due to the lift upgrade work that is currently ongoing. At the time of the fire risk assessment, these breaches had been filled; the level of fire resistance the breaches should have been fire stopped to is 60 minutes, as noted in the previous assessment. It is assumed that WCHG have completed this action in line with the previous recommendation.</p> |

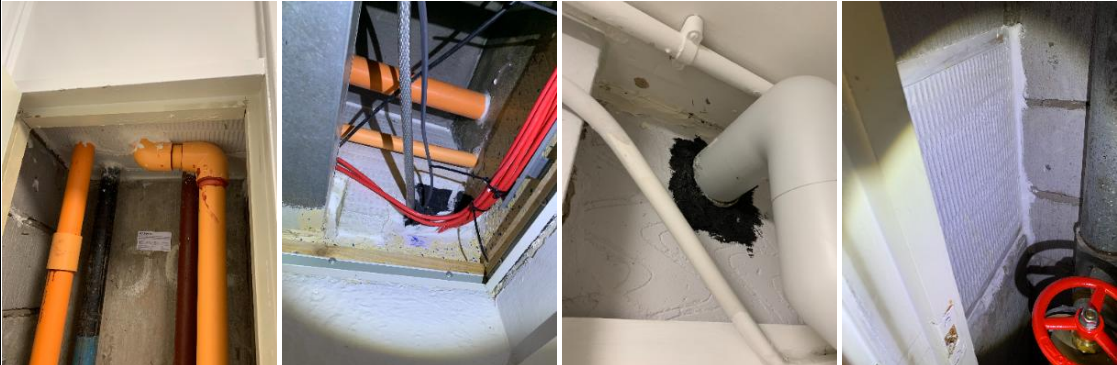
| 9.1, 9.8 | <p>As highlighted previously, compartmentation works have been carried out throughout the premises by Allied Protection Ltd. They are an accredited passive fire protection contractor and it is understood they have provided WCHG with documentary/photographic evidence of their work (not seen on this assessment). Following the installation of the fire alarm system, further fire stopping was required. This was carried out by Flame Hold Ltd who are also an accredited passive fire protection contractor. It is also understood they have provided WCHG with documentary/photographic evidence of their work (not seen on this assessment). The majority of the fire stopping and compartmentation work throughout the premises was observed to be of a high standard.</p> |

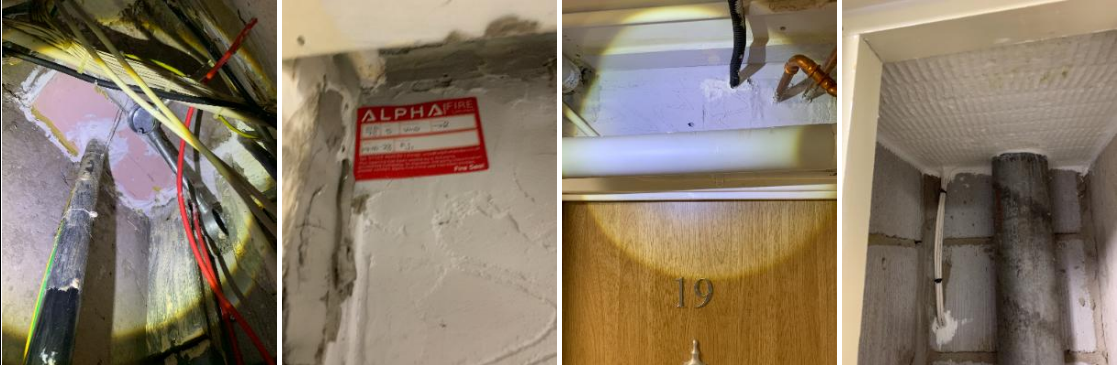
| 9.1, 9.8 | <p><b>Historical information:</b> The previous fire risk assessment raised an action in regard to multiple breaches in compartmentation throughout the building. At the time of the assessment, the assessor was able to access the areas in which the breaches were noted to be. Breaches caused by cables and pipework appear to have been fire-stopped. The panelling above the flats has been removed and is currently being upgraded, Fire-stopping stickers from Alpha Fire Limited, indicate that fire-stopping has been carried out in July 2023.</p> <p><b>Note:</b> The photos below show fire stopping in the ground floor roof area above the false ceilings, within risers and electrical cupboards and above flat entrance doors.</p> <div data-bbox="236 1149 1358 1512"> </div> |

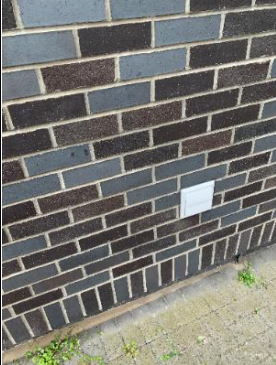
| 9.17-9.18 | <p>A vent has been installed on the side of the premises near the smoking area as per the previous recommendation.</p> |

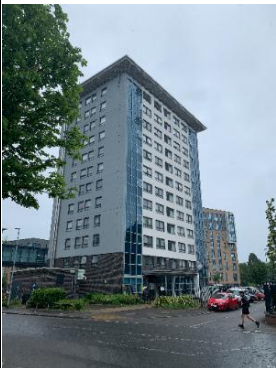
| 9.28-9.29 | <p><b>The previous FRA confirmed the below in relation to the external cladding system on the building. No changes have been advised:</b></p> <p>A product sheet certificate has been provided to our assessor for the external wall insulations (EWI) system fitted to the building. This is a TERMOK8 external wall insulating render system comprising of mechanically fixed mineral wool dual density or mineral wool lamella insulation slabs, with supplementary adhesive, reinforced basecoat and either render or brick slip finishes. The product certification states a reaction to fire classification of A2-s1, d0 in accordance with EN 13501-1, which exceeds the minimum requirements for a building with a storey above 18m as detailed in Section 10.6 of Approved Document B Volume 1 (this minimum requirement is A2-s3, d2).</p> <p>In addition to the provision of this product sheet, WCHG provided our assessor with an external façade report for the building, carried out by 'High Rise Fire Safety' in 02/2018. This certification states on page 5 of the report that 'The cladding affixed to the external façade of the premises is made up of layers of materials that individually, and collectively, have limited or non-combustible fire ratings as defined in Appendix A (A6 &amp; A7) of Approved Document B of the Building Regulations'. The report then goes on to confirm that the cladding will not contribute to fire spread on the building.</p> <p>Previous fire risk assessments have confirmed that the enclosed balconies have curtain wall glazing which is aluminium framed with clear and opaque glazing throughout.</p> |

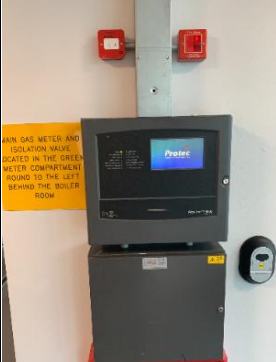
| Ref | COMMENTARY |
|---|---|
| 10.1, 10.4-10.6 | <p>The common area fire alarm and detection system incorporates smoke detection throughout the majority (except the biomass boiler room - see another commentary 10.1, 10.4-10.6) and heat detection in the hallways of each resident flat. It was noted that in this building, detection linked to the common BS5839-1 system was only provided in the corridor serving the community room areas, but not within each of the rooms adjoining this corridor. Instead, BS5839-6 Grade D interlinked detection was provided in this room to provide early warning to the occupants of those rooms. This is considered satisfactory. The fire alarm panel for the BS5839-1 fire alarm system is located at ground floor level in the staircase enclosure. It was previously confirmed that the system is addressable. Further detail regarding the fire alarm system and its purpose within the building is provided in commentary 12.14.</p> |

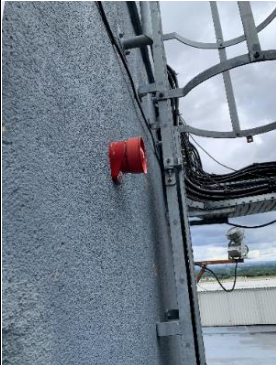
| Ref | COMMENTARY |
|---|---|
| 10.12 | <p><b>Extract from previous fire risk assessment:</b> The previous FRA raised an action in relation to there being no confirmation on whether a sounder linked to the fire alarm system was provided on the roof, nor could it be confirmed that, where provided, such a sounder is programmed to be audible. The previous FRA action has been signed off as complete on 16/09/2022 by Mike Holt. Threshold access was gained to the roof on this assessment with which a sounder was seen. Red cabling could also be seen penetrating the lift motor room walls to the roof area in this block indicating the fire alarm system extends to this area. Due to the action being signed off as complete, it is reasonable to assume that the sounder has been confirmed as audible as previously recommended.</p> |

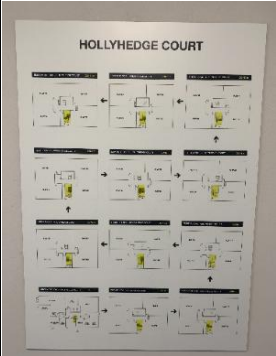
| Ref | COMMENTARY |
|---|---|
| 10.13 | <p>At the time of the fire risk assessment, a zone plan was observed adjacent to the fire alarm panel.</p> |

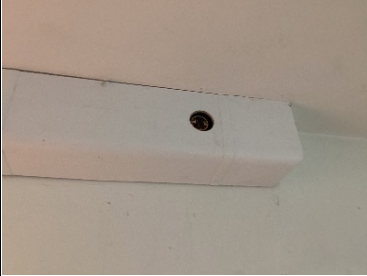
| 12.0 Fire Fighting Equipment, Facilities, Systems & Fixed Installations: Finding(s) | |
|---|---|
| 12.8 | <p>It was observed that there was a sprinkler cap missing in the community room/office area.</p> |

| 12.0 Fire Fighting Equipment, Facilities, Systems & Fixed Installations: Finding(s) | |
|---|---|
| 12.8 | It is recommended that a sprinkler cap be fitted. |

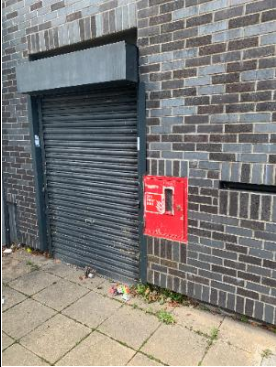
| Ref | COMMENTARY |
|---|---|
| 12.6 | <p>The dry riser inlet is located on the building's external façade.</p> |

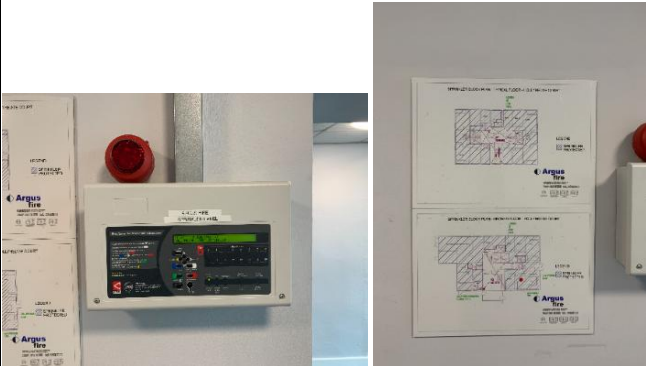
| Ref | COMMENTARY |
|---|---|
| 12.8 | <p><b>As noted on the previous FRA:</b></p> <p>A BS9251 sprinkler system has been installed. In each flat, there are concealed sprinkler heads located in the hallway, each bedroom, the lounge, and the kitchen. In addition, there are also sprinkler heads located in some ground floor plant and community areas. There are control valves for each floor in riser cupboards that adjoin the lift lobbies. A pump and water tank for the sprinkler system have been provided in the sprinkler tank room which is within the old caretaker's area. A sprinkler panel and plan are provided by the fire alarm panel in the staircase enclosure at the ground floor level. The previous FRA confirmed that the system is maintained and serviced by an approved contractor on a quarterly basis and contractors also attend weekly to visually check the sprinkler system.</p> |

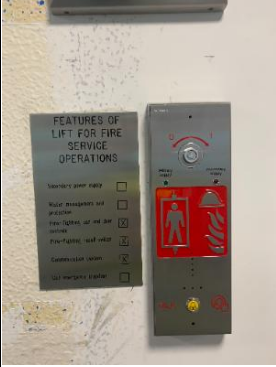
| 12.11-12.13 | <p>The previous fire risk assessment noted that the original 'Firemen's Switch' function for exclusive use by firefighters in an emergency was not confirmed. This action has been completed. The new lift has had the following alterations;</p> <ul style="list-style-type: none"> <li>• Fire-fighting car and door controls.</li> <li>• Fire-fighting recall switch.</li> <li>• Communication system.</li> </ul> <p>The function of the lift is noted on a metal plaque on the ground floor. WCHG have confirmed that the lifts will continue to be tested monthly. WCHG have confirmed that all information required and all keys will be provided to the Fire Service and will continue to be held in the SIB.</p> |

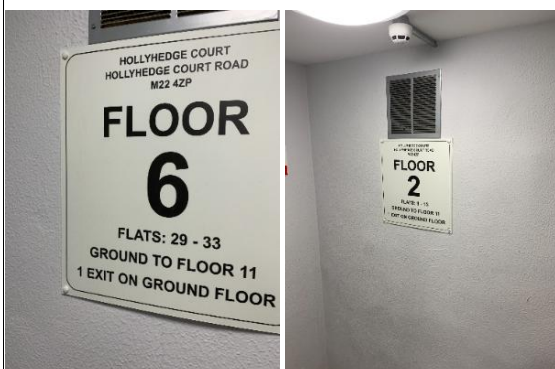
| Ref | FINDINGS |
|---|---|
| 13.15-13.16 | Wayfinding signage that has the floor number and directional signage to the flats, including flat numbers, is displayed in the lift lobbies and on the stairway landings. They appear to be mounted at the recommended height as per ABD and are all visible and in good condition.<br>Supplementary signage is also present, with signage outside the lift areas to show which flats are on each floor and which floors the two lifts access. |
