# TOTAL FIRE GROUP LTD

## Fire Risk Assessment

Village 135  
3 Hollyhedge Court Road  
Wythenshawe  
Manchester  
M22 4GW

12 January 2026

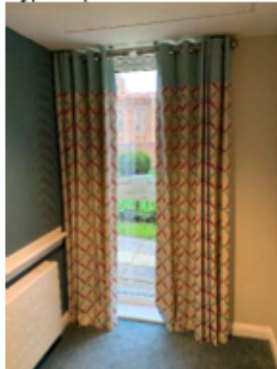
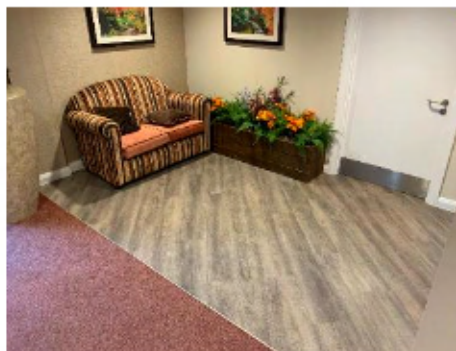
5.2 Some artificial plants and curtains were seen in various locations, including at the end of and in the corners of corridors. Previous FRAs have noted that certification dated 06/2019 was previously provided to our assessor, which evidenced that samples of these had been tested by 'Greenplants Group Ltd', which evidenced that each sample met the requirements for Type B performance in BS5867-2:2008.

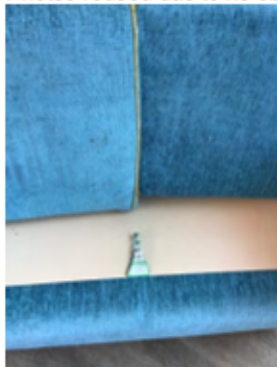
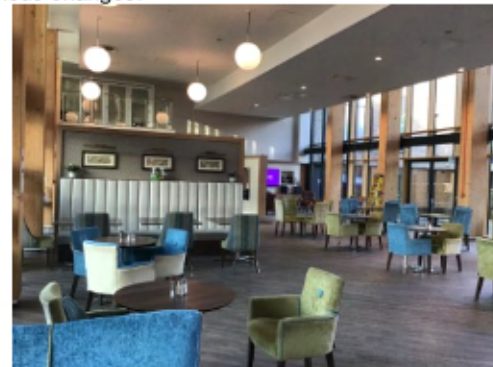
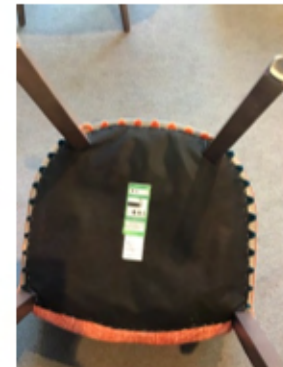
5.3-5.4 A sample of labels was observed, indicating the furniture to be of a reputable fire retardant standard. All furniture seen was found to be in good condition and free from any rips and tears. Upholstered chairs and occasional tables are located in lift lobbies, which are separated from the protected escape corridors by self-closing fire-resisting doors and alternative exit routes are provided from the corridors. These chairs are provided to assist residents whilst they wait for the lift or for transport. There were no obvious sources of ignition within the lift lobbies, and the stairs are protected by AOVs and smoke detection. Photos reused due to no obvious changes:

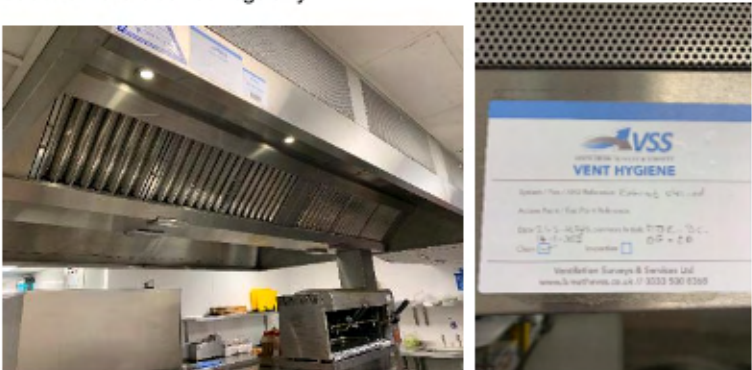
| Ref | COMMENTARY |
|---|---|
| 6.17-6.18 | A label on the ductwork extraction system located in the Bistro kitchen indicated that professional cleaning is carried out periodically, and was last cleaned/inspected on 14/01/2025. The kitchen Bistro is managed by a private company, but it is understood that WCHG would maintain the ducting. WCHG have confirmed via their standard responses that filters and ductwork are cleaned regularly. |

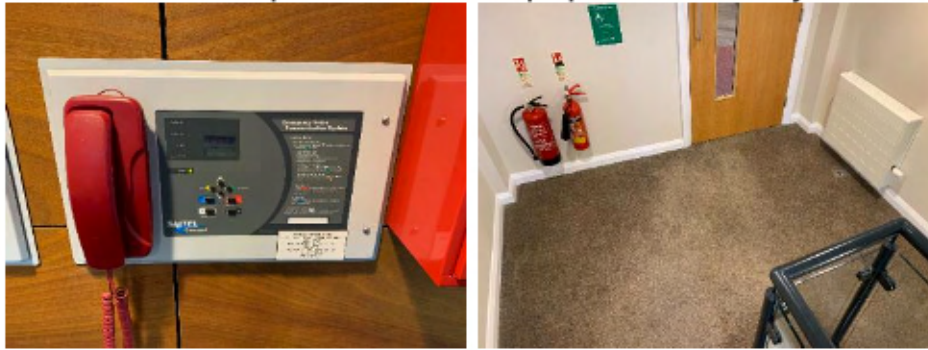
- 7.7 Each alternative escape staircase is provided with at least one chair, for use by those who require assistance using the stairs in the event of a fire. It is understood that staff are trained in their use. Refresher training for the use of the evacuation chairs should continue to be provided periodically.

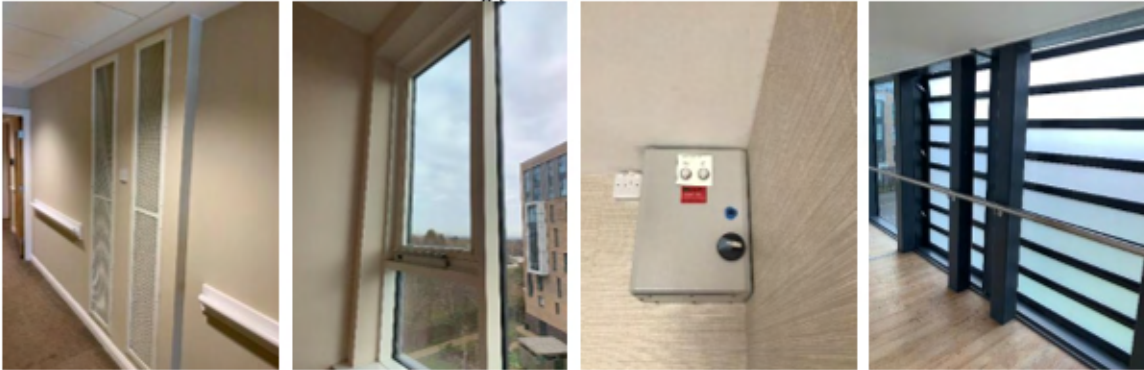
| Ref | COMMENTARY |
|---|---|
| <p><b>Retained for historical purposes</b> - The AOV control panel at the head of the main stairs in Redwood appeared in the off position with no lights illuminated, as previously observed. However, it has been confirmed that no lights should be illuminated because during works a couple of years ago, the original control panel motherboard was removed and the housing retained. DH Mechatronics mounted a new D+H motherboard inside the original panel housing, and the new motherboard is not connected to the LEDs on the front of the existing panel.</p> | |

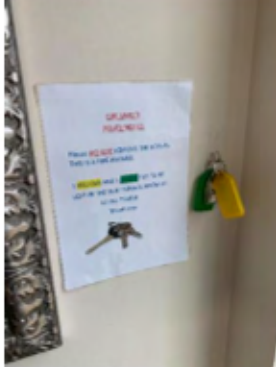
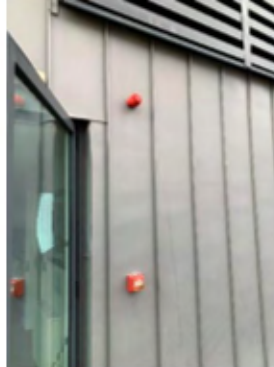
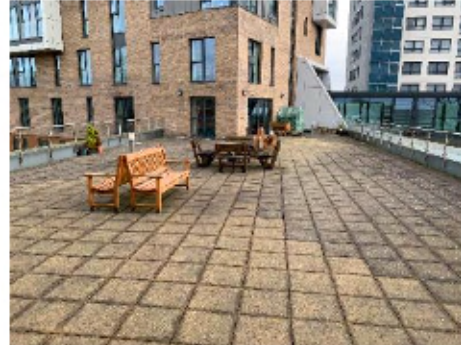
- 8.6 The roof garden area above the Hub (Skylark Terrace) was observed, and keys are provided on hooks by each entrance door. This has been a long-standing measure, and at each annual fire risk assessment, the keys have always been noted as being available as recommended. The keys on hooks remain a suitable precaution for the exit doors. The procedure when opening the garden is to unlock both doors of the garden to provide alternative exits; however, this is not essential as there is a substantial distance between the escape routes within the open air, and any fire is highly unlikely to present a significant risk to persons on the roof garden. The correct keys were observed to be in position by each door. Additionally, suitable fire alarm sounders are in position on the exterior walls of the roof garden. Residents would be aware of the fire alarm sounding in the building.

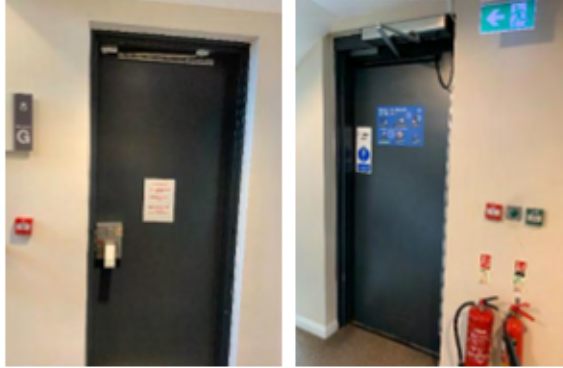
Some of the doors from the Bistro cafe area are key-operated/locked, but there are designated escape routes that have push pads in the same area, which is considered to be acceptable.

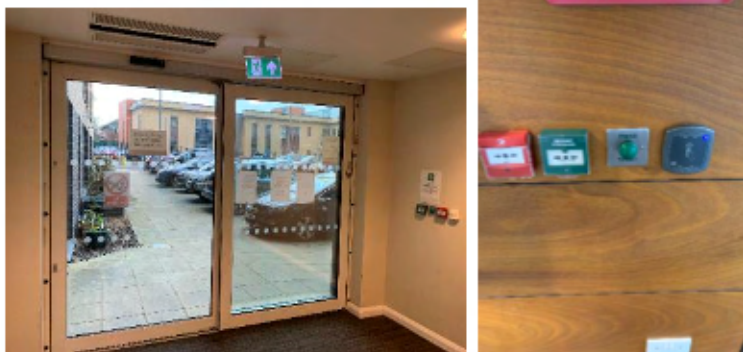
Some final exit and restricted access doors in the common areas are provided with electromagnetic locks and power-assisted openers. They are linked to the fire alarm and release upon its activation. They are also provided with a 'Green Box' emergency override device in accordance with current guidance, which releases the locks, allowing the doors to be pushed open if required. The call points and release buttons were also shielded to prevent accidental actuation.

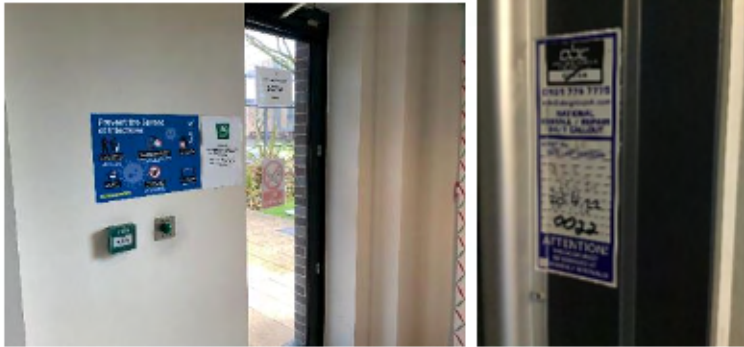
- 8.17 The door leading externally by flat 1 in Block A is electromechanically secured and operated by a fob from the outside and a green push button internally, together with a fail-safe emergency box with a frangible cover. This door is intended for exit and access by residents of the block. At the build stage, an illuminated emergency exit sign was fitted above the door, indicating it as an emergency exit. The door is not provided with the recommended emergency-type release devices normally expected for an emergency exit door. However, the door is not required as part of the emergency exit strategy as there is sufficient provision of exits within recommended travel distances, which may be used if this door is unavailable. Also, only a very small number of persons would attempt to use this exit for evacuation purposes due to the presence of other nearby exits. To alter the security devices on this door to provide security from the outside and simple manual devices internally to conform to the current guidance is considered excessive and not reasonably practicable, given the very small reduction in risk to life that would be achieved. Other electronically controlled exit doors are regularly serviced.

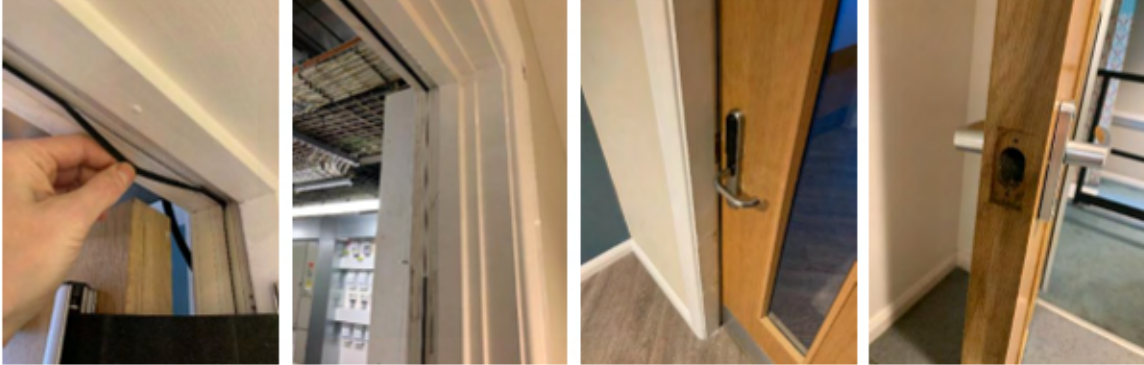
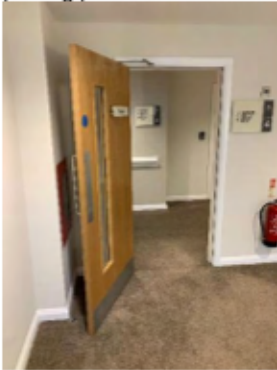
| Ref | FINDINGS |
|---|---|
| | <p><b>Observation</b></p> <p>9.1, 9.5-9.6 Several communal fire doors had deficiencies that were identified on this assessment. The types of issues include:</p> <ul style="list-style-type: none"> <li>• Doors do not fully self-close into their rebates.</li> <li>• Doorsets that had large gaps that exceeded the recommended tolerances (typically 3-4mm for smoke stopping doors).</li> <li>• Doors that had missing or damaged intumescent fire and cold smoke seals.</li> <li>• A door was noted to have unsealed voids in the door edges, a damaged architrave and gaps between the architrave and surrounding structure (this was isolated to the refuse room on the ground floor for block C (Hawthorne) and D (Oak)).</li> </ul> <p>Where fire doors are not self-closing, have holes/gaps, or have missing/damaged components, fire or other products of combustion may be able to spread onto the escape route, placing persons at risk of harm.</p> <p><b>Note:</b> A full list of issues (17 separate issues identified) was handed over to the onsite caretaker for specific locations and the type of issue. It must be noted that the doors checked on this assessment were a sample of the doors within the building, and there may be other doors with similar issues that have not been picked up due to a sample check.</p> <p>Example pictures of the issue identified:</p> <p><b>Recommended Actions</b></p> <p>9.1, 9.5-9.6 As part of the building fire door audits that are undertaken by a competent person, any deficiencies identified should be rectified. Remediation works should include ensuring intumescent fire and cold smoke seals are installed/replaced where required, doors/self-closing devices adjusted to enable doors to fully close unaided, gaps reduced to tolerable levels, and gaps filled with fire-rated material to the same standard as the doors.</p> <p><b>Observation</b></p> <p>9.5 The stairway door in Block C (Hawthorne) on the 4th floor, opposite flat 107, stuck in the open position on the carpet when tested. Where fire doors do not self-close, fire or other products of combustion may be able to spread onto the escape route, placing persons at risk of harm.</p> <p><b>Recommended Actions</b></p> <p>9.5 It is recommended that the flooring/door/self-closing device be adjusted to ensure the door fully closes into its rebates unaided by persons.</p> |

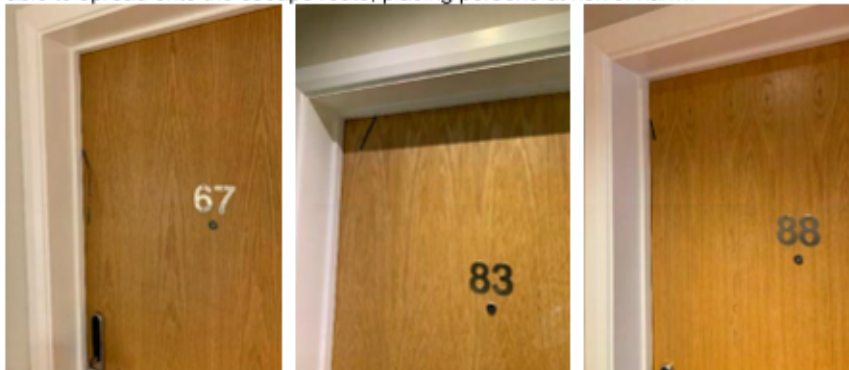
- 9.6 Although the doors were not accessed in the open position, flats 67, 83 and 88 seemed to have a smoke seal damaged and hanging down in front of the doors. Where fire doors have damaged components, fire or other products of combustion may be able to spread onto the escape route, placing persons at risk of harm.

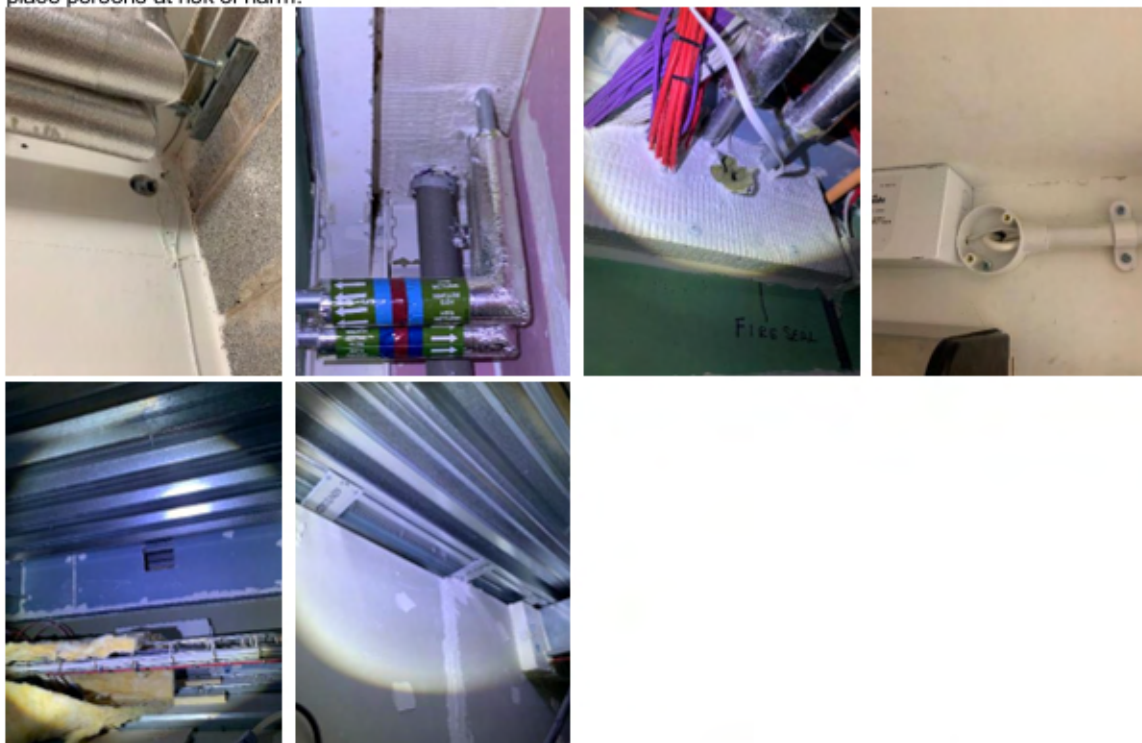
**It must be noted that the areas checked on this assessment were a sample within the building.** Breaches in fire resisting construction that are not suitably fire stopped could lead to a fire spreading beyond the compartment of fire origin and place persons at risk of harm.

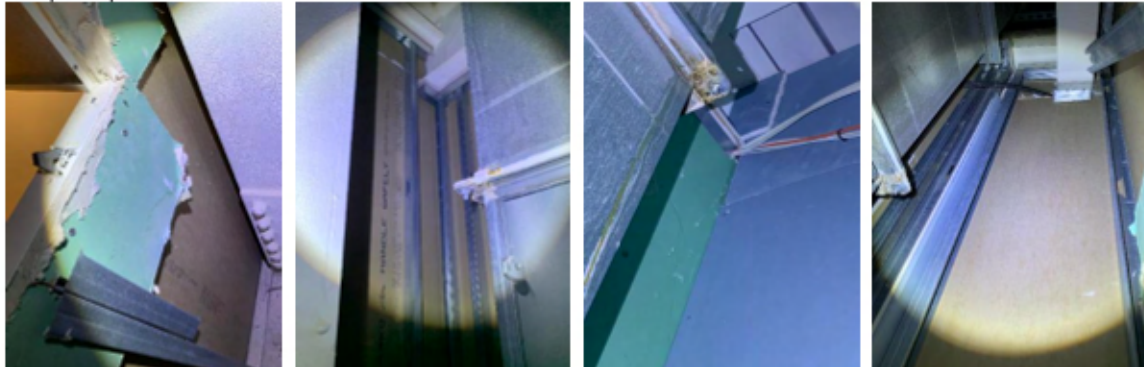
- 9.8 The riser for the kitchen extraction in Block B (Cedar) runs through a shaft, and there does appear to be missing fire stopping on the inside of the shaft walls where cables run and other areas where plasterboarded edges haven't been sealed or are missing and damaged. This shaft opens into flat corridors. Breaches in fire resisting construction that are not suitably fire stopped, or areas that are not adequately compartmented, could lead to a fire spreading beyond the compartment of fire origin and place persons at risk of harm.

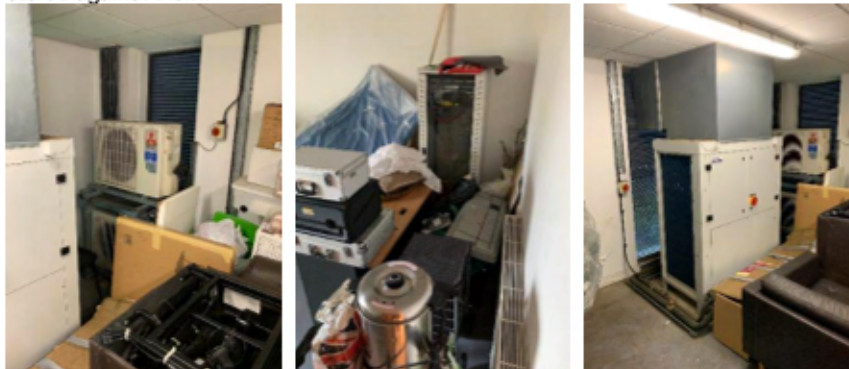
- 9.16 Some of the stores contain plant and electrical equipment, and combustible items were found stored in proximity to and up against them. Plant and electrical equipment can be a potential source of ignition if combustible materials are within reach and stored against them.

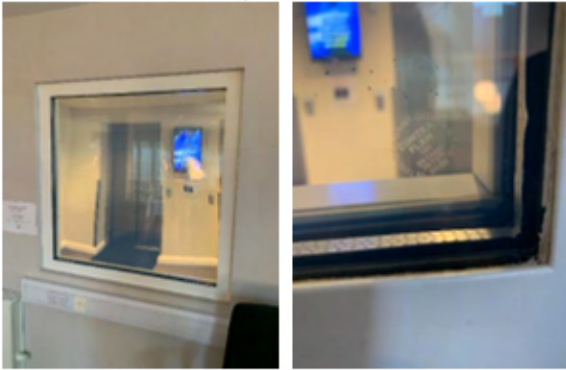
| Ref | COMMENTARY |
|---|---|
| 9.1 | <p>There are window-glazed units that separate the firefighting shaft from the lobby areas in Block B (Cedar) on the 1st and 2nd floors (includes the area to the walkway bridge). These windows appear to be fire-rated with the stamp on the glazing stating Vetrotech Saint-Gobain Int.Ag - ContraFlam 120.</p> <p>There are also other glazing units that are adjacent to the community hub area and other rooms on upper floors, and glazing units next to other doors, such as those on the Mezzanine room and Goldfinch room, which all appear to be fire rated glazing.</p> <div data-bbox="236 344 804 712"> </div> |

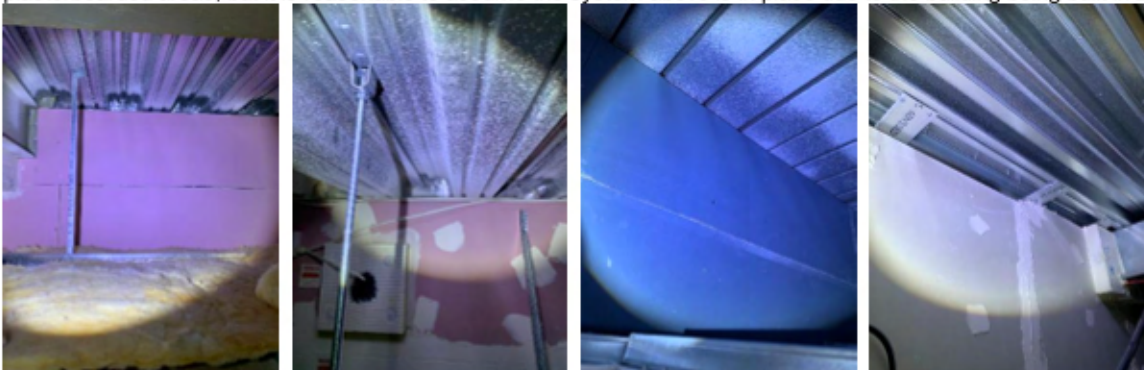
| Ref | COMMENTARY |
|---|---|
| 9.1-9.2, 9.8 | <p>Some areas were viewed from a sample check above false ceilings, where the plasterboard walls fall short of the floor slab above, and have not been fully sealed around this area on the outer layer of the plasterboard. However, although this has not been confirmed, this appears to be the commonly known deflection head system and is very common in newly built buildings complying with Approved Document B. In many constructions, slight movements from thermal expansion, seismic activity, or differential settlement require that a movement joint be provided, especially at the head of the wall junction where a plasterboard fire compartment wall meets an adjoining element such as a floor in this scenario, and as noted in Approved Document B it states that compartment walls should be able to accommodate deflection of the floor, when exposed to fire. There were, however, other areas that had these areas fire stopped and sealed. If there are any doubts about this system, then WCHG should seek confirmation on the system arrangement to ensure adequate compartmentation exists behind the plasterboarded areas, but it is reasonable to assume the system above is in place due to the building being built in 2017.</p> <div data-bbox="236 1032 1385 1400"> </div> |

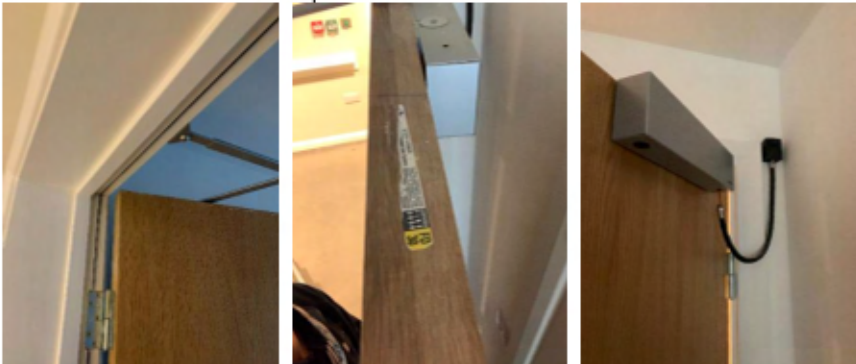
| Ref | COMMENTARY |
|---|---|
| 9.1, 9.5-9.6 | <p>The apartments accessed are fitted with self-closing FD30s flat entrance doors. The doors were on free-swing self-closing devices, which would be linked to the BS5839-1 and BS5839-6 fire alarm systems in the flat. Internal rooms within the apartment were also fitted with FD30 notional doors. A suitable type of letter plate is fitted halfway down the main access door to the flats. These have spring-loaded and sealed flaps both internally and externally. It is assumed that all the access doors to the apartments/flats in the premises are of the same standard.</p> <p>Communal, and store/riser fire doors appeared to be similar in nature to the above, to either an FD30/60s standard. Test evidence of all of the fire doors performance was not available.</p> <div data-bbox="236 1615 1096 1977"> </div> |

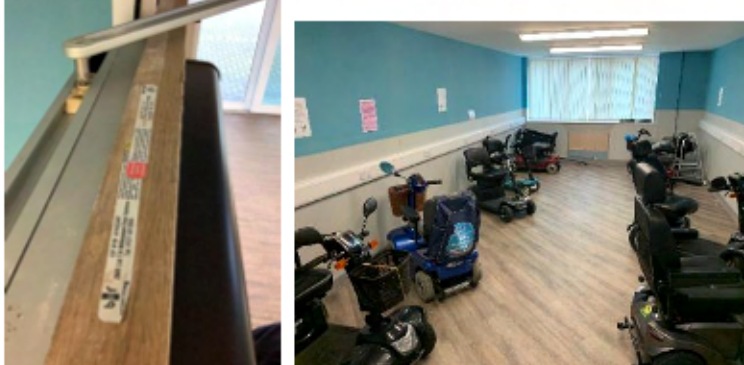
- 9.1, 9.5-9.6 It was identified that the doors to both the mobility scooter stores are of an FD30s standard and the scooter stores are quite large, often containing more than 6 scooters on charge at any one time (15 noted in one on this assessment). However, the doors do not open directly onto an escape route, but rather into the entrance lobbies at the front; there is at least two FD30 door separations between each scooter room and any escape corridor serving flats. This was considered acceptable by our consultant, as a fire in the scooter rooms would be quickly detected, they are sprinkler protected, and alternative escape routes would be available to the sides and rear, and the 2-door separation detailed above is in place. Staff are on site 24 hours a day, and any alarm activations are quickly investigated.

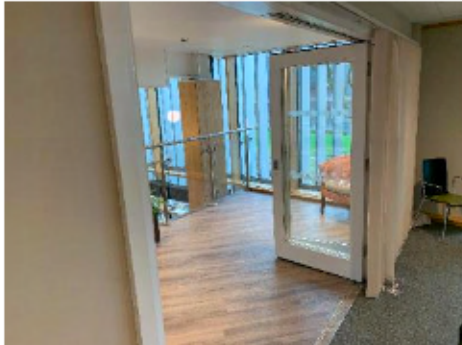
- 9.1, 9.5-9.6 The Nightingdale room has bi-folding doors that open into the main hub area on the ground floor. These do not appear to be fire rated doorsets. However, there is a fire doorset at the entrance to the room that appears to be adequate and is kept locked shut when not in use. It is understood that the bi-folding doors are also kept in the closed position when the room is not in use. Our assessor considers this to be low risk.

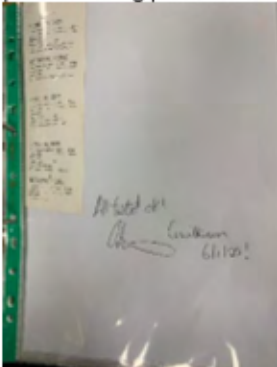
| Ref | FINDINGS |
|---|---|
| 10.15 | <p><b>Observation</b></p> <p>The fire alarm system doesn't appear to be tested weekly at different call points, as call point 64 is the only call point that appears to be tested. The testing documentation is noted on a plain piece of paper with every fire alarm ticket log. Failing to test all call points in rotation may result in the system not operating as required in the event of a fire, raising the potential for persons being placed at risk of harm.</p> |

| 10.15 | <p><b>Recommended Actions</b></p> <p>It is recommended that all call points be included when testing the fire alarm system. Testing one call point per week would be acceptable.</p> |

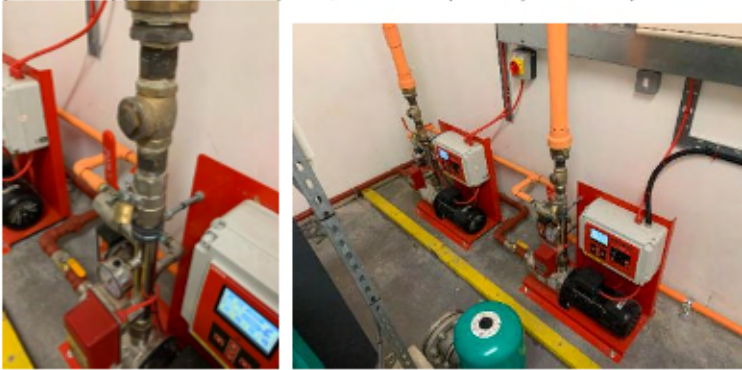
- 12.8 The previous FRA raised a finding concerning the main sprinkler stop valves in the Cedar and Hawthorn tank rooms not being secured, and should be secured open by a padlock. The previous FRA action was signed off as complete on 06/02/2025 with comments against the finding, noting that Argus returned and locked off all the levers in all blocks. On this assessment, padlocks appeared to be in place, and a sample of sprinkler stop valves was observed to be locked in the open position.

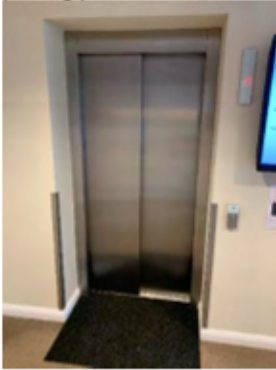
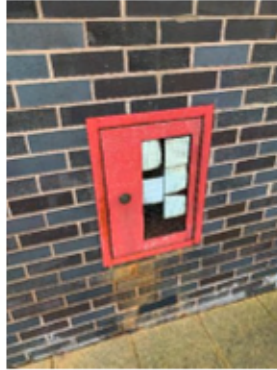
| Ref | FINDINGS |
|---|---|
| 13.10 | <p><b>Observation</b></p> <p>The areas outside the lifts on some of the floors in Block B (Cedar) were missing a 'Do Not Use Lift In The Event of Fire' sign, and the dry riser inlet located on the front of Block D (Oak) was missing. If residents use the lift in a fire situation, they may become trapped, putting them at risk of harm. Also, missing signage on dry risers may delay firefighting operations, also placing persons at risk of harm.</p> <div data-bbox="236 389 512 757" data-label="Image"> </div> <div data-bbox="523 389 801 757" data-label="Image"> </div> <p><b>Recommended Actions</b></p> <p>It is recommended that a "Do Not Use Lift In The Event of Fire" sign be displayed at each level, and a dry riser inlet sign be displayed on the identified inlet.</p> |

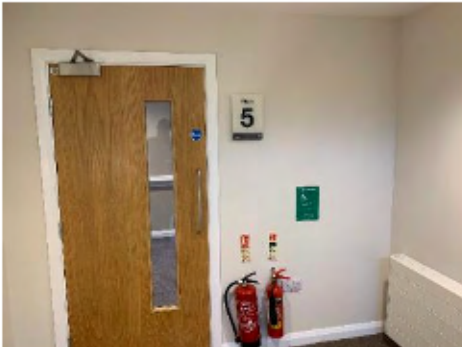
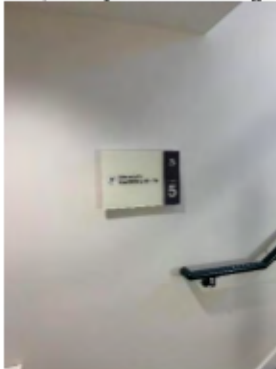
| Ref | FINDINGS |
|---|---|
| 13.15-13.16 | <p><b>Observation</b></p> <p>Wayfinding signage has been installed to indicate floor levels and flat locations in the communal corridors to the upper floors in Block B (Cedar), which are deemed acceptable as they are all visible and in good condition. However, this doesn't appear to fully align with the guidance, as the wayfinding signage to assist attending firefighters in the identification of flat locations within staircase 2 of the block is not provided on the correct floor level where the flats are located. Although the lower floors state what is located on the floor above, the absence of wayfinding signage on the correct floors may disorientate and delay firefighters in reaching the required area of the building, placing persons at risk of harm.</p> <p><b>Note:</b> Wayfinding signage not fully in line with the recommendations in current guidance has been raised on previous FRAs, and the action has been signed off as complete with notes stating the following: 19/07/24 Updated 15/07/24 Spoke with GMFRS, Paul Watson. I explained the comments in the FRA that signage may not strictly comply with approved Document B; however, he asked if every floor had signs and emergency lighting. I confirmed the village did, and he said that was acceptable. No action is needed at the present time; it may need revisiting if legislation changes.</p> <div data-bbox="236 1211 699 1556" data-label="Image"> </div> <div data-bbox="710 1189 986 1556" data-label="Image"> </div> <p><b>Recommended Actions</b></p> <p>If the fire service has previously confirmed that this arrangement is suitable, then confirmation in writing should be sought, or the following action is required.</p> <p>It is recommended that wayfinding signage be provided in the staircase areas identified, which will adequately assist attending firefighters in identifying flat locations within the building. Such signage should be clearly visible in low light or smoky conditions, and it may be prudent to provide such signage at a low level as well due to the possibility of smoke layers.</p> <p><b>Note:</b> All floor identification signs should be supplemented by flat indicator signs, which provide information relating to the flats accessed on each storey.</p> |

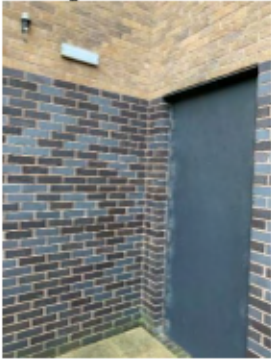
| Ref | COMMENTARY |
|---|---|
| 13.10 | <p>Although not all fire exits have 'Fire Exit Keep Clear' signage affixed to the external side, those that do not, are not at risk of being blocked due to these being set back from areas where blockage could occur (e.g. on raised pavement areas). No blockage of these exits was observed at the time of this fire risk assessment.</p> |
