# TOTAL FIRE GROUP LTD

## Fire Risk Assessment

1-58 Benchill Court  
Wythenshawe  
Manchester  
Greater Manchester  
M22 4GL

04 June 2025

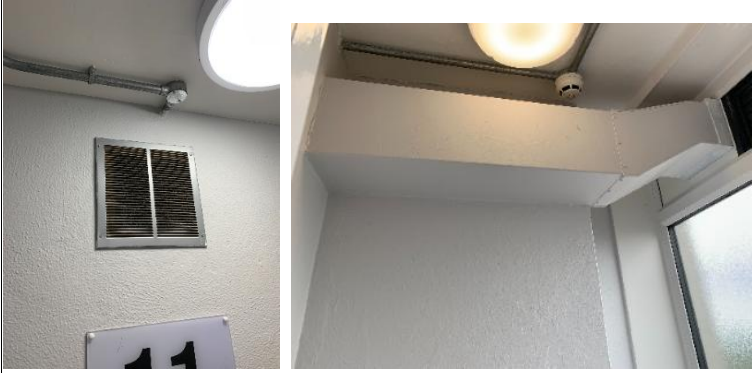
Ref	COMMENTARY
8.2	<p>The below photographs show an example of the means of smoke ventilation in the stairway of the premises. The layout is the same on all floors from the first floor upwards. The vent on the stairs leads into the metal ducting which in turn vents direct to outside, passing through the refuse chute room on its way. The previous FRA confirmed that WCHG have engaged third parties to confirm that this method of smoke ventilation is adequate. Smoke modelling calculations have been provided by a fire engineer who concluded that provided new grilles were fitted and the ducting was cleaned that the existing provisions for smoke ventilation are satisfactory. Also previously advised is that in addition, the ducting has been inspected by another third party who confirmed that they were fit for purpose. Although not viewed on this assessment, it is understood that WCHG has documentary evidence available issued by the third parties.</p> <div data-bbox="236 448 991 819">

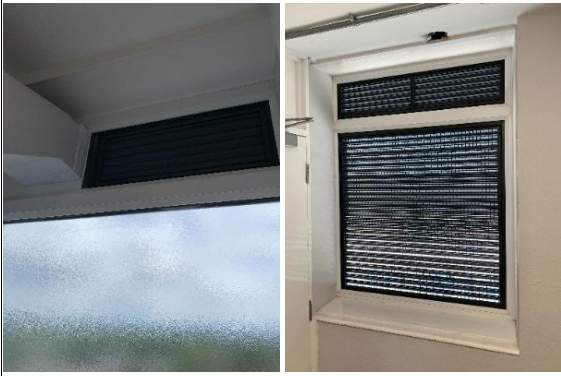
8.2	<p>The corridor between the lobby serving flats and the staircase is provided with permanent ventilation, as is the refuse chute room.</p> <div data-bbox="236 898 799 1272">

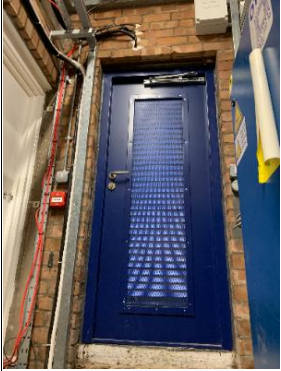
8.6	<p>A louvred door provides a means of permanent ventilation to the lift motor room.</p> <div data-bbox="236 1328 517 1697">

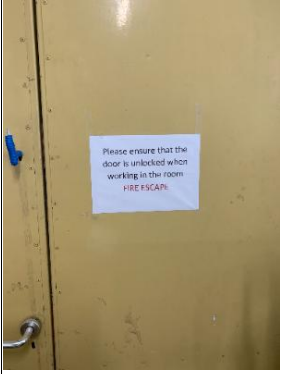
8.11	<p>The previous assessment noted that the double doors from the plant room within the caretaker area were found key-locked shut. Although an alternative exit is available back through the building, this exit leads directly to open air and would be the preferred choice if evacuation were needed from this area.</p> <p><b>Note:</b> It was observed that there was now signage on the door that informed the occupant to unlock the doors when undertaking any work. This is deemed acceptable as the doors need to be secure (security risk).</p>

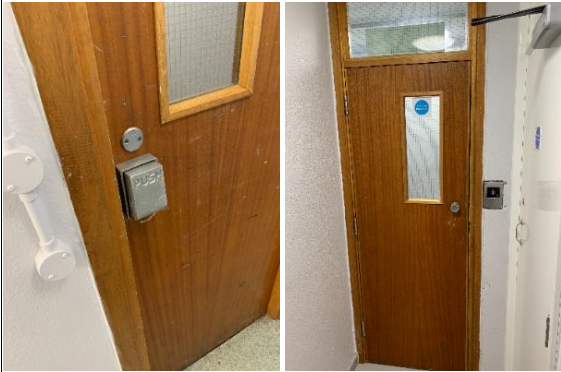
8.17	<p>Electromechanically secured doors separate the staircase from the corridors serving flats and these require fob access in the direction towards the flats. In the direction of escape, a suitable push pad device is provided leading into the stairs.</p>

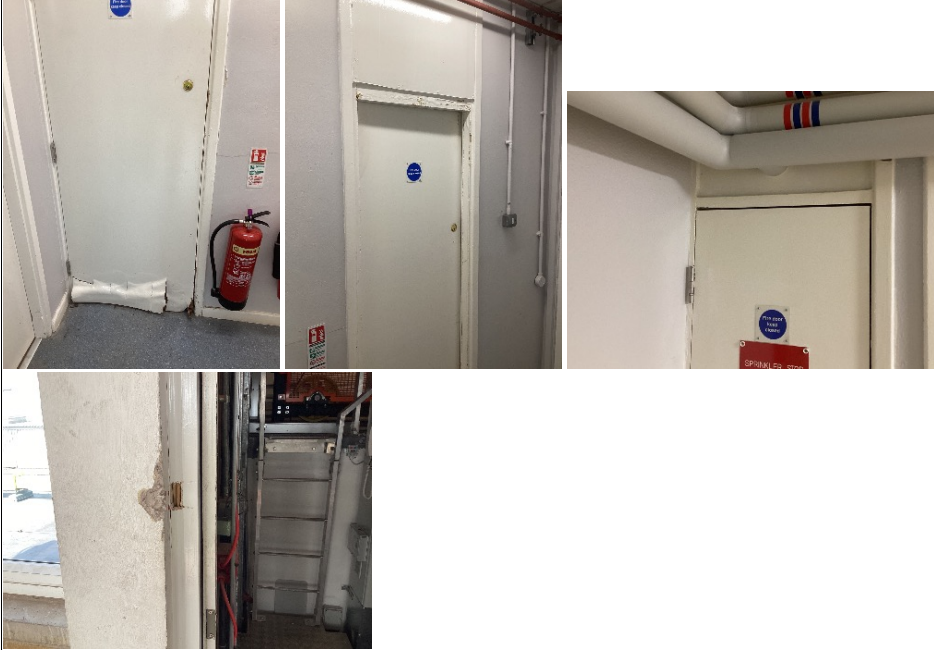
Ref	FINDINGS
	<b>Observation</b>
9.1, 9.5	<p>It was observed at the time of the fire risk assessment that there were deficiencies to communal doors ;</p> <ul style="list-style-type: none"> <li>• There was damage to the doorframe of the lift motor room.</li> <li>• The bin room door on the 10th floor had a damaged smoke seal.</li> <li>• There was an excessive gap at the top of the sprinkler valve cupboard door exceeding 4mm adjacent to flat 20.</li> <li>• The storage room and electrical room doors within the hallway outside of the community room were found to be water-damaged.</li> </ul> <p>Where there are deficiencies to fire doors as highlighted above, fire doors may not perform as expected in the event of a fire, placing persons at risk of harm.</p>

9.1, 9.5	<p>It is recommended that, where fire doors/ doorframes are damaged, they be repaired/replaced. Damaged smoke seals should be replaced. Gaps to the top of fire doors should be reduced to around 3-4mm.</p>
	<b>Observation</b>

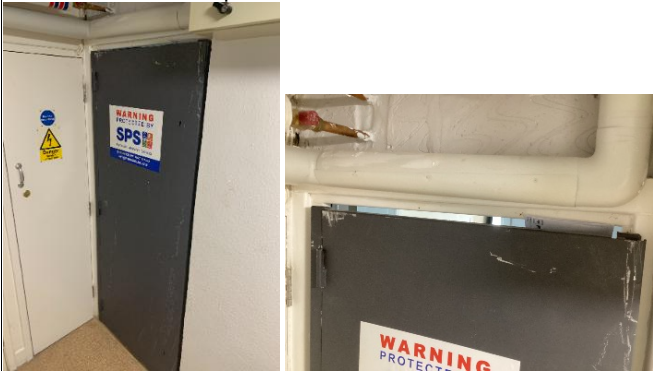
9.1, 9.5-9.6, 9.8	<p>At the time of the fire risk assessment, it was observed that the entrance door to flat 43 had been removed and replaced with a temporary, ill-fitting metal door. This door is not a certified fire door (FD30s) and would not provide the expected level of fire and smoke resistance, placing persons at risk of harm.</p> <p><b>Note:</b> This flat is occupied.</p>

9.1, 9.5-9.6, 9.8	<p>It is recommended that this flat be fitted with an appropriate FD30s.</p>

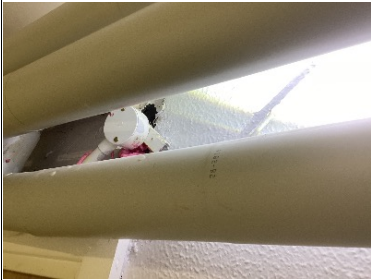
<b>Observation</b>
9.1, 9.8	<p>It was observed that pink foam had been used above flat 5 to potentially seal a breach in compartmentation. Where potentially inappropriate materials are used to fire stop breaches, it may not provide the expected level of fire resistance, placing persons at risk of harm.</p>

9.1, 9.8	<p>It is recommended that the pink foam used be confirmed to be fire-resistant and to a 60 minute standard. It should be noted that the data sheet for the pink foam should be consulted to ensure that it has been installed as recommended by manufacturers.</p>
	<b>Observation</b>

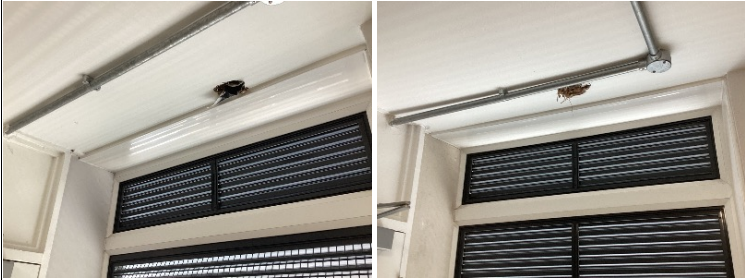
9.1, 9.8	<p>It was observed at the time of the fire risk assessment that there was damage to the ceiling outside of the bin room on the top floor and the second floor. Where there is damage to the ceiling of the communal area, it may not provide the expected level of fire resistance, placing persons at risk of harm.</p>

9.1, 9.8	<p>It is recommended that the damage be repaired so that the ceiling is rated to 60 minutes of fire resistance.</p>

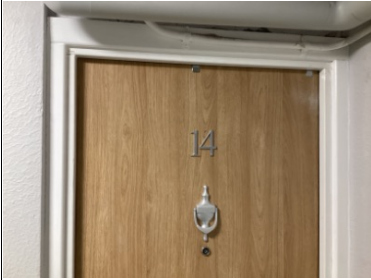
Ref	RECOMMENDATIONS
	<b>Observation</b>
9.1, 9.6	<p>Previously highlighted, it was observed at the time of the fire risk assessment that there were overhanging hooks on the flat entrance door of flat 14. These hooks may potentially harm the smoke seals on the top of the door.</p> <p><b>Note:</b> Justin Gill attached a photo to this recommendation of the entrance door to flat 14 with no overhanging hook. The resident has since put this hook back on the door.</p>

9.1, 9.6	It is recommended that this hanger be removed and the resident be reminded that they should refrain from hanging items from their flat entrance door.
	<b>Observation</b>

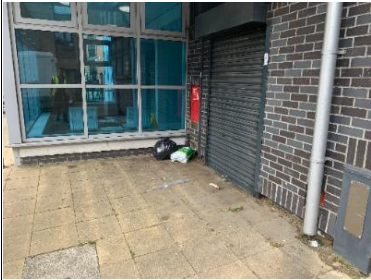
9.15-9.16	<p>It was observed at the time of the fire risk assessment that refuse sacks were stored against the side of the building.</p> <p><b>Note:</b> The amount of combustibles had been reduced since the previous fire risk assessment, however, it seems that residents may use this area to store rubbish.</p>

9.15-9.16	It is recommended that these items be removed.
	<b>Observation</b>
9.16	<p>Rubbish was found stored in the ground-floor electrical room from the community area.</p>

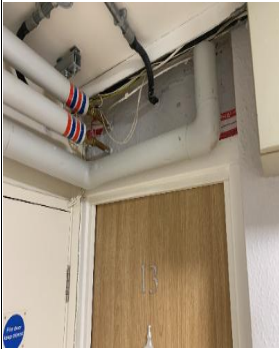
9.1, 9.5-9.6	The previous fire risk assessment noted that there were works ongoing to remove the panelling above flat entrance doors, this work is ongoing. (1. photo from the previous assessment.) (2. Current state above the flat entrance doors). (3. most recent photo of above the flat entrance doors).

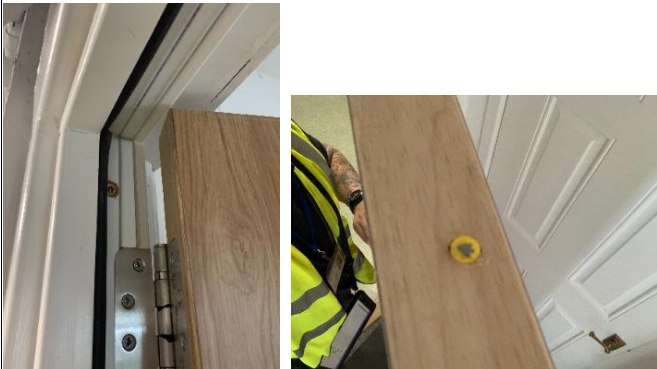
9.1, 9.5-9.6	A sample of flat entrance doors were accessed and visually inspected. The entrance doors accessed appeared to be robust timber doors certified to FD30, and installed with intumescent fire and cold smoke seals, and a self-closer. A label was provided on the top door edge, and BM Trada door plugs were also installed in the door edges. It is reasonable to assume that the remaining flat entrance doors are of the same door assembly and furniture as they all visually appeared to be the same. Test evidence of each fire door's performance was not available, however, one was observed as part of a previous action.

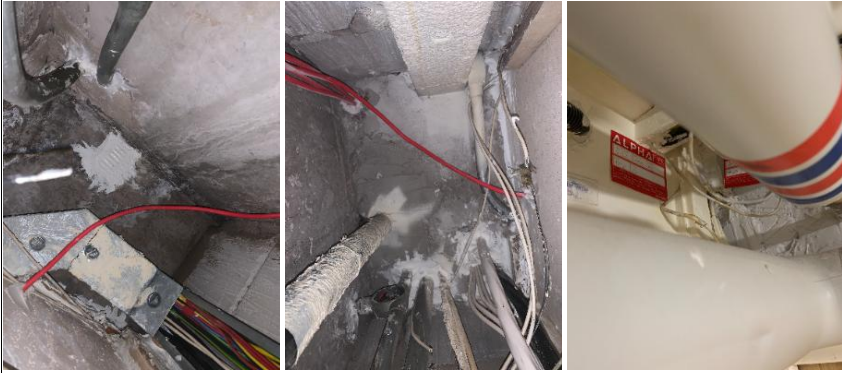
9.1, 9.8	<p>As highlighted previously, compartmentation works have been carried out throughout the premises by Allied Protection Ltd. They are an accredited passive fire protection contractor and it is understood they have provided WCHG with documentary/photographic evidence of their work (not seen on this assessment). Following the installation of the fire alarm system, further fire-stopping was required. This was carried out by Flame Hold Ltd who are also an accredited passive fire protection contractor. It is also understood they have provided WCHG with documentary/photographic evidence of their work (not seen on this assessment). The majority of the fire-stopping and compartmentation work throughout the premises was observed to be of a high standard. Exceptions to these high standards have been detailed within the finding 9.1/9.8.</p>

9.1, 9.8	<p>Where the level of fire stopping or fire resisting construction is found to be below an acceptable standard remedial fire stopping work should be carried out. Breaches in fire resisting construction should be filled with suitable fire resisting materials to maintain the standard of fire resistance of the surrounding structure in accordance with BS 476 Pt 22 or BS EN 1364 Pt 1 to 6. The use of third party accredited passive fire protection contractors and products should ensure any remedial actions will be to the required standard in the most cost effective manner.</p> <p>The Responsible Person ought to have in place a system for ensuring that the integrity of any passive fire protection measures is not compromised when building alterations are carried out e.g. for the installation of new pipes, cables and other services. Records of these should be maintained for future inspection by auditors and enforcement agencies.</p> <p>One common available fire stopping product is expanding fire resisting foam. To avoid unnecessary costs, the universal use of expanding fire resisting foam products should be used with caution and in strict accordance with the manufacturer's recommendations to achieve the required fire resistance. Generally, expanding foam products are tested as narrow linear gap seals and will not work in a large penetration seal. The Guide to Inspecting Passive Fire Protection for Fire Risk Assessors produced by The Association for Specialist Fire Protection advises that PU expanding fire resisting foam products should only be used to seal linear gaps between walls and walls / floors / ceilings. It cannot be used to seal pipe or cable penetrations unless tested for that end-use application. In this case, other more appropriate fire stopping products should be used. It is recommended where rectifying life safety compartmentation issues that third party accredited contractors, who have been accredited to undertake the particular aspect of works, using appropriate third party accredited products is considered.</p> <p><b>Note:</b></p> <p><b>Compartmentation</b> - Compartment walls and floors should form a complete barrier to fire between compartments they separate and have the appropriate fire resistance.</p> <p><b>Fire Stopping</b> - If compartmentation is to be effective, every joint or imperfection of fit, or opening to allow services to pass through the compartment, should be adequately protected to the same standard of fire resistance by sealing or fire stopping so that the fire resistance of the compartment is not impaired.</p>

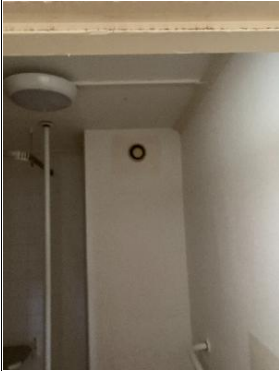
9.11	<p>The previous FRA confirmed that WCHG has confirmed that Allied Protection Ltd has completed fire stopping and compartmentation works to prevent fire spread via the common bathroom and shower room extract shafts. They have also fitted fire-rated valves with an intumescent infill in the bathrooms which are connected to the ducting and shaft. Although these valves will not prevent smoke spread into the shaft in the early stages of a fire they are considered an acceptable method of preventing fire spread. Documentary and photographic evidence is available to evidence the works carried out by Allied Protection Ltd and are held by WCHG. These were not viewed during this assessment.</p>

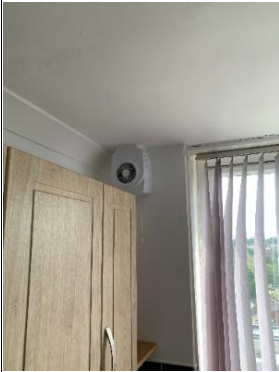
9.11	<p>It was noted that the kitchen ventilation in the flats seen is extracted directly to the outside, via a powered fan, which was not common to any other flats. It is assumed that all the flats in the block have similar provisions installed.</p>

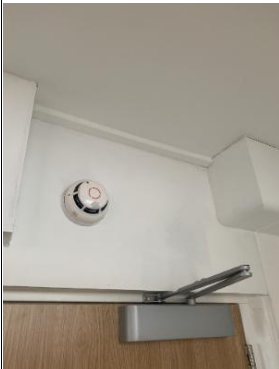
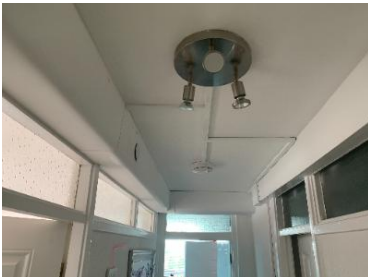
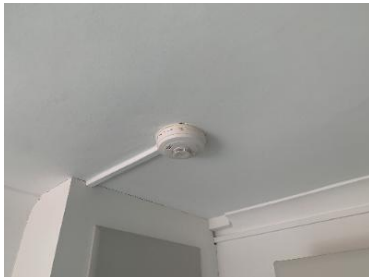
10.2-10.3	<p>In general, the resident flats accessed were provided with BS5839-6 Grade D LD1 fire alarm systems and WCHG have previously confirmed that that this provision is consistent throughout all of the flats in the building. As part of their standard responses, WCHG advised that all alarms in flats are checked and the findings recorded as part of the annual gas servicing.</p> <p>Due to the above process and physically seeing detection in flats accessed, it is reasonable to assume that this is representative of the remainder of the flats.</p> <div data-bbox="236 792 515 1160" data-kind="parent" data-rs="3">

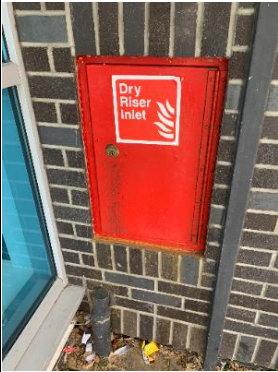
12.4-12.5	It is understood that firefighting equipment is inspected on a monthly basis and was last serviced by Complete Fire Systems Ltd on 09/2024.
12.6	<p>The dry riser inlet is located on the building's external façade.</p>

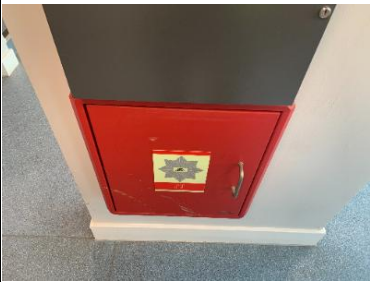
12.6, 12.15-12.16	<p>As part of their standard responses, WCHG maintains Secure Information Boxes (SIB). Although not accessed, it was seen that a SIB has been installed in the entrance foyer. It is reasonable to assume the fire service carries a key to gain access to the box. It must be noted that the responsibility for providing and updating the information with regard to any vulnerable tenants remains with WCHG.</p> <p><b>Therefore, WCHG should ensure that the information stored in the SIB is correct in line with current guidance, kept up-to-date, and regularly reviewed.</b></p> <p>The previous FRA noted that WCHG confirmed that the SIB contains the following information:</p> <ul style="list-style-type: none"> <li>• Access keys for all areas.</li> <li>• Personal Emergency Evacuation Reports.</li> <li>• Passenger lift supporting information.</li> <li>• Access codes.</li> <li>• Asbestos refurbishment survey.</li> </ul>

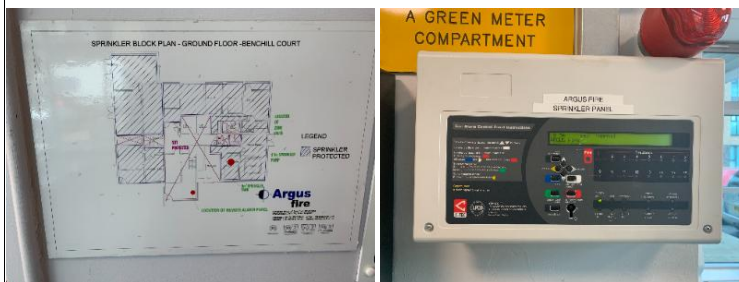
- 12.8-12.9 **As noted on the previous FRA:**
- A BS9251 sprinkler system has been installed. In each flat, there are concealed sprinkler heads located in the hallway, each bedroom, the lounge, and the kitchen. In addition, there are also sprinkler heads located in some ground floor plant and community areas. There are control valves for each floor in riser cupboards that adjoin the lift lobbies. A pump and water tank for the sprinkler system have been provided in the sprinkler tank room which is within the old caretaker's area. A sprinkler panel and plan are provided by the fire alarm panel in the staircase enclosure at the ground floor level. The previous FRA confirmed that the system is maintained and serviced by an approved contractor on a quarterly basis and contractors also attend weekly to visually check the sprinkler system.

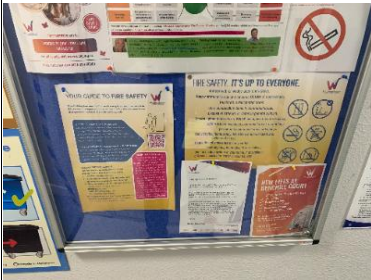
Ref	COMMENTARY
13.0	<p>The previous assessor noted that there was a Fire Safety document on the notice board that was worded incorrectly. Such as; "Light BBQs on balconies, communal areas, or landings" Although trivial, the document is missing "DO NOT" phrases, which may confuse residents regarding the contents of the document. This document has been removed.</p>

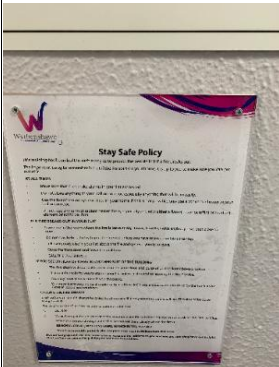
13.6, 13.8	<p>A suitable 'stay safe' fire action notice was provided in the common area by the main entrance. This captures the 'stay safe' essence of the fire strategy whilst incorporating instructions should residents hear the BS8629 Evacuation Alert System sound on their floor, and that it will pulse on the floor above and below.</p>

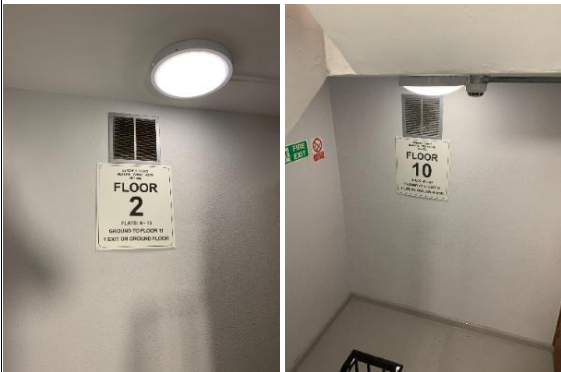
13.12	<p>Suitable 'No Smoking' signage was observed in the common area.</p>
13.15-13.16	<p>Wayfinding signage that has the floor number and directional signage to the flats, including flat numbers, is displayed in the lift lobbies and on the stairway landings. They appear to be mounted at the recommended height as per ABD and are all visible and in good condition.</p> <p>Supplementary signage is also present, with signage outside the lift areas to show which flats are on each floor and which floors the two lifts access.</p>

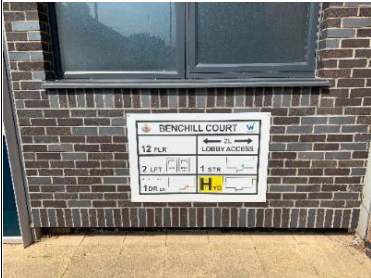
14.11	<p>A building information board showing key building facilities is present by the main entrance. This shows:</p> <ul style="list-style-type: none"> <li>• Number of floors.</li> <li>• Stating the 'lobby access' nature of the building.</li> <li>• Number of lifts.</li> <li>• Number of stairs.</li> <li>• Number of dry risers.</li> <li>• Location of nearest fire hydrant.</li> </ul>
