TOTAL FIRE GROUP LTD

Fire Risk Assessment

1-58 Hollyhedge Court
223 Hollyhedge Road
Manchester
Greater Manchester
M22 4QD

04 June 2025

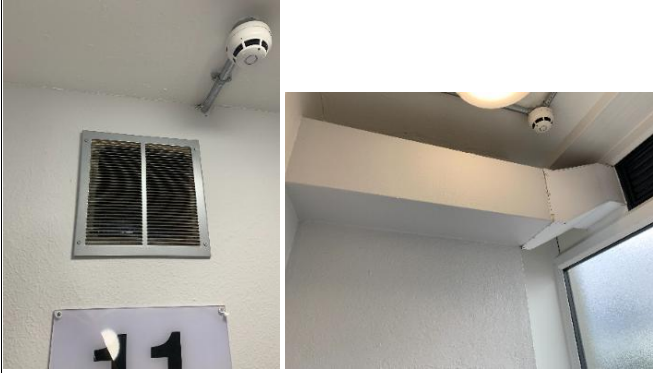
Ref	COMMENTARY
8.2	<p>The below photographs show an example of the means of smoke ventilation in the stairway of the premises. The layout is the same on all floors from the first floor upwards. The vent on the stairs leads into the metal ducting which in turn vents direct to outside, passing through the refuse chute room on its way. The previous FRA confirmed that WCHG have engaged third parties to confirm that this method of smoke ventilation is adequate. Smoke modelling calculations have been provided by a fire engineer who concluded that provided new grilles were fitted and the ducting was cleaned the existing provisions for smoke ventilation are satisfactory. In addition, the ducting has been inspected by another third party who confirmed that they were fit for purpose. Although not viewed on this assessment, it is understood that WCHG have documentary evidence available issued by the third parties.</p>

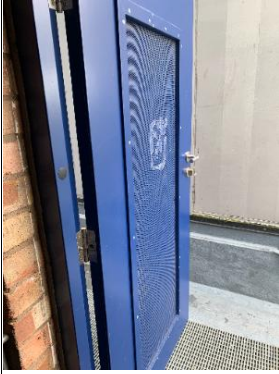
8.2	<p>Noted during the previous fire risk assessment: A louvred door provides a means of permanent ventilation to the lift motor room.</p>

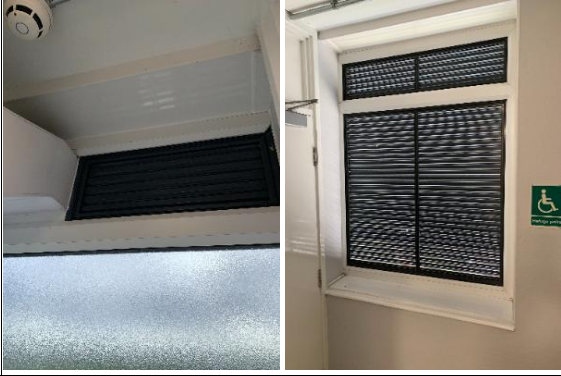
8.2	<p>The corridor between the lobby serving flats and the staircase is provided with permanent ventilation, as is the refuse chute room.</p>

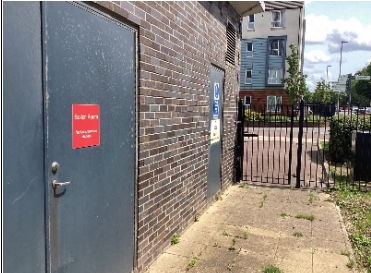
8.6	<p>It was observed at the time of the assessment that the gated area has not been provided with an emergency override. This area is for authorised persons only; they would not be working in this area for long periods of time, and there is a choice of direction within the plant rooms.</p>

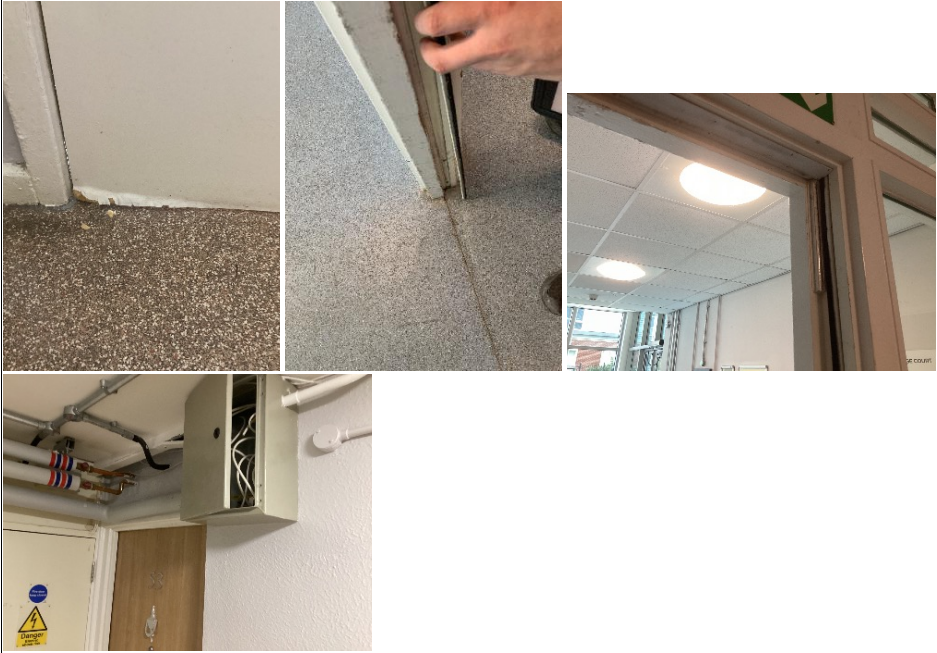
9.1, 9.5, 9.8	<p>It was observed at the time of the fire risk assessment that the smoke seal on the ground floor lobby door was loose, and there were no smoke/intumescent seals observed to the top of the doorframe. The 10th-floor bin room door was seen to have damage to the base. The service box above flat 53 could not be secured. Where fire doors are damaged, missing components and doors are not able to be secured, this may lead to the spread of fire throughout the communal areas, placing persons at risk of harm.</p>

9.1, 9.5, 9.8	<p>It is recommended that smoke seals be secured to the grooves in the doorframe and smoke/intumescent seals be installed to the top of the door. Damaged doors be repaired, and where doors are not able to be secured, they are adjusted so that they are able to be closed.</p>
	Observation

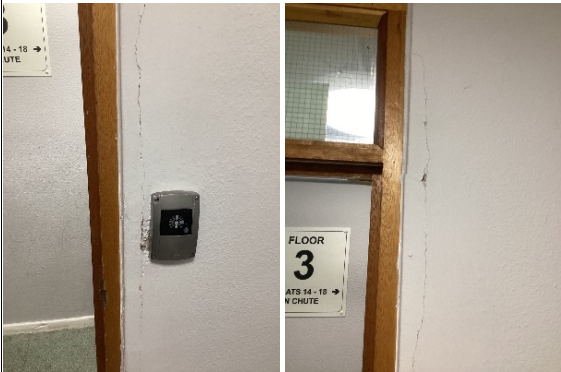
9.1, 9.8	<p>It was observed at the time of the fire risk assessment that there was damage to the wall within the staircase on floor three. Where there is damage to fire-resistant construction, it may not provide the expected level of fire resistance as expected, placing persons at risk of harm.</p>

9.1, 9.8	<p>It is recommended that the damage be repaired so that the wall is rated to 60 minutes of fire resistance.</p>

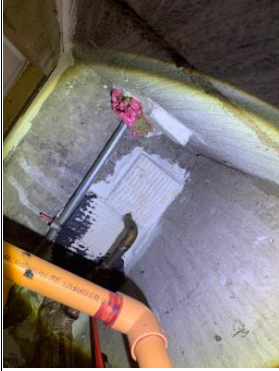
Observation	
9.1, 9.8	<p>It was observed that there was evidence of pink foam usage in existing fire stopping in the sprinkler valve cupboard (third floor). Where potentially inappropriate materials are used to fire stop breaches, it may not provide the expected level of fire resistance, placing persons at risk of harm.</p>

9.1, 9.8	<p>It is recommended that the pink foam used be confirmed to be fire-resistant and to a 60 minute standard. It should be noted that the data sheet for the pink foam should be consulted to ensure that it has been installed as recommended by manufacturers.</p>
Observation

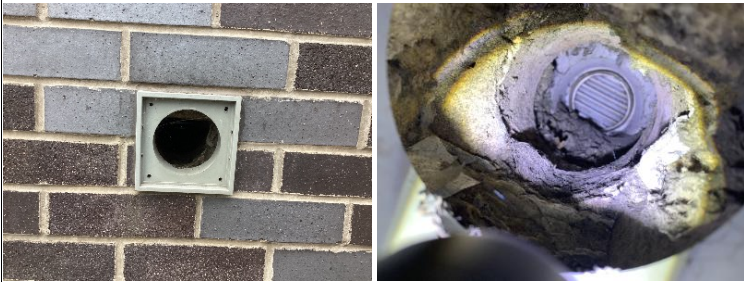
9.16-9.17	<p>It was observed at the time of the fire risk assessment that the cover was missing to a vent on the side of the building close to the smoking area. Cigarettes could be thrown into this open vent with malicious intent, a fire could potentially develop within the wall cavity and spread into the premises, placing persons at risk of harm.</p>

9.16-9.17	<p>It is recommended that a vent cover be installed on this vent.</p>
Ref	RECOMMENDATIONS
Observation	
9.18	<p>As previously identified; The electromechanically securing doors from the staircase leading towards flats on a number of floors were not secured and this may enable unauthorised access to the lift lobby/flat entrance areas.</p> <p>Note: This was observed on a number of floors, improvements have been made since the previous fire risk assessment.</p>
Recommended Actions

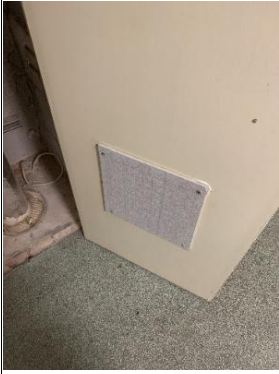
Ref	COMMENTARY
9.1	<p>The previous fire risk assessment noted that the gas service riser cupboard adjacent to flat 7 (first floor) is provided with an intumescent grille. Intumescent grilles would not prevent the spread of products of combustion prior to reaching the temperature required to seal, meaning that some products of combustion may be able to enter the escape route and place persons at risk of harm. At the time of the fire risk assessment, it was observed that the vent had been sealed from the interior side of the door.</p>

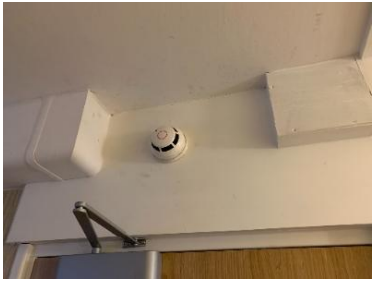
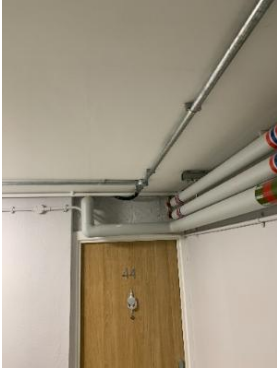
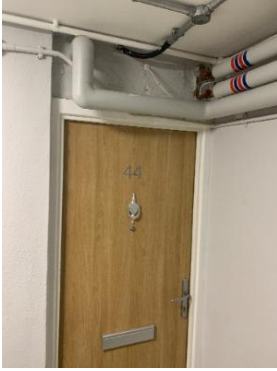
9.1	<p>The previous fire risk assessment noted that there were works ongoing to remove the panelling above flat entrance doors, this work is ongoing. (1. photo from the previous assessment.) (2. Current state above the flat entrance doors). (3. most recent photo of above the flat entrance doors).</p> <div style="display: flex; justify-content: space-around;"> <div style="text-align: center;">

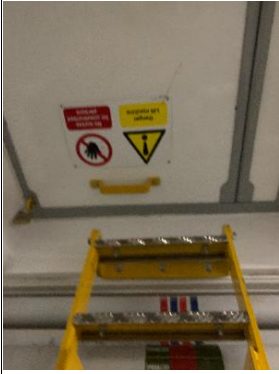
9.1	<p>As previously noted, a fire resisting hatch appears to have been installed between the eleventh floor and the lift motor room.</p>

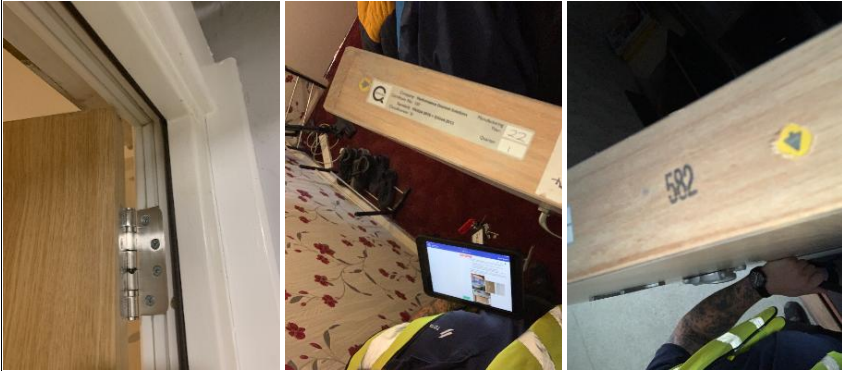
9.1, 9.5-9.6	<p>A sample of flat entrance doors were accessed and visually inspected. The entrance doors appeared to be robust timber doors certified to FD30, and installed with intumescent fire and cold smoke seals, and a self-closer. A label was provided on the top door edge, and BM Trada door plugs were also installed on the door edges. It is reasonable to assume that the remaining flat entrance doors are of the same door assembly and furniture, as they all visually appeared to be the same. Test evidence of each fire door's performance was not available, however, one was observed as part of a previous action.</p> <div data-bbox="236 748 1082 1117">

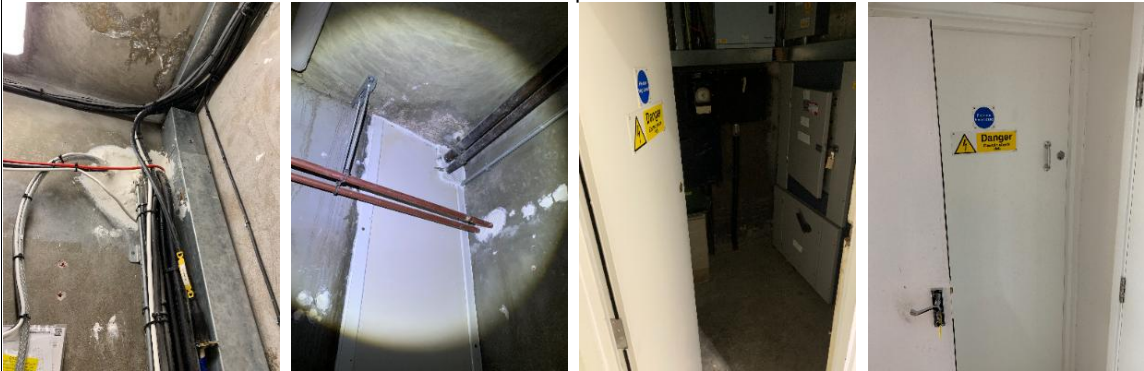
9.1, 9.5-9.6	<p>Extract from previous fire risk assessment: The previous FRA raised an action in relation to several cupboards adjoining the corridor serving the community areas/server room that could not be accessed be fitted with FD30s doorsets and fire stopped within. The previous FRA action has been signed off as complete on 23/09/2022 by Mike Holt. Access was gained into 2 out of 3 cupboards in this area to show that the doors are robust timber doors with intumescent fire and cold smoke seals installed, and fire door signage on the doors. Also within the cupboards accessed, fire stopping was undertaken. It is reasonable to assume the same in the none accessed cupboard.</p> <div data-bbox="236 1335 1385 1704">

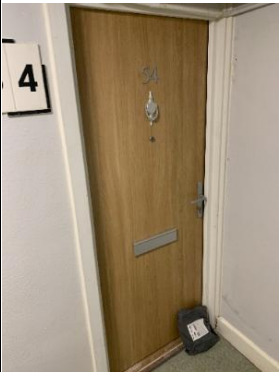
9.1, 9.5, 9.8	<p>The previous fire risk assessment noted that it was observed at the time of the fire risk assessment that the entrance door to flat 54 was damaged. At the time of the fire risk assessment it was observed that a new FD30s door had been fitted.</p>

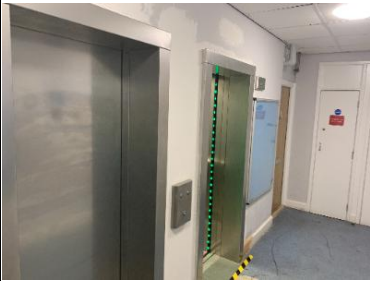
9.1, 9.8	<p>It was observed during the previous fire risk assessment that there were breaches in the lift shaft wall due to the lift upgrade work that is currently ongoing. At the time of the fire risk assessment, these breaches had been filled; the level of fire resistance the breaches should have been fire stopped to is 60 minutes, as noted in the previous assessment. It is assumed that WCHG have completed this action in line with the previous recommendation.</p>

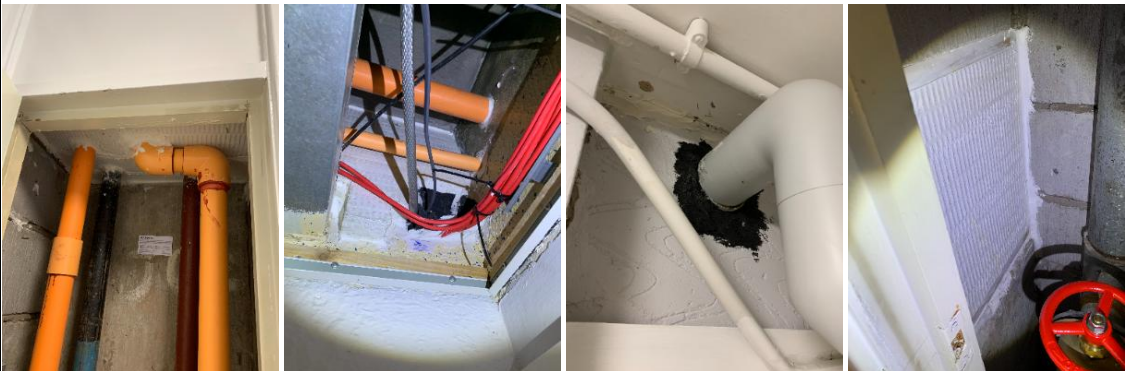
9.1, 9.8	<p>As highlighted previously, compartmentation works have been carried out throughout the premises by Allied Protection Ltd. They are an accredited passive fire protection contractor and it is understood they have provided WCHG with documentary/photographic evidence of their work (not seen on this assessment). Following the installation of the fire alarm system, further fire stopping was required. This was carried out by Flame Hold Ltd who are also an accredited passive fire fire protection contractor. It is also understood they have provided WCHG with documentary/photographic evidence of their work (not seen on this assessment). The majority of the fire stopping and compartmentation work throughout the premises was observed to be of a high standard. A singular exception to these high standards have been detailed within the finding 9.1/9.8.</p>

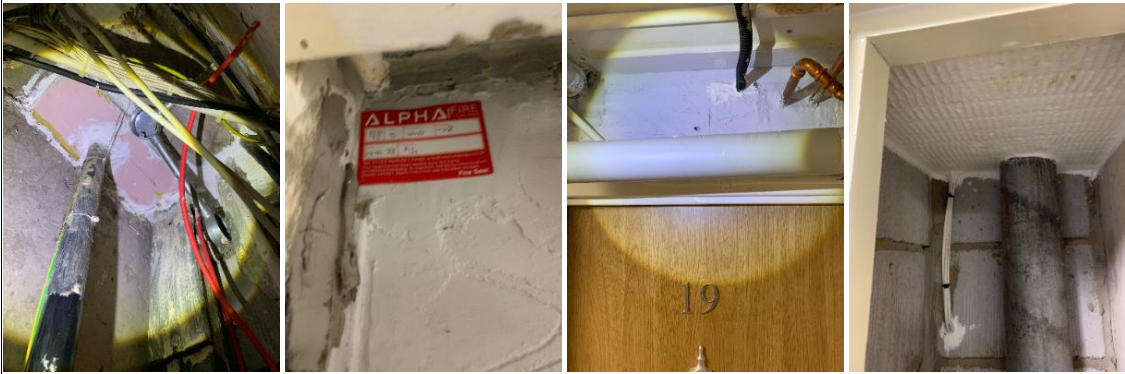
9.1, 9.8	<p>The previous fire risk assessment raised an action in regard to multiple breaches in compartmentation throughout the building. At the time of the assessment, the assessor was able to access the areas in which the breaches were noted to be. Breaches caused by cables and pipework appear to have been fire-stopped. The panelling above the flats has been removed and is currently being upgraded, Fire-stopping stickers from Alpha Fire Limited, indicate that fire-stopping has been carried out in July 2023.</p> <p>Note: The photos below show fire stopping in the ground floor roof area above the false ceilings, within risers and electrical cupboards and above flat entrance doors.</p> <div data-bbox="236 1153 1366 1525">

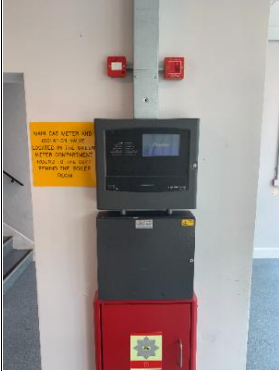
10.1, 10.4-10.6	<p>The common area fire alarm and detection system incorporates smoke detection throughout the majority (except the biomass boiler room - see another commentary 10.1, 10.4-10.6) and heat detection in the hallways of each resident flat. It was noted that in this building, detection linked to the common BS5839-1 system was only provided in the corridor serving the community room areas, but not within each of the rooms adjoining this corridor. Instead, BS5839-6 Grade D interlinked detection was provided in this room to provide early warning to the occupants of those rooms. This is considered satisfactory. The fire alarm panel for the BS5839-1 fire alarm system is located at ground floor level in the staircase enclosure. It was previously confirmed that the system is addressable. Further detail regarding the fire alarm system and its purpose within the building is provided in commentary 12.14.</p>

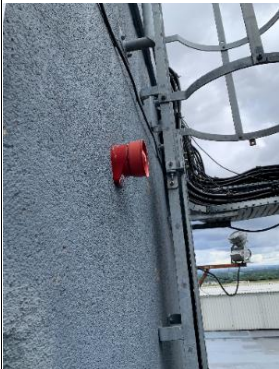
10.12	<p>Extract from previous fire risk assessment: The previous FRA raised an action in relation to there being no confirmation on whether a sounder linked to the fire alarm system was provided on the roof, nor could it be confirmed that, where provided, such a sounder is programmed to be audible. The previous FRA action has been signed off as complete on 16/09/2022 by Mike Holt. Threshold access was gained to the roof on this assessment with which a sounder was seen. Red cabling could also be seen penetrating the lift motor room walls to the roof area in this block indicating the fire alarm system extends to this area. Due to the action being signed off as complete, it is reasonable to assume that the sounder has been confirmed as audible as previously recommended.</p>

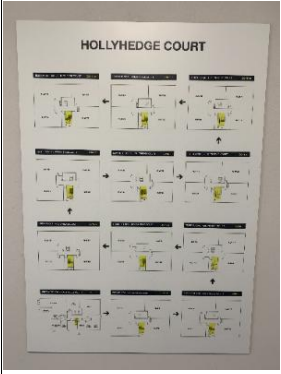
10.13	<p>At the time of the fire risk assessment, a zone plan was observed adjacent to the fire alarm panel.</p>

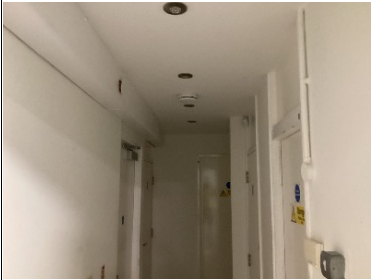
Ref	FINDINGS
	None.
Ref	RECOMMENDATIONS
	Observation
11.7	<p>It was observed at the time of the fire risk assessment that the normal lighting in the caretakers area as seen on the photo below was no working at the time of the fire risk assessment.</p>

11.7	It is recommended that the normal lighting in the hallway be repaired.
Ref	COMMENTARY
11.1-11.3	Suitable provision of emergency lighting was observed throughout the common areas, including the plant and old caretaker's rooms. It was not possible to ascertain the exact level of illumination, but the coverage appeared to be satisfactory.

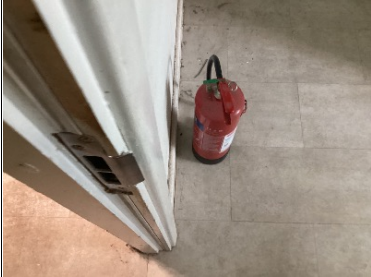
12.0 Fire Fighting Equipment, Facilities, Systems & Fixed Installations: Finding(s)	
Ref	FINDINGS
	None.
Ref	RECOMMENDATIONS
	Observation
12.2	<p>It is noted that an out-of-date dry powder extinguisher was present in the ground-floor kitchen. The discharge of a powder extinguisher within buildings can cause a sudden reduction of visibility and can also impair breathing, which could temporarily jeopardize escape, rescue or other emergency action. For this reason, powder extinguishers should generally not be specified for use indoors, unless mitigated by a health and safety risk assessment (taken from BS5306 Part 8:2012; sec 5.4.3).</p>

12.2	The powder extinguisher should be replaced with a suitable alternative. For further information, a competent fire extinguisher engineer could be consulted for further advice on the risks covered by dry powder extinguishers.
	Observation

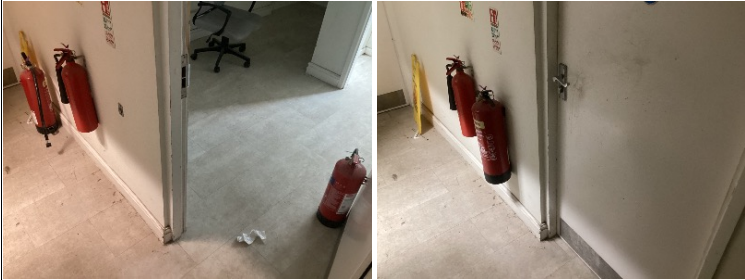
12.3	<p>Extinguishers within the ground floor caretakers' area were found on the floor and wedging the kitchen door open. This was corrected by the assessor at the time of the fire risk assessment.</p>

12.3	It is recommended that the staff be reminded not to move the extinguishers from designated points and to especially not wedge fire doors open.

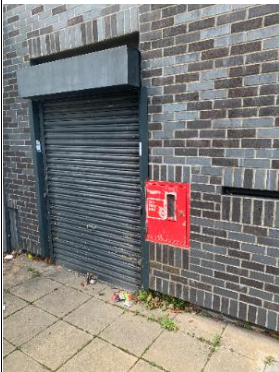
12.6	<p>The dry riser inlet is located on the building's external façade.</p>

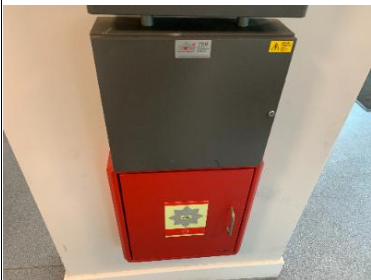
12.6, 12.15-12.16	<p>As part of their standard responses, WCHG maintains Secure Information Boxes (SIB). Although not accessed, it was seen that a SIB has been installed in the entrance foyer. It is reasonable to assume the fire service carries a key to gain access to the box. It must be noted that the responsibility for providing and updating the information with regard to any vulnerable tenants remains with WCHG.</p> <p>Therefore, WCHG should ensure that the information stored in the SIB is correct in line with current guidance, kept up-to-date, and regularly reviewed.</p> <p>The previous FRA noted that WCHG confirmed that the SIB contains the following information:</p> <ul style="list-style-type: none"> • Access keys for all areas. • Personal Emergency Evacuation Reports. • Passenger lift supporting information. • Access codes. • Asbestos refurbishment survey.

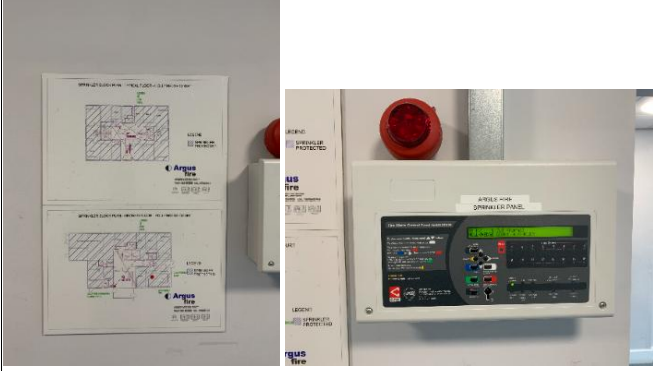
12.8-12.9	<p>As noted on the previous FRA:</p> <p>A BS9251 sprinkler system has been installed. In each flat, there are concealed sprinkler heads located in the hallway, each bedroom, the lounge, and the kitchen. In addition, there are also sprinkler heads located in some ground floor plant and community areas. There are control valves for each floor in riser cupboards that adjoin the lift lobbies. A pump and water tank for the sprinkler system have been provided in the sprinkler tank room which is within the old caretaker's area. A sprinkler panel and plan are provided by the fire alarm panel in the staircase enclosure at the ground floor level. The previous FRA confirmed that the system is maintained and serviced by an approved contractor on a quarterly basis and contractors also attend weekly to visually check the sprinkler system.</p>

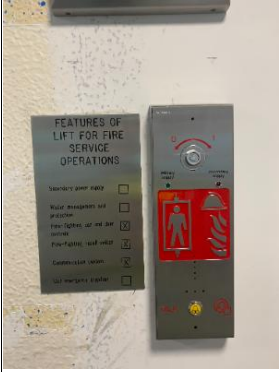
12.11-12.13	<p>The previous fire risk assessment noted that the original 'Firemen's Switch' function for exclusive use by firefighters in an emergency was not confirmed. This action has been completed. The new lift has had the following alterations;</p> <ul style="list-style-type: none"> • Fire-fighting car and door controls. • Fire-fighting recall switch. • Communication system. <p>The function of the lift is noted on a metal plaque on the ground floor. WCHG have confirmed that the lifts will continue to be tested monthly. WCHG have confirmed that all information required and all keys will be provided to the Fire Service and will continue to be held in the SIB.</p>

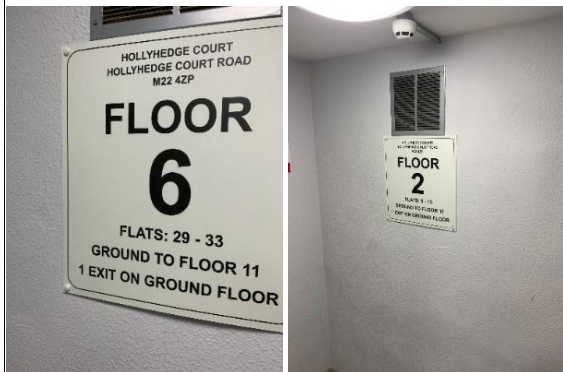
13.12	Suitable 'No Smoking' signage was observed in the common area.
13.15-13.16	Wayfinding signage that has the floor number and directional signage to the flats, including flat numbers, is displayed in the lift lobbies and on the stairway landings. They appear to be mounted at the recommended height as per ABD and are all visible and in good condition. Supplementary signage is also present, with signage outside the lift areas to show which flats are on each floor and which floors the two lifts access.
