## TOTAL FIRE GROUP LTD

### Fire Risk Assessment

25-82 Brownley Court
Wythenshawe
Manchester
Greater Manchester
M22 4QH

09 June 2025

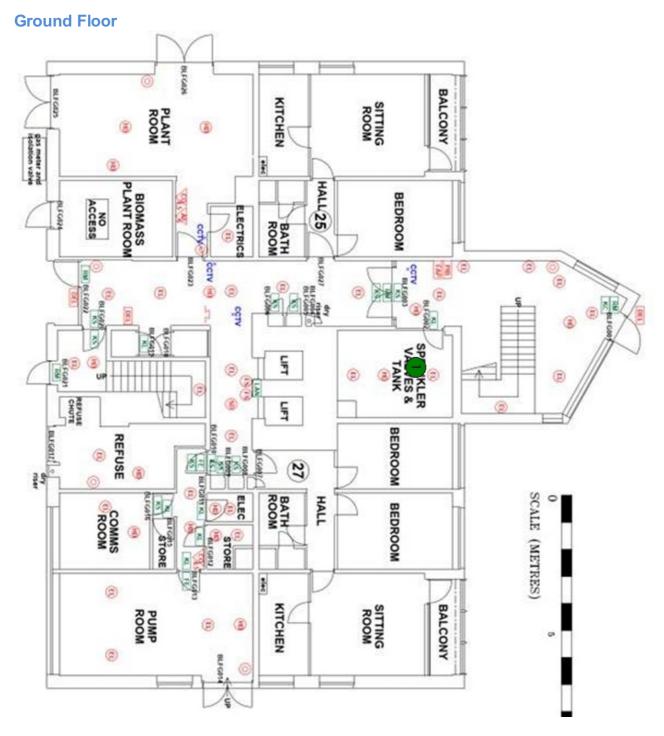
# 1 The Confinement of Fire - 9.1, 9.5-9.6

9.0 The Confinement of Fire: Finding(s)
Ref	FINDINGS
0.4.05.00	Observation (1.5)
9.1, 9.5-9.6, 9.8	At the time of the fire risk assessment there were a number of deficiencies to communal fire doors;

9.0	There was a loose smoke/intumescent strip on the riser door opposite flat 25.
	There was a gap above the handle to the staircase door on the first floor.
	There was damage to the external face of the riser door next to flat 37.
	The communal door on the 9th floor was missing a smoke seal to the edge of the door.
	Where there are deficiencies to fire doors, they may not perform as expected in the event of a fire, placing persons at risk of
	harm.
	/E/ Palidel
	Programmend at Astions

9.1, 9.5-9.6, 9.8	It is recommended that smoke strips/intumescent seals be fitted to doors that they are missing from. Where there are gaps in doors/handles, they should be sealed or reduced. Damage to fire doors should be repaired; if the damage cannot be repaired to the door should be replaced.
	Observation
