TOTAL FIRE GROUP LTD

Fire Risk Assessment

Bagnall Court Greenway Manchester M22 4LT

04 March 2025

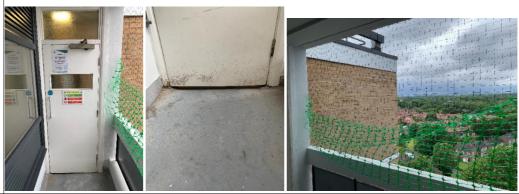
The refuse doors on each floor have large gaps at the foot of the doors. These doors are in place for smoke control to prevent smoke from affecting the balcony egress to the staircase should a fire occur in the bin chute areas. The refuse chute rooms have an open balcony which allows smoke to escape before it reaches the bottom of the doors, and the end of the refuse chute is protected by a fire shutter plate. With this in mind and the opinion of our assessor, the gaps at the foot of the doors are considered low risk. However, should future upgrades take place, the gaps at the foot of the doors should be reduced to a tolerable level.
