TOTAL FIRE GROUP LTD

Fire Risk Assessment

Bagnall Court
Shawcross Lane
Greenway
Manchester
M22 4LT

06 June 2022

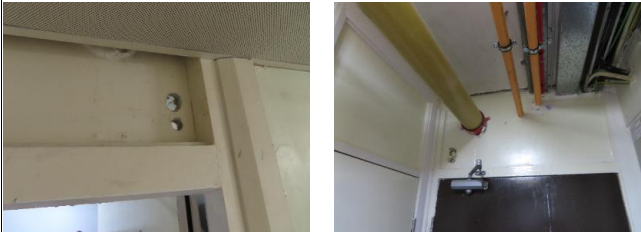
9.1, 9.5	<p>As previously identified; There is a hole or holes in the fire resisting board, above the fire door leading the the caretaker's / cleaners area. This would allow the products of combustion from a fire to spread more easily and affect the common lobby, placing persons at risk of harm.</p> <p>Holes in board above door to cleaners store area.</p>

9.1, 9.5	WCHG ought to ensure that the holes are made up and sealed by using appropriate fire resisting materials, that will provide a sufficient amount of fire resistance. See the commentaries below.
	Observation

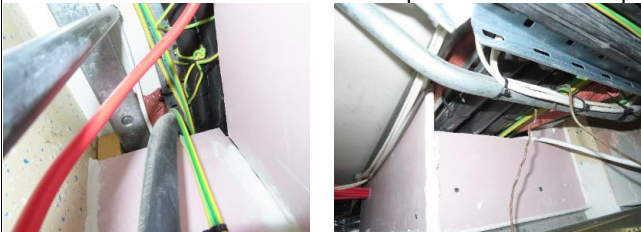
9.1, 9.5	<p>There is a large hole above the mains electrical riser cupboard, within the entrance foyer, where cables pass through above the false ceiling. This would allow a fire in the cupboard or smoke to affect the main entrance foyer and place persons at risk of harm.</p> <p>View from inside and outside the riser cupboard where cables pass through.</p>

9.1, 9.5	WCHG ought to ensure that the hole / gap is fully sealed and made up by using appropriate fire resisting materials that will provide a sufficient amount of fire resistance, equivalent to the wall of the cupboard. See the commentary below regarding Compartmentation at 9.1, 9.5
	Observation

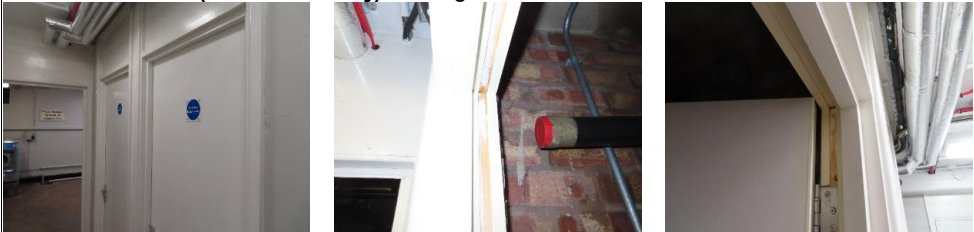
9.2	WCHG ought to inform the cleaners / caretakers that the door should be kept firmly closed when not in use or when the room is empty.
	Observation
9.3	<p>It was seen that the door or frame to one of the stores within the laundry area has not been fitted with any intumescent cold smoke seals and the store contains combustibles. This may allow smoke from a fire to spread into the laundry corridor and place persons at risk of harm.</p> <p>Door to store room (nearest laundry) missing the intumescent cold smoke seals around the frame.</p>

9.3	WCHG ought to install suitable intumescent cold smoke seals around the frame which has been rebated and ensure that the door continues to fully close and lock.

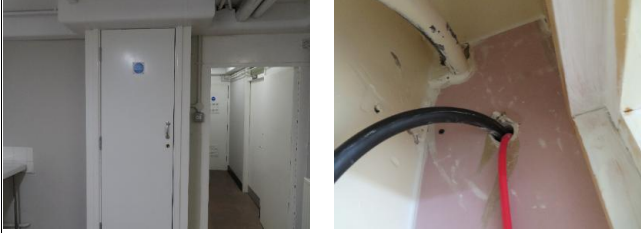
Observation
9.5	<p>It was seen that there is a hole in the mains electrical cupboard within the laundry, where cables pass through the side wall. This may allow a fire in the cupboard to spread further than is necessary and place persons at risk of harm in the building. Mains cupboard in laundry and hole where cables pass through.</p>

9.5	WCHG ought to make up / fill and seal the hole with appropriate fire resisting materials.
	Observation
9.13	<p>As previously identified; A previous Fire Risk Assessment has highlighted an issue with the unknown external wall system (EWS), window / spandrel panels on the external walls and the panels that form the balconies. The EN classification, material specification, insulation and fixing method were still unknown at this time. Following the previous assessment, WCHG appointed consultants to assist in the identification of the fire risks associated with the EWS. A decision to replace the system has been made. Arrangements are now underway with an expectation that work onsite will begin possibly later on this year. Where the external wall / structure can assist fire spread, it may place persons at risk of harm.</p>

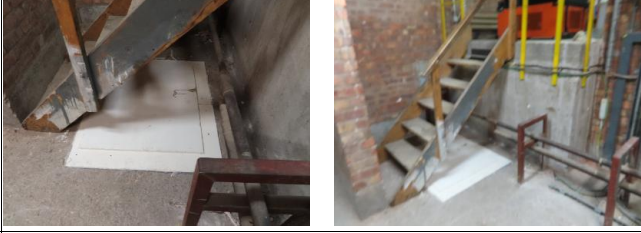
9.1, 9.5	<p>As previously identified; The board on the floor of the lift motor room, that covers the hole to the redundant hatch, has now been replaced with a fire resisting board. The works were completed during October 2021.</p>

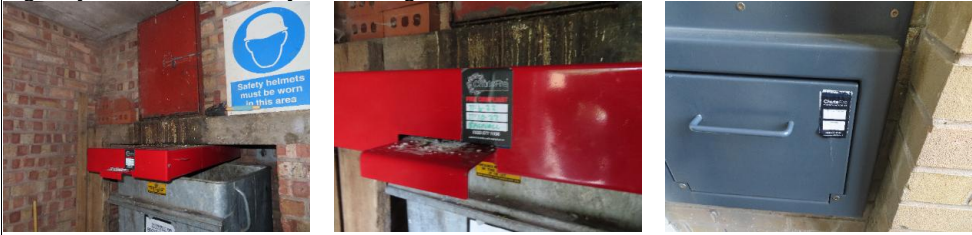
9.5, 9.14	<p>The refuse chute is protected within the bin room by means of a spring loaded gate, connected to a fusible link. The metal gate slides across the base of the refuse chute to provide fire separation if the temperature from a fire in a bin causes the link to melt. (Approx 72 degrees C) The operation of the spring loaded gate is checked and serviced six monthly by a contractor and was last serviced during April 2022. The chute access rooms and bin hoppers in each open balcony are also checked regularly and are protected by self closing fire doors.</p>

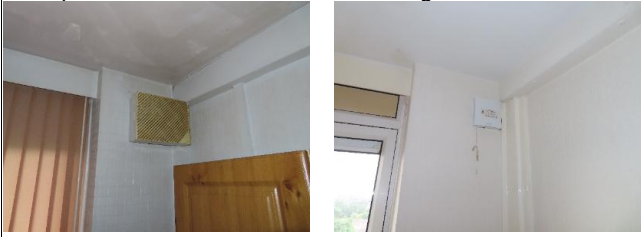
9.8	<p>Kitchen Extraction: It was noted that the kitchen ventilation in the flats seen is extracted directly to the outside, via a powered fan, installed within the kitchen wall of the flat and which was not common to any other flats. It is assumed that all the flats in the block have similar provisions installed. Examples of kitchen extraction fans leading direct to outside.</p>

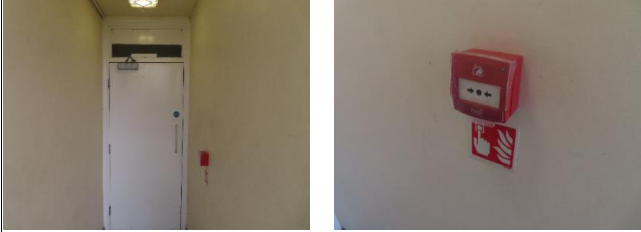
10.0 Fire Alarm System: Finding(s)	
Ref	SIGNIFICANT FINDINGS
	Observation
10.3-10.5	<p>It was noted that manual fire alarm call points (MCPs) are provided within every landing access lobby, between the stairs and lift lobbies. They are not in view of any CCTV and it was stated by the facilities manager from WCHG that several false / malicious alarms have occurred within the past few months, caused by the deliberate activation of a manual call point in one of these areas. False alarms tend to generate a 'cry wolf scenario' among the occupants and persons tend to learn to ignore an evacuation alarm, placing them at risk of harm during a genuine emergency. Additionally, manual call points and common fire alarms are NOT normally required within blocks of flats or apartments that are operating on a Stay Put / Stay Safe evacuation policy. These manual call points are outside the scope of the current guidance and recommendations for these flats.</p> <p>Manual Call Points in common lobbies on every floor.</p>

<p>Note; If a smoke detector is activated within the common areas, then the alarm system is silent within the stair lobbies and stairs etc. However, it seems that it is audible if a MCP (call point) is broken. If the call points are removed it would also prevent the alarm panel from showing a fault or silent activation and prevent the fire service from being called un-necessarily.</p>

Recommended Actions
10.3-10.5	<p>WCHG ought to arrange for the manual call points within the access lobbies to be disabled and removed.</p> <p>NB; The manual call points within the service / plant rooms, on the roof and ground floor, as well as the call point in the main foyer, covered by CCTV should remain in place and fully functional, so that contractors or staff can operate these if required. Also the alarm sounders within the roof voids, service and plant rooms and ground floor, should also remain functional / audible, so as to give warning to persons at work in those areas. All other floors can be a silent system, except when activated by the fire and rescue service from the main alarm panel / evacuation control.</p>
	Observation

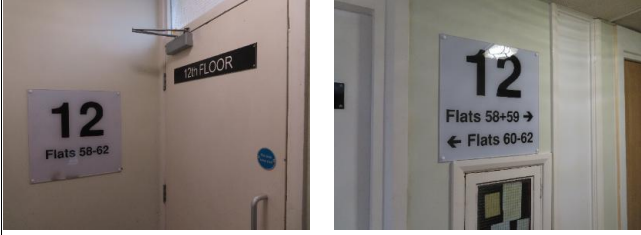
13.0	<p>As previously identified; Adequate signs are provided both on the stair landings and in the lift lobbies, opposite the lift doors, that indicate the floor level and the flat numbers. Our consultant did not consider there to be a need to install further signs on the rear of the lobby access doors, as these would be of little benefit. Access doors are often wedged in the open position by fire fighters during an emergency or fire fighting operations. However, see the finding and recommendation above regarding Wayfinding signs. Examples of floor level signs on the stairs and lift lobbies.</p>

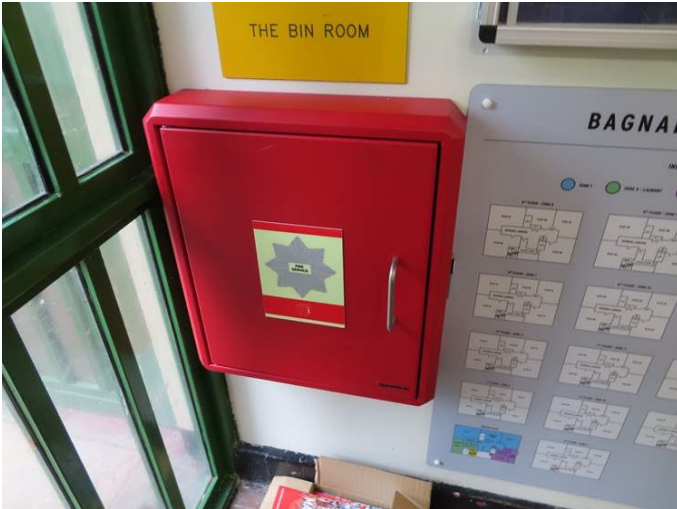
1 Persons at Risk Audit - 7.3

7.3	<p>As previously identified; It was seen that a Premises Information Box (PIB) has now been installed in the entrance foyer that contains information specifically for the fire service, including any information regarding vulnerable or disabled residents. The fire service carry a key to gain access to the box. It must be noted that the responsibility for updating the information with regards to any vulnerable tenants remains with WCHG. It was stated that the information contained within the box is in keeping with NFCC and FIA released guidance.</p> <p>Therefore, WCHG (Housing Section) should ensure that the information stored in the PIB is kept up to date and regularly reviewed.</p> <p>PIB in entrance foyer.</p>

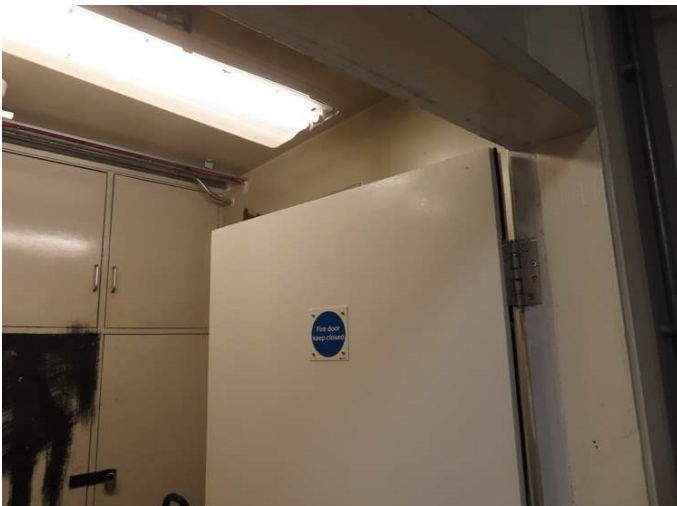
3 The Confinement of Fire - 9.2

9.2	<p>It was noted that the door to the caretakers / cleaners refreshment room had been kept open and not closed shut. This would allow a fire starting in the room to spread and affect the corridor leading from the water tank room, placing persons at risk of harm.</p> <p>Door to cleaners room left open.</p>

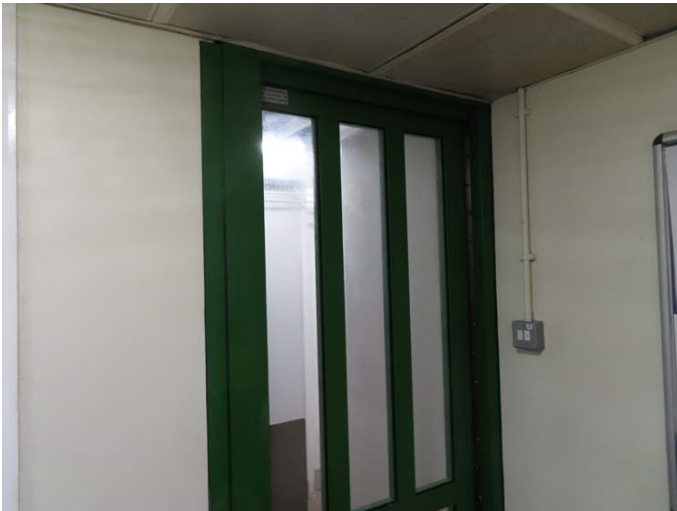
5 The Confinement of Fire - 9.1

9.1	<p>It was noted that the security door between the common area and the laundry / store rooms could not be confirmed as of a suitable fire resisting standard. Although the door is magnetically locked and is of a good standard, no smoke seals were fitted and the glazing was not fire resisting. Additionally, the inner door to the laundry room was kept open. A fire in the laundry room would affect the common area lobby / foyer as smoke and heat would be able to spread, placing persons at risk of harm. Security door to laundry area and inner door to laundry room kept open.</p>  
	Recommended Actions

9.1	<p>WCHG ought to confirm that the security door is of a suitable fire resisting standard or take remedial actions to replace the door with an appropriate type. (FD30s) This may involve contacting the manufacturers for advice etc. The inner door to the laundry room should also be fitted with a self-closing device and the door allowed to fully close when persons enter or leave the room. This would provide two doors of separation between the laundry and the common area entrance foyer.</p>
	Observation

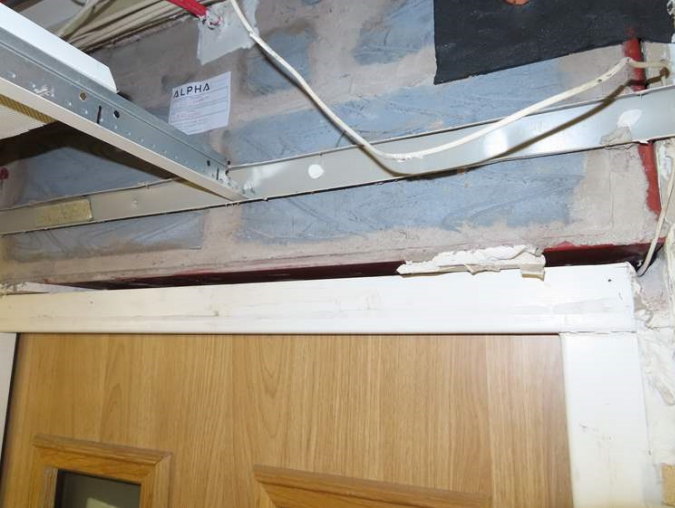
1 The Confinement of Fire - 9.1

Ref	SIGNIFICANT FINDINGS
	Observation
9.1	<p>The frame around the door to Flat 50 had yet to be fire sealed and fitted with architrave. A gap could be seen between the frame and the wall. This would allow the products of combustion from a flat fire to spread onto the common lobby and place persons at risk of harm. Gap between frame and wall of Flat 50.</p>  
	Recommended Actions

9.1	<p>WCHG ought to ensure that the gap between the frame and wall to Flat 50 is appropriately filled and sealed with suitable fire resisting materials and the architraves correctly replaced, inside and out.</p>
	Observation

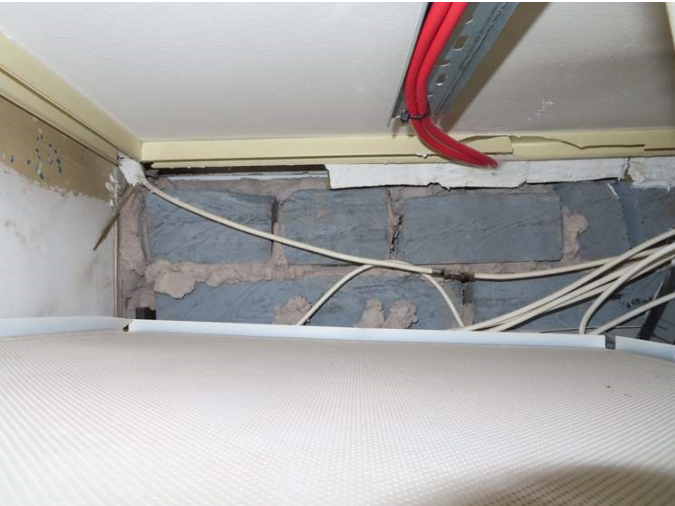
3 The Confinement of Fire - 9.1

9.1	<p>It was noted that there is a large gap at the top of the wall, on the 12th floor, above Flat 62, that goes through to the flat, possibly where the wall has been damaged. This would allow the products of combustion from a flat fire to spread onto the common area and place persons at risk of harm. Gap in wall above door to Flat 62, 12th floor.</p>  
	Recommended Actions

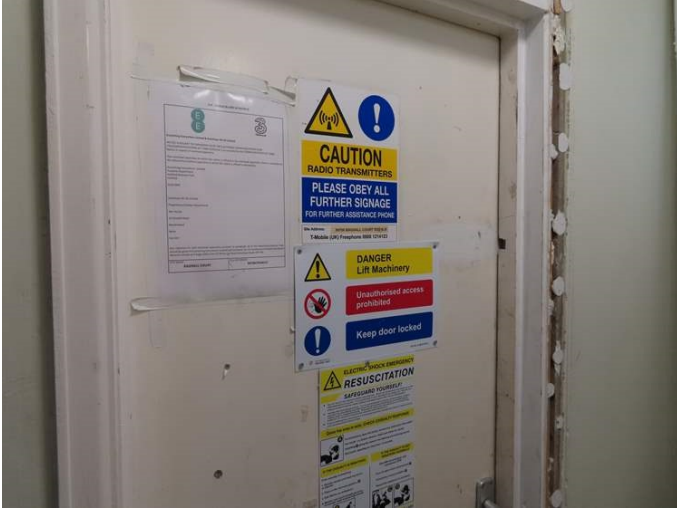
4 The Confinement of Fire - 9.1-9.2

9.1-9.2	<p>It was seen that the architrave around the door to the lift motor room, on the stair landing of the 12th floor, was missing on the right hand side. This may allow smoke to percolate around the door frame and affect the staircase, placing persons at risk of harm during an emergency. Missing architrave on R/H side of lift motor room door.</p>

Recommended Actions
9.1-9.2	Any holes / gaps between the frame and the wall ought to be appropriately sealed with fire resisting materials and the architrave replaced and fixed into place.
	Observation
