TOTAL FIRE GROUP LTD

Fire Risk Assessment

1-58 Benchill Court
Wythenshawe
Manchester
Greater Manchester
M22 4GL

04 July 2023

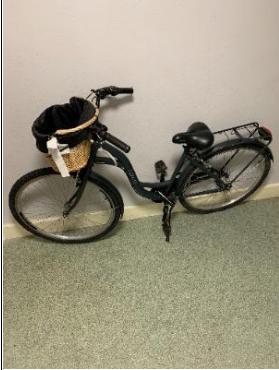
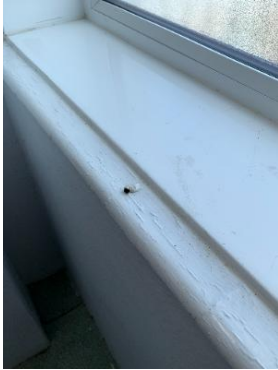
Ref	SIGNIFICANT FINDINGS
	Observation
8.7	<p>There was a bicycle stored outside flat 54 and evidence of smoking in 7th floor bin refuse room. It has been advised that WCHG operates a sterile policy, along with no smoking in common areas, which the above conflicts with these policies. Items in common areas affecting the escape route, encourage additional storage/trip hazards, and smoking in common areas may cause a fire, which could place persons at risk of harm.</p>

8.7	It is recommended that the items identified in the communal area are removed and residents reminded of the "sterile" and "no smoking" policies for common areas.
Ref	RECOMMENDATIONS
	Observation

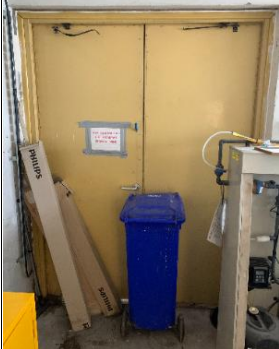
8.11	<p>The double doors from the plant room within the caretaker area were found blocked and key-locked shut. Although an alternative exit is available back through the building, this exit leads directly to open air and would be the preferred choice if evacuation would be needed from this area.</p>

8.11	It is recommended that this exit is made available and kept clear. The doors should be unlocked when the room is occupied and work is being undertaken.

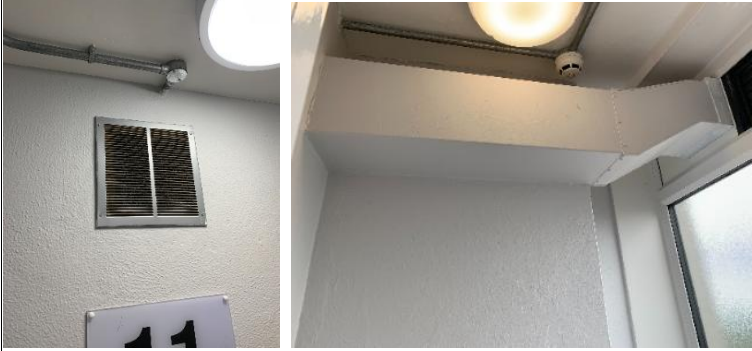
Ref	COMMENTARY
8.2	<p>The below photographs show an example of the means of smoke ventilation in the stairway of the premises. The layout is the same on all floors from the first floor upwards. The vent on the stairs leads into the metal ducting which in turn vents direct to outside, passing through the refuse chute room on its way. The previous FRA confirmed that WCHG have engaged third parties to confirm that this method of smoke ventilation is adequate. Smoke modeling calculations have been provided by a fire engineer that concluded that provided new grilles were fitted and the ducting was cleaned that the existing provisions for smoke ventilation are satisfactory. Also previously advised is that in addition, the ducting has been inspected by another third party who confirmed that they were fit for purpose. Although not viewed on this assessment, it is understood that WCHG have documentary evidence available issued by the third-parties.</p>

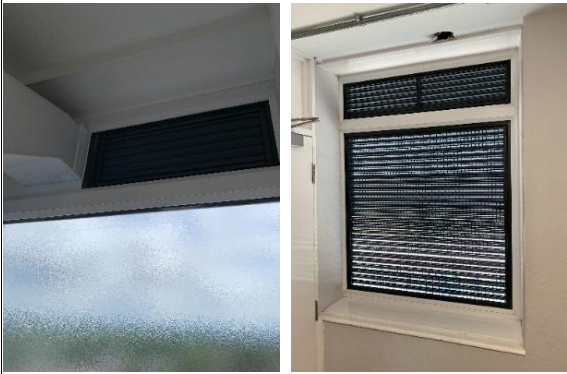
8.2	<p>The corridor between the lobby serving flats and the staircase is provided with permanent ventilation, as is the refuse chute room.</p>

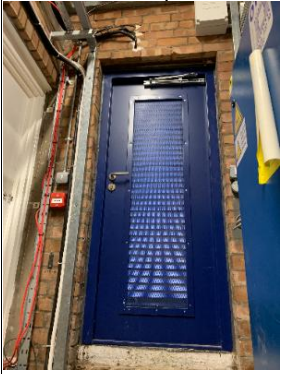
8.6	<p>A louvered door provides a means of permanent ventilation to the lift motor room.</p>

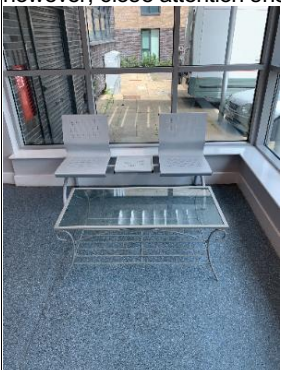
8.7	<p>A metal bench and a glass table are located in the main entrance lobby, where the staircase serving all of the floors discharges. The presence of these items is not considered to significantly increase the risk to the life of the residents, however, close attention should be paid with regard to the prevention of any additional items being placed in the area.</p>

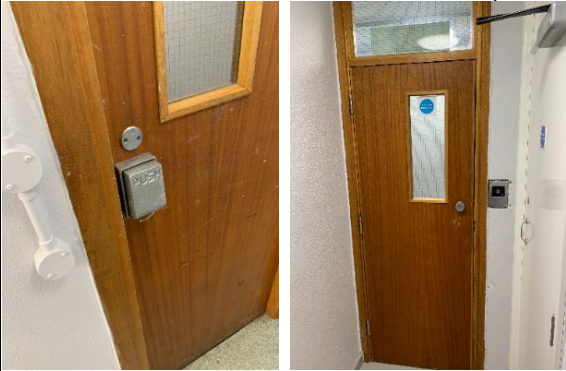
8.17	Electromechanically secured doors separate the staircase from the corridors serving flats and these require fob access in the direction towards the flats. In the direction of escape, a suitable push pad device is provided leading into the stair.

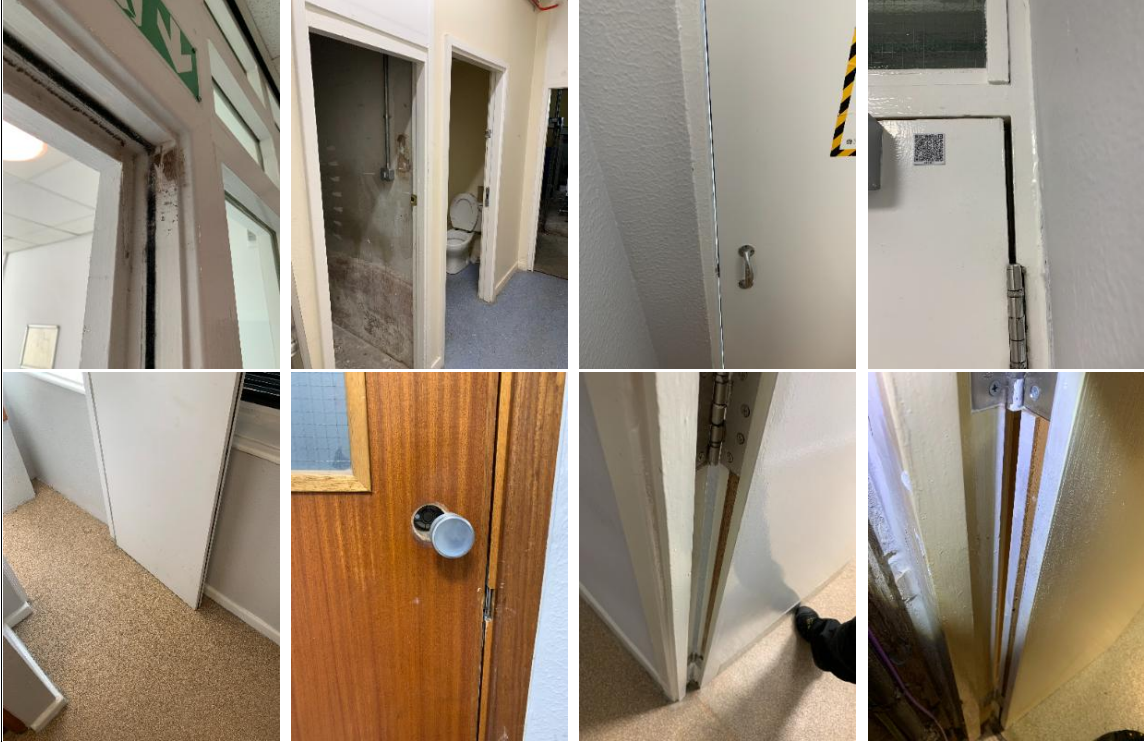
Ref	SIGNIFICANT FINDINGS
	Observation
9.5-9.6	<p>Communal doors - Fire door deficiencies with communal doors were identified in this assessment. These include:</p> <ul style="list-style-type: none"> • The ground floor automatic door separating the entrance foyer to the lift lobby has damaged seals at the top. • Some of the riser cupboard doors accessed were missing intumescent fire and cold smoke seals. These cupboards were only sampled, and it is reasonable to assume other doors may have the same issue. • Two of the ground floor plant room area doors do not shut into their rebates. • The 10th and 11th floor lobby doors to flats/the lift had large gaps at the top edge of the doors (around 10mm). • The 10th floor staircase door did not fully close into its rebate. • The majority of the bin refuse doors had gaps in the doors where daylight could be seen. The gaps didn't seem excessive, however, the cold smoke seals did not fill the gap between the door and frame. • The 7th floor lobby door to the flats/lift had missing intumescent fire and cold smoke seals. • The 4th floor refuse door was found open due to the door sticking on the floor. • The 3rd floor staircase door handle/knob was found loose and moved, exposing the inner part to the mechanism/door. • The door frame to the riser cupboard next to flat 18 was damaged and cracked. <p>Where fire doors are damaged, stuck open, have gaps, or are missing components, a fire or other products of combustion may be able to spread onto the escape route, placing persons at risk of harm.</p>

Recommended Actions
9.5-9.6	<p>It is recommended that the doors identified are repaired where required, missing components re-instated, doors are adjusted to ensure they fully close, and gaps are reduced to a tolerable level/cold smoke seals fill the gaps.</p>

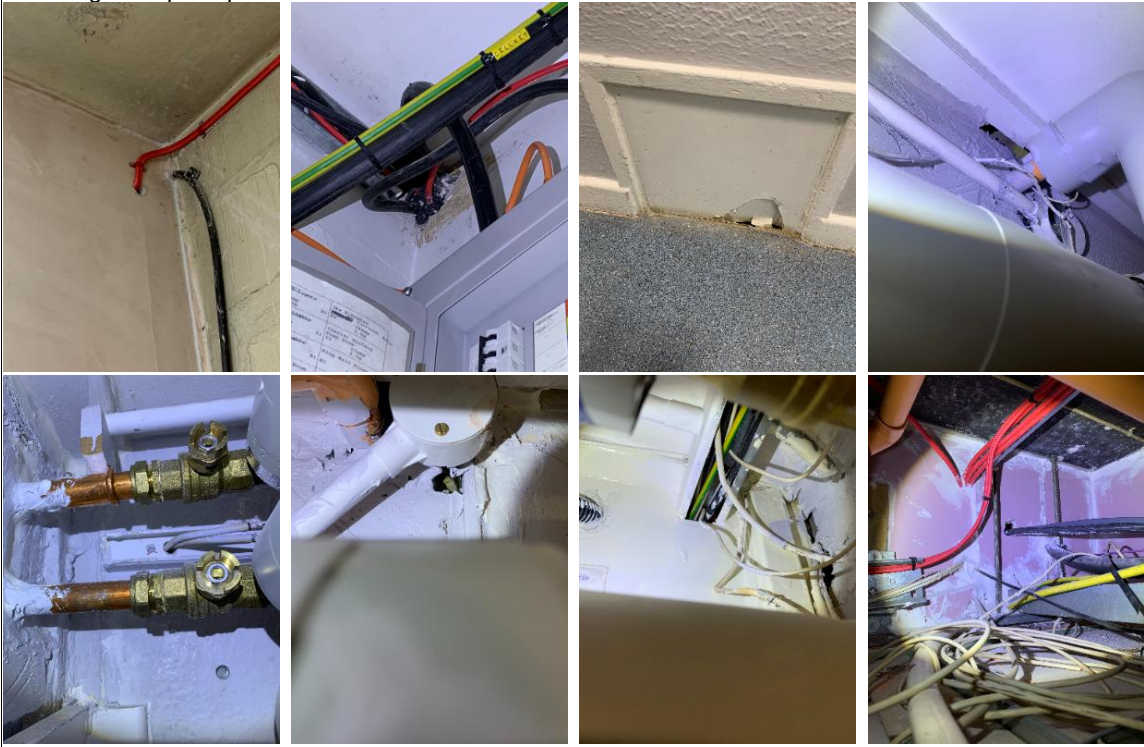
Observation
9.8	<p>Breaches in compartmentation were identified within the communal areas throughout the block. These include:</p> <ul style="list-style-type: none"> • Previously raised - Above the false ceiling (ground floor) - Cable breach from lift lobby into community room corridor. There were also other penetrations above the false ceiling that were not sealed. • The ground floor CCTV room from the community area had a cable penetration not sealed. • The electrical cupboard from the community room corridor had penetrations not sealed fully. • The low-level ground floor under the stairs panel was kicked in. • Penetrations were not sealed/sealed inappropriately above a number of flat entrance doors from the communal side. • Penetrations were not sealed within the plastic trunking in the common areas (a couple were viewed). • The previous fire stopping above a riser cupboard next to flat 8 was found damaged. <p>Breaches in fire-resisting construction that are not suitably fire stopped could lead to a fire spreading beyond the compartment of fire origin and place persons at risk of harm.</p>

Recommended Actions
9.8	<p>It is recommended that the areas identified are opened and checked/surveyed, and all areas are adequately fire stopped to provide the same level of fire resistance as the surrounding walls.</p>
	Observation

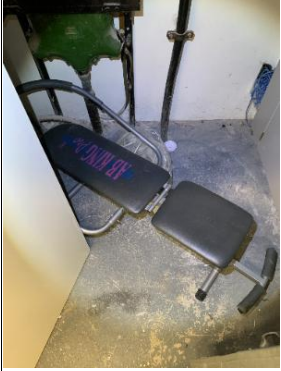
Ref	RECOMMENDATIONS
	Observation
9.16	Items were found stored in the ground floor electrical room from the community area.

Recommended Actions
9.16	It is recommended that this area is kept clear and sterile and the room is locked against unauthorised access.
	Observation

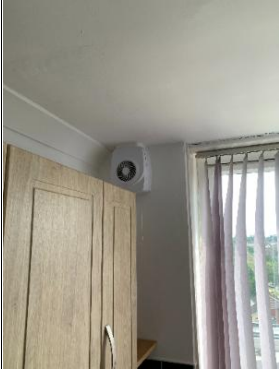
9.11	<p>It was noted that the kitchen ventilation in the flats seen is extracted directly to the outside, via a powered fan, which was not common to any other flats. It is assumed that all the flats in the block have similar provisions installed.</p>

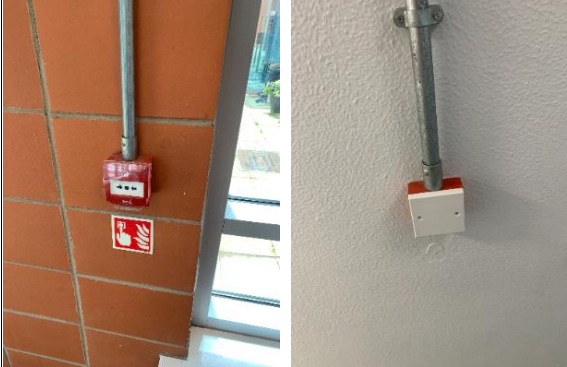
10.0 Automatic Fire Detection: Finding(s)	
Ref	SIGNIFICANT FINDINGS
	None.
Ref	RECOMMENDATIONS
	Observation
10.6	<p>As previously identified; Manual call points were provided in the ground floor common areas which are regularly accessed by the residents. Our assessor understands that whereas detectors are silent when activated, the manual call points may be clearly audible. This may result in frequent false alarms and may result in faults or similar showing on the fire alarm.</p> <p>Note: The previous FRA action has been signed off as complete on 16/09/2022. However, as the call points are still active in the ground floor communal areas, the action has been reopened. The manual call points on the upper floors within the communal areas have been blanked off.</p>

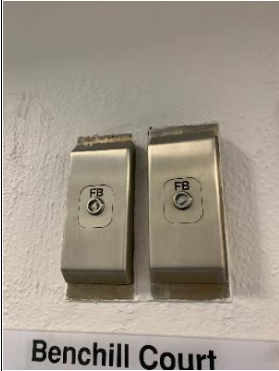
12.0 Fire Fighting Equipment, Facilities, Systems & Fixed Installations: Finding(s)	
Ref	SIGNIFICANT FINDINGS
	Observation <p>12.11-12.13 As previously identified. The original 'Firemen's switch' function for exclusive use by firefighters in an emergency is not confirmed.</p> <p>As previously identified; Both lifts are understood to have been fitted with a fire alarm interface that returns them to the ground floor. The previous FRA noted that WCHG have confirmed that the lifts are standard lifts. As different types of lifts provide different levels of safety and control of the lift for fighters, it is important that the correct details are available. Firefighters using a lift that does not provide a perceived level of safety would be placed at risk of harm which could place residents (relevant persons) and risk of harm due to delays in rescues.</p> <p>Note: The previous FRA action has been signed off as complete on 07/10/2022 by Joy Ashley. However, no evidence or feedback has been provided to indicate what types of lifts have been installed resulting in the action being reopened. In the opinion of our assessor, the lifts appear to be that of a Fireman's lift incorporating only simple means to recall the lift to a designated floor, with no complex lift controls or protection measures for fire and rescue service use, also known as a fire service lift.</p>
