TOTAL FIRE GROUP LTD

Fire Risk Assessment

Birch Tree Court
Rowlandsway
Wythenshawe
M22 5SL

14 June 2022

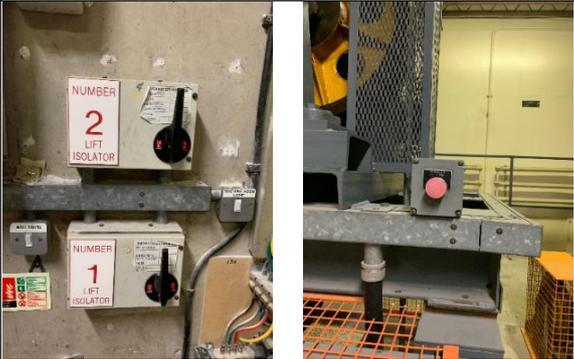
<p data-bbox="236 600 1070 629">Isolation and emergency stop switches for the lifts are located in the lift motor room.</p>

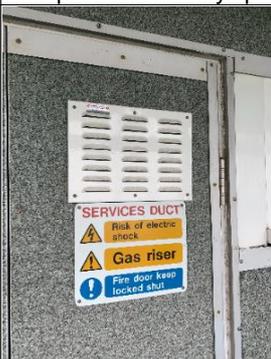
6.16

<p data-bbox="236 1720 967 1751">Suitable hazard signage was fitted to service risers across the premises.</p>

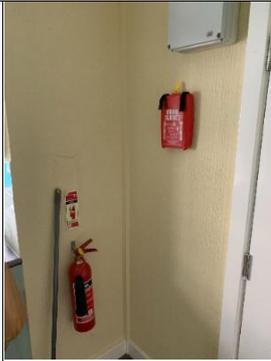
6.17, 6.19

A kitchen incorporating refreshment facilities has been provided in the community room area. A fire blanket and a CO2 fire extinguisher are installed in this location.

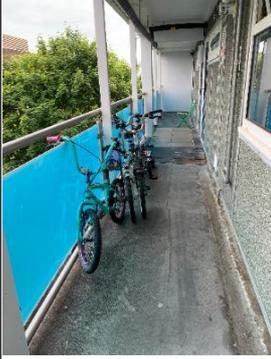
<p>Bikes were observed as stored on the open deck balcony area near to flat 64 (fifth). Where there is such storage this may encourage additional storage, may pose a slip/trip hazard and may contribute to the development of a fire which has spread onto the escape route, all of which may place persons at risk of harm.</p>
	Recommended Actions
8.6	It is recommended that the bikes are removed from this area and the owners of the bikes are advised accordingly.
Ref	RECOMMENDATIONS
	None.

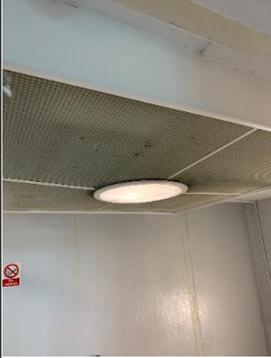
Ref	COMMENTARY
8.5

<p>WCHG have previously confirmed that the vent at the head of the stairway is a permanently open vent and has an area of at least 1m². At this time, this vent is acceptable for smoke ventilation purposes.</p>

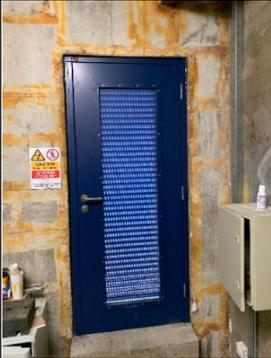
<p>The door onto the roof from the lift motor room provides a means of permanent ventilation.</p>
8.5

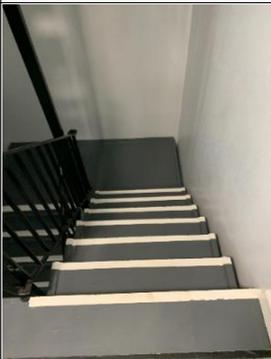
<p>Steps on the internal staircase are nosed, ensuring clear visibility for those using them.</p>

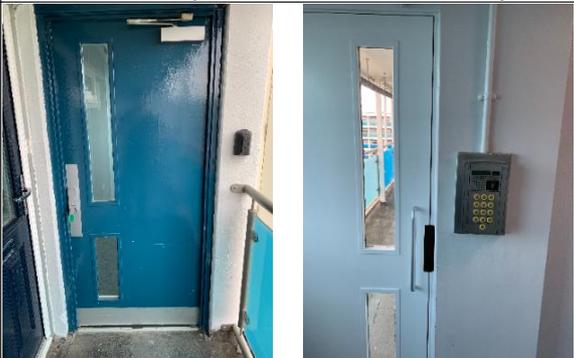
8.16

<p>The access doors to all the open decks are fitted with electromechanical locks. They are provided with push pads that allow them to be opened on the open deck side of the door without the use of a key.</p>

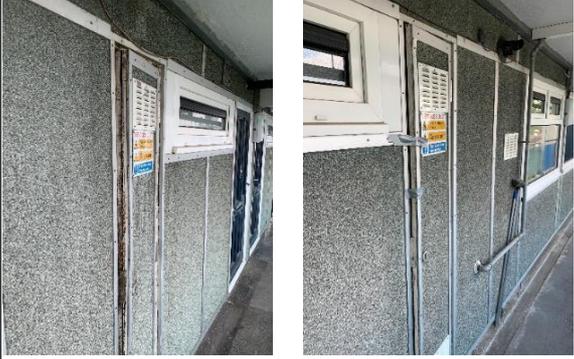
<p>A number of doors to open deck service risers were in poor condition or were ill fitting at the time of the assessment, resulting in them not being able to close or secure shut. These are detailed as follows:</p> <ol style="list-style-type: none"> 1. By flat 86 (seventh) - poor condition and not closing. 2. By flat 87 (seventh) - poor condition and not closing. 3. By flat 23 (third) - Is ill fitting. 4. By flat 12 (first) - Was unlocked and was of a different key type so our assessor could not lock. <p>Where service riser cupboards are not able to close they may compromise the protection afforded to the single direction of travel open decks, placing persons at risk of harm.</p>
	Recommended Actions

9.1	It is recommended that remedial works are carried out as appropriate to ensure the service riser cupboard doors are in good condition, are well fitting and can be secured/locked.
	Observation

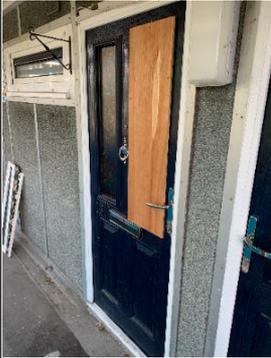
<p>The flat entrance door to flat 12 (first) had been damaged and had been boarded over as a result. Where fire doors do not offer the required standard of protection to the adjoining escape route this may enable the spread of products of combustion, placing persons at risk of harm.</p>
	Recommended Actions

9.1-9.2	It is recommended that a competent person attends site to replace/repair the flat entrance door to flat 12 as appropriate.
	Observation
9.1-9.2

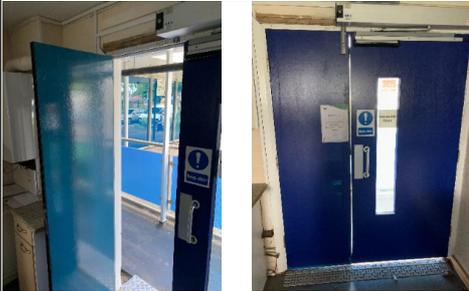
<p>The scooter charging room adjoins a ground floor open deck which serves a number of flats. The doors leading to the scooter room are double doors and, although one side was automatic and was closed, the other side was left open and had no self-closing device. Our assessor closed this door at the time of the assessment but it appears that this door is being opened to allow for easier passage of mobility scooters. When closed there was an 8mm gap between the meeting edges of the double doors. Where the adjoining escape route is inadequately protected this may enable the spread of products of combustion, placing persons at risk of harm.</p>
	Recommended Actions

9.1-9.2	A competent person should attend site to reduce the gaps between the meeting edges of the doors to a maximum of 4mm and a means of ensuring BOTH leaves of the door remain shut when not in use should be implemented.

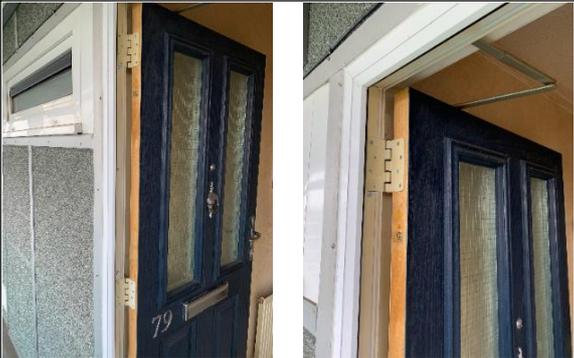
Observation
9.1-9.2

<p>It is observed that there are composite construction fire doors installed to flat entrances. Test evidence of the fire doors performance was not available.</p> <p>A number of manufacturer's flat entrance fire doors have previously failed fire tests when subjected to fire on both sides of the door despite being certified as FD30s compliant. The flat doors could not be confirmed as meeting current test evidence and certified as FD30s door assemblies conforming to BS476-22 (compatible door, frame, ironmongery, hardware etc.) and fitted with a positive-action self-closing device. Flat entrance fire doors should have test evidence demonstrating they meet the performance requirement in the Building Regulations guidance for fire resistance and smoke control from both sides.</p> <p>Where a flat entrance door is not self-closing or does not provide the relevant degree of fire resistance, a fire in a flat may prejudice the common means of escape as the doors may not form an effective barrier against the products of combustion placing relevant persons at risk of harm.</p>

Recommended Actions
9.1-9.2	<p>As a high priority, investigations should be made to determine the fire resisting standard of the composite flat entrance doors.</p> <ul style="list-style-type: none"> • If doors meet current test evidence and are certified as FD30s door assemblies conforming to BS476-22 (compatible door, frame, ironmongery, hardware etc), fitted with a positive-action self-closing device and installed in accordance with the manufacturer's instruction based on the original test specimen then no further action is necessary. • Where it is known that the fire doors fitted do not have test evidence demonstrating they meet the performance requirement in the Building Regulations guidance for fire resistance and smoke control from both sides, then they should be replaced with fully compliant FD30s doors (compatible door, frame, ironmongery, hardware etc.) and fitted with a positive-action self-closing device. • Any doors identified as damaged at any time should be immediately replaced/repaired as appropriate. • As an interim measure, ensure all doors have a self-closing device installed. <p>For further information and guidance regarding composite flat entrance doors, see commentary 9.1-9.3.</p>

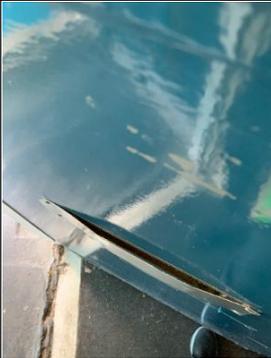
Observation
9.2

<p>A cleaner's cupboard adjoins a ground floor open deck serving flats. The door is of the notional type and the letterbox had been covered by a metal plate, however the metal plate was loose and had gaps around. Where fire doors are compromised this could also result in the adjoining escape route being compromised, placing persons at risk of harm.</p>
	Recommended Actions

9.2	<p>It is recommended that the letterbox to the cleaner's cupboard is sealed in a manner which would not allow products of combustion to leave in the event of a fire.</p>

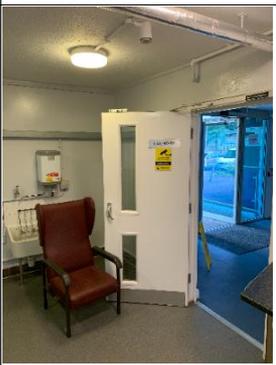
<p>The door to the laundry room was wedged open at the time of the assessment. Where fire doors are wedged open this will enable the spread of products of combustion onto the escape routes, placing persons at risk of harm.</p>
Recommended Actions

9.2	The door should be unwedged and residents should be advised against wedging this door.	
Observation		
9.2	Neither the entrance door to the communal room nor the kitchen door within the communal room are effectively self-closing. Where fire doors are not effectively self-closing they may enable the spread of products of combustion, placing persons at risk of harm.	
Recommended Actions

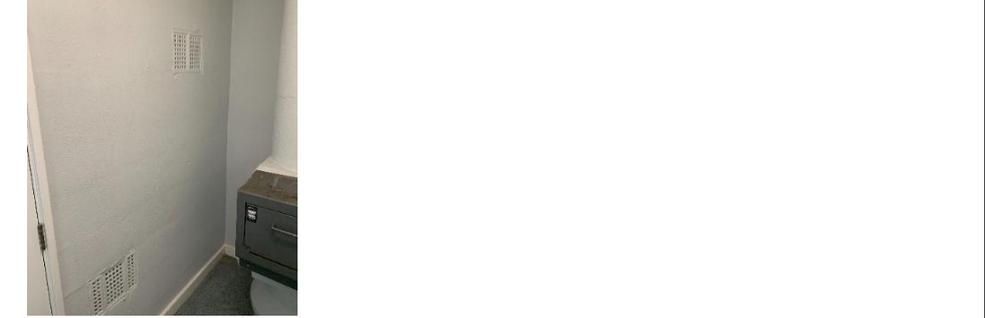
<p>Between the refuse chute room and the electrical room on the seventh floor are bricks with small air holes. Where these bricks enable spread of fire and products of combustion between the two areas, persons may be placed at risk of harm.</p>
Recommended Actions

9.5	It is recommended that the bricks are fire stopped to prevent passage of products of combustion between the seventh floor chute and electrical rooms.	
Observation

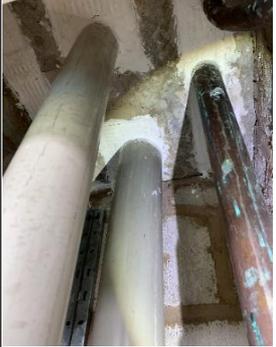
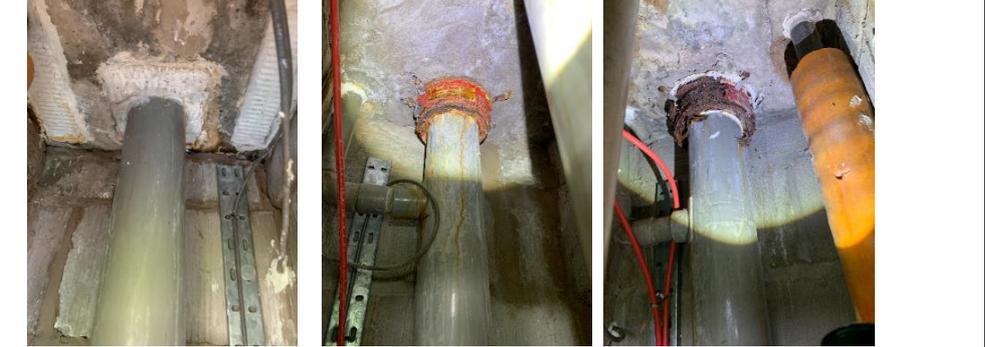
<p>Corroded intumescent collars were observed in service riser cupboards and some pipes passing through service cupboards, particularly on the seventh floor, were observed not to be fitted with such collars. Where corroded/damaged fire stopping is present or where fire stopping is absent where required this may enable the spread of products of combustion, placing persons at risk of harm.</p>
Recommended Actions

9.5	<p>It is recommended that the service riser cupboards across the service premises are surveyed and, where necessary, intumescent collars are installed or replaced.</p> <p>Note - Where services passing through ceilings are part of a 'shaft' as portrayed in Section 7.23 and Diagram 7.1 of Approved Document B (ADB) Volume 1, the collars will not require replacement or installation. However, where there is potential for products of combustion to spread to other areas of the building in the absence of such collars, these should be replaced or installed.</p>

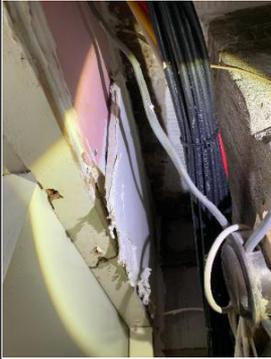
Observation	
9.5

As previously highlighted, the boarding which has been installed in the service riser by flat 85 (seventh) is poorly fixed. In the event of a fire, products of combustion may be able to leave the cupboard by passing behind the poorly fixed material, placing persons at risk of harm.	
	Recommended Actions

9.5	A competent person should attend site to fix/replace the boarding down so as to maintain the standard of fire stopping within the service riser.	
	Observation

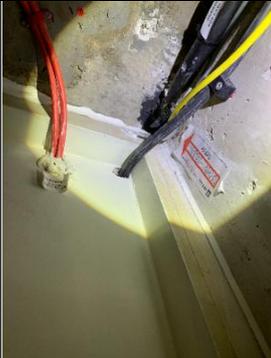
A number of cable breaches were identified in cupboards around the building, where fire alarm works had previously been undertaken. Where there are breaches in compartmentation this may enable the passage of products of combustion, placing persons at risk of harm.	
	Recommended Actions

9.5	It is recommended that the cupboards across the premises are surveyed and, where cable breaches are identified, these are fire stopped to 60 minutes fire resistance. In order to prevent re-occurrence in the future, WCHG should ensure systems of work are in place so as to ensure such breaches are fire stopped once the associated works have been completed.	
	Observation

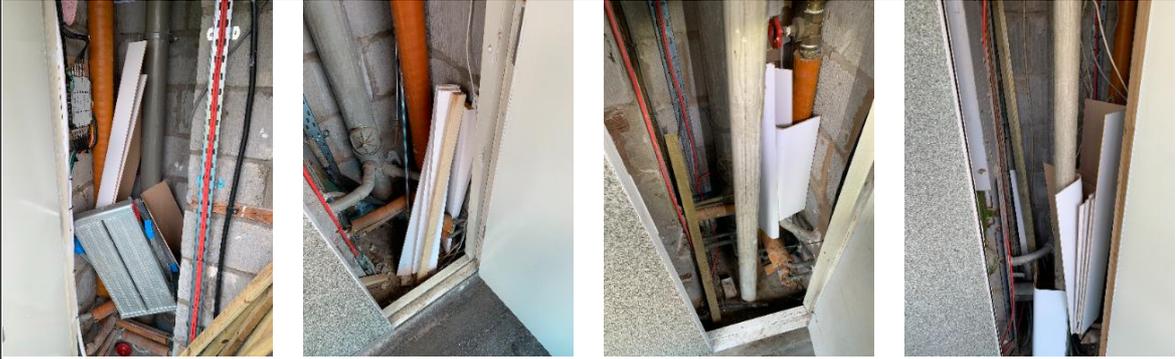
Combustibles were observed as stored within a number of service riser cupboards on the premises. Where combustibles are stored within risers they may provide a means of fuelling a fire which has spread into the riser areas, placing persons at risk of harm.

Recommended Actions
9.14	The service riser cupboards should be surveyed and should be cleared where any storage/waste is identified.
	Observation
9.14	The dry riser cupboard on the third floor could not be locked. Where persons gain unauthorised access to areas such as the dry riser cupboard they may tamper with key firefighting facilities, placing persons at risk of harm.
	Recommended Actions

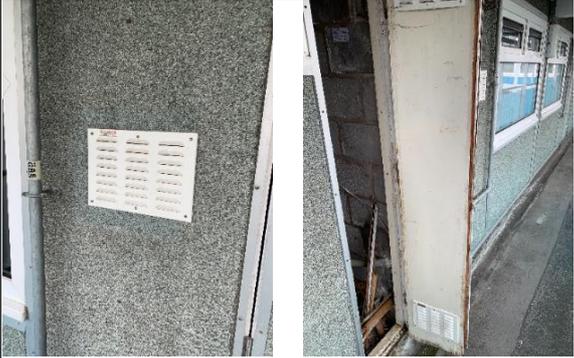
Ref	COMMENTARY
9.1

<p data-bbox="236 573 1497 651">Service risers adjacent to flats are provided with high and low level intumescent grilles. Although these will not seal in the early stages of a potential fire, therefore enabling passage of smoke and other products of combustion, the flats are accessed via open deck therefore this is considered acceptable.</p>

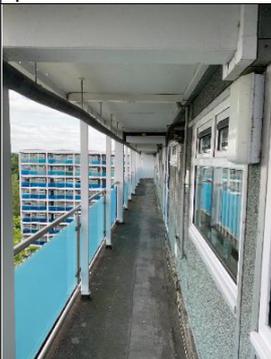
9.1

<p data-bbox="236 1010 1497 1070">Windows overlooking single direction of travel open decks are not fire resisting, however are over 1.1m in height, therefore are considered acceptable in line with Section 59.5 of the LGA Purpose Built Blocks of Flats guidance.</p>

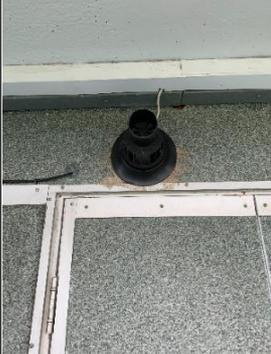
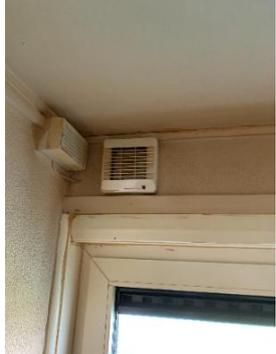
9.8

<p>In the flats that were viewed during this and previous Fire Risk Assessments, it was confirmed that the ventilation arrangements for the kitchen and bathroom were located on the external wall onto the open deck and did not pass through any other compartmentation. The extraction passes out of the flats at high level, therefore does not affect persons escaping past. Extraction from the laundry was observed to lead directly to outside.</p>

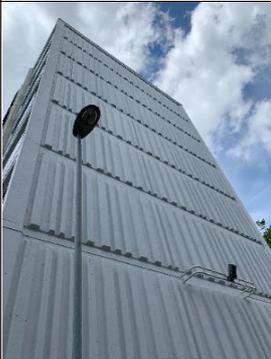
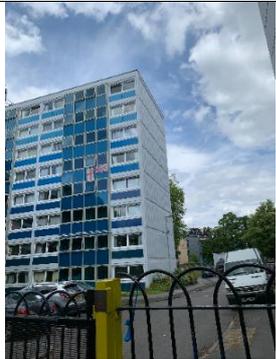
9.13

<p>As was recommended at the time of the previous assessment, a consultant attended site on behalf of WCHG and took a core sample from the gable ends of the building. It was confirmed that no other material of insulation was present behind the gable ends, therefore no further action has been taken.</p>

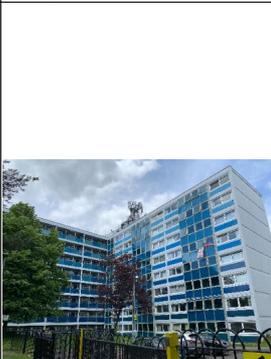
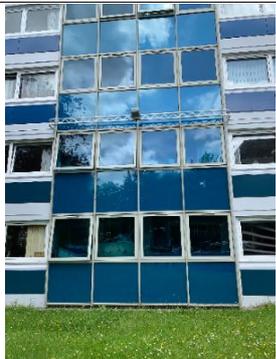
9.13

<p>WCHG has communicated to our assessor that the building is of panel system type construction consisting of concrete walls and floors. There are also portions of curtain wall glazing around the enclosed balconies within resident flats.</p>

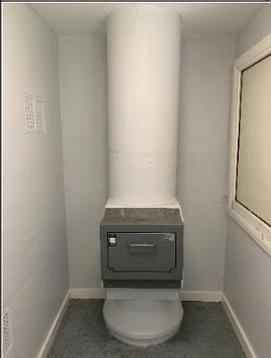
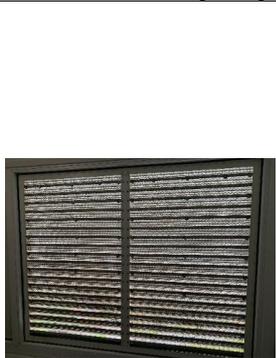
9.14

<p>In the bin room on the ground floor, the bin in use is located adjacent to a lid that has a fusible link which enables the lid to self-close over the bin should a fire occur. This is to prevent the fire, smoke and toxic gases spreading up the chute. The fusible link is checked annually by an appointed contractor and a label indicated that this was last carried out on 04/04/2022. Both the main bin room and the chute rooms are provided with a means of ventilation.</p>

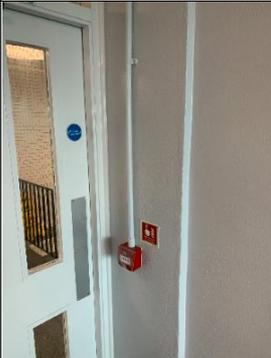
10.3-10.5

<p>Manual call points were provided throughout the common areas which are regularly accessed by the residents. Our assessor understands that whereas detectors are silent when activated, the manual call points are clearly audible. This may result in frequent false alarms and may result in faults or similar showing on the fire alarm panel.</p>
	Recommended Actions

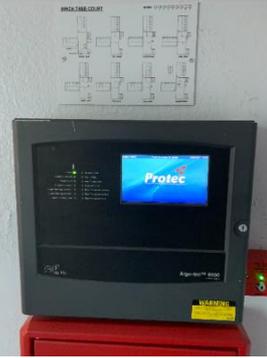
</div> <p>The common area fire alarm and detection system incorporated smoke detection throughout commonly used areas and heat detection in the hallways of each resident flat. The fire alarm panel for the system is located in the lift lobby at ground floor level and appeared healthy at the time of the assessment. It was confirmed to our assessor that the system is addressable. Further detail regarding the fire alarm system and its purpose within the building is provided in commentary 10.0.</p>

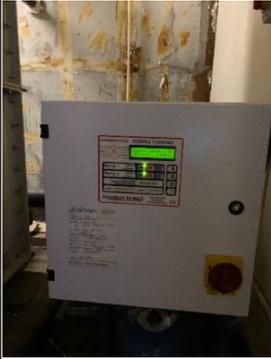
12.6-12.9

<p>A BS 9251 sprinkler system has been installed. In each flat, there are concealed sprinkler heads located in the hallway, each bedroom, the lounge, any enclosed balcony and the kitchen. In addition, there are also sprinkler heads located in the ground floor plant and common areas. There are control valves for each floor located in the dry riser cupboard in lobby off which the refuse chute room is also located. A pump and water tank for the sprinkler system have been provided in the tank room, which is accessed via the lift motor room. The system is maintained and serviced by an approved contractor on a quarterly basis and Argus also attend weekly to visually check the sprinkler system.</p>

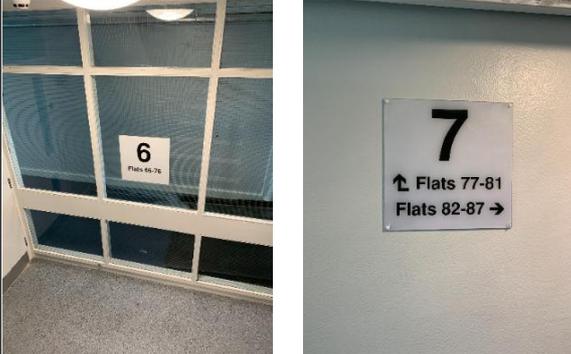
<p>Wayfinding signage that has the floor number and directional signage to the flats, including flat numbers, is now displayed in the lift lobbies and on the stairway landings. These are not low level, however are considered satisfactory.</p>

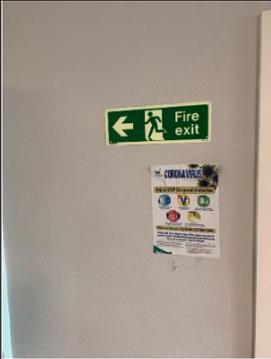
13.1-13.4

<p>Directional signage was observed in the common areas. This building has a single staircase and residents will be familiar with access and egress from the building.</p>

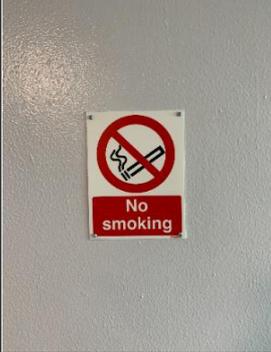
13.12

<p>Suitable 'No Smoking' signage was observed in the common area.</p>
