TOTAL FIRE GROUP LTD

Fire Risk Assessment

25-82 Brownley Court
Wythenshawe
Manchester
Greater Manchester
M22 4QH

04 July 2022

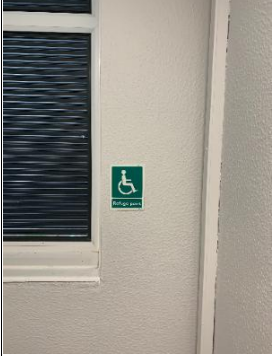
| 7.6 | <p>Refuge signage is provided in the corridors between lobbies serving flats and the staircase. This is consistent with Section 70.11 of the Fire Safety in Purpose Built Blocks of Flats guidance, which states: 'Many older and disabled residents will find it difficult to use stairs in the event of a fire, and additional measures may need to be considered. These could include temporary safe refuge areas or spaces within existing protected lobbies and stairs'. It should be noted that these areas may be considered TEMPORARY refuge areas only and persons should not be encouraged to wait in these areas for rescue.</p> |

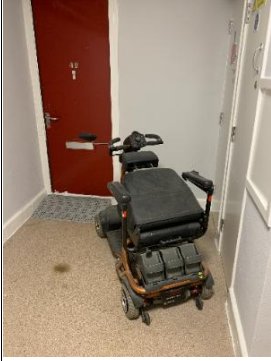
| 8.0 Escape: Finding(s) | |
|---|--|
| 8.6 | <p>A mobility scooter was observed in the common area outside flat 49 (fifth floor) at the time of the assessment. Where there is such storage this may encourage additional storage, may pose a slip/trip hazard and may contribute to the beginning of or development of a fire, all of which may place persons at risk of harm.</p> |

| 8.0 Escape: Finding(s) | |
|---|--|
| 8.6 | Arrangements should be made to remove the scooter from the escape route, with the owner of the scooter advised accordingly regarding its storage in the common area. |

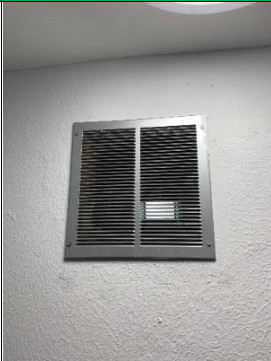
| Ref | COMMENTARY |
|---|--|
| 8.5 | <p>The above photographs show an example of the means of smoke ventilation in the stairway of the premises. The layout is the same on all floors from the first floor upwards. The vent on the stairs leads into the metal ducting which in turn vents direct to outside, passing through the refuse chute room on its way. WCHG have engaged third parties to confirm that this method of smoke ventilation is adequate. Smoke modelling calculations have been provided by a fire engineer that concluded that provided new grilles were fitted and the ducting was cleaned that the existing provisions for smoke ventilation are satisfactory. In addition, the ducting has been inspected by another third party who confirmed that they were fit for purpose. WCHG have documentary evidence available issued by the third-parties.</p> |

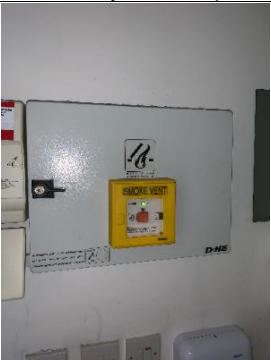
| Ref | COMMENTARY |
|---|--|
| 8.5 | <p>The alternative staircase serving only ground and first floor contains an AOV at its head. The smoke control panel is located in the toilet which adjoins the escape route on the first floor and was not showing any faults at the time of the assessment. It was confirmed to our assessor that the smoke control system is tested monthly in house and is serviced six monthly by a competent person. The last six monthly service was undertaken on 07/04/2022.</p> |

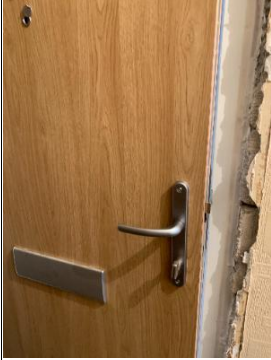
| 8.10, 8.12 | | <p>The new fire doors that are being fitted to flats have thumb turn type locking devices on their internal side.</p> |

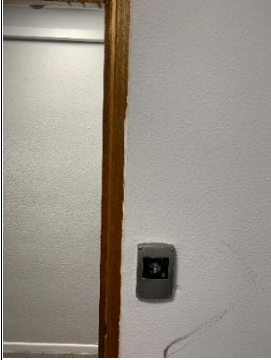
| 8.16 | | <p>Electromechanically secured doors separate the staircase from the corridors serving flats and these require fob access in the direction towards the flats. In the direction of escape, a suitable push pad device is provided leading into the stair.</p> |

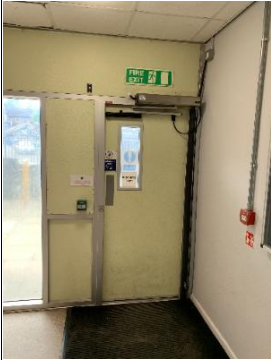
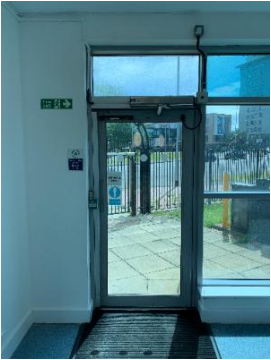
| 8.17-8.18 | | <p>Several final exit doors from the building were electromagnetically secured and were accompanied by suitable green box emergency overrides. The same electromagnetically secured door and override arrangement is provided to the fire resisting doors which separate these two exits. It was previously confirmed that these doors are configured fail to the openable position on activation of the fire alarm system.</p> |

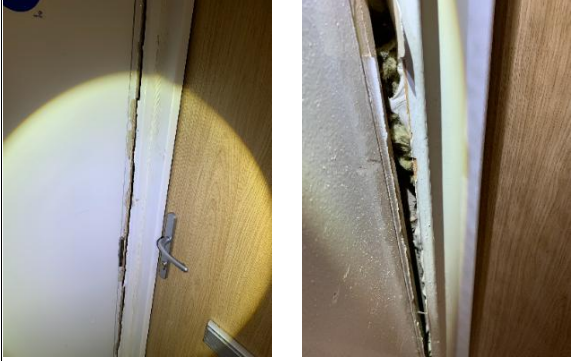
| 9.0 The Confinement of Fire: Finding(s) | |
|---|---|
| 9.1 | <p>An architrave around flat 77's (tenth floor) entrance door appeared to be damaged, however behind the architrave it was observed that fire stopping and Rockwool had been applied. Should the damaged architrave affect the efficiency of the fire door set as a whole, persons may be placed at risk of harm.</p> |

| 9.0 The Confinement of Fire: Finding(s) | |
|---|---|
| 9.1 | A competent person should attend site to assess the situation and, where the fire resistance of the door set is considered to be affected, remedial works carried out to restore the set to ensure a minimum of 30 minutes fire resistance is provided. |

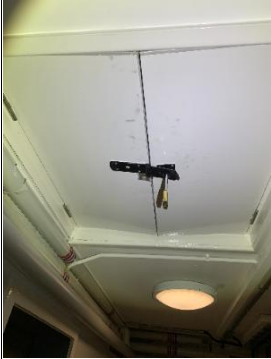
| 9.0 The Confinement of Fire: Finding(s) | |
|---|---|
| 9.1-9.2 | <p>As highlighted on the previous fire risk assessment, the fire resisting hatch between the eleventh floor and the lift motor room was not fully secured shut when locked. Where fire doors do not close fully, they will not act as a barrier to prevent the spread of fire and the products of combustion from spreading from one area to another, including the escape routes. This would place persons at risk of harm.</p> |

| 9.0 The Confinement of Fire: Finding(s) | |
|---|---|
| 9.1-9.2 | The fire resisting hatch doors should be replaced or repaired so that it can securely close and form an imperforate barrier between the eleventh floor and the lift motor room. |

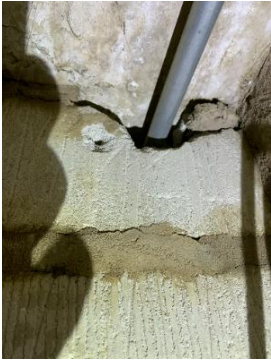
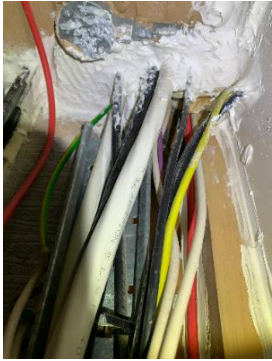
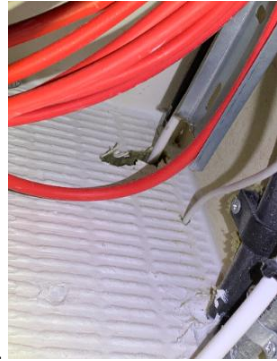
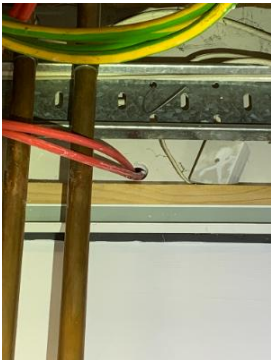
| | Observation |
|---|---|
| 9.5 | <div data-bbox="261 212 1177 929"> </div> <p>1. Breaches in compartmentation were observed in several areas of the building, detailed as follows:</p> <ol style="list-style-type: none"> 1. Cupboard by main entrance door within flat 56 (sixth) leading back into the communal areas. 2. From the corridor adjoining the bin chute room appearing to breach into an unknown area above the bin chute room ceiling (sixth floor). 3. Electrical riser cupboard by flat 57 - Cables in the corner have been fire stopped around however some foam was observed in the centre of this stopping and it could not be confirmed that this is of the fire resisting type and that it has been applied in the manner detailed in the manufacturer's guidance (sixth floor). 4. Breach in fire batt above the false ceiling, above the fire resisting doors which separate the front and rear final exits. 5. Cable breach above the false ceiling through the plasterboard into flat 27 (ground floor). <p>Where there are breaches in compartmentation these may enable products of combustion to spread, placing persons at risk of harm.</p> |

| | Observation |
|---|---|
| 9.5 | It is recommended that a competent person attends site to fire stop the identified breaches to a standard of 60 minutes fire resistance. |

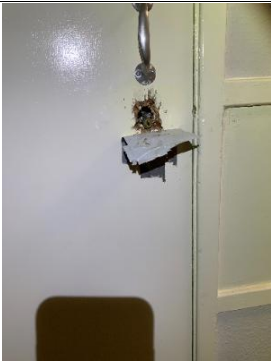
| | Observation |
|---|---|
| 9.14 | <div data-bbox="261 1377 533 1736"> </div> <p>1. Several riser cupboard doors could not be locked shut at the time of the assessment, detailed as follows:</p> <ol style="list-style-type: none"> 1. Electrical riser cupboard by flat 34 (second floor). 2. Sprinkler valve cupboard (second floor). 3. Electrical room within old caretaker's area. <p>Where fire doors to restricted access areas cannot be properly secured there may be cases of unauthorised access or doors being left open/unsecured, placing persons at risk of harm.</p> |

| | Observation |
|---|---|
| 9.14 | Remedial works should be carried out so as to ensure these doors can be locked/secured. |

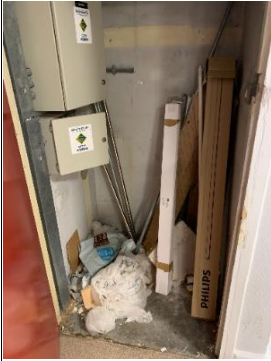
| Observation | |
|---|---|
| 9.14 | <p>Combustible storage was observed within the electrical cupboard which is close to the door into the base of the stair serving all floors. Where there is such combustible storage in the presence of a source of ignition there is increased potential for a fire to begin and develop, placing persons at risk of harm.</p> |

| Observation | |
|---|---|
| 9.14 | It is recommended that the combustible storage is removed and this cupboard is kept free of storage. |

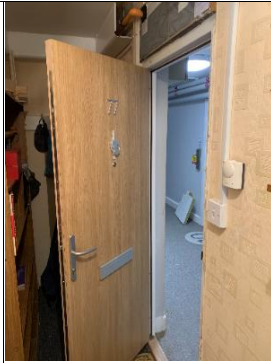
9.1-9.3

Flat entrance door replacements were being carried out throughout the premises at the time of the assessment. Our assessor accessed several flats where these doors had been replaced and it was observed that the doors were FD30s with self-closing metal letterboxes approximately midway down their length. It was observed that none of the fire doors had yet been fitted with self-closing devices and the site manager confirmed that a contractor was due shortly to install these across the premises.

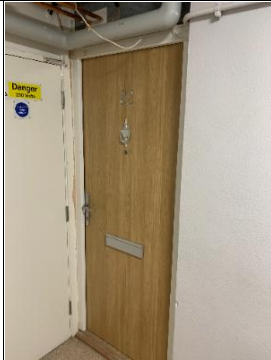
9.1-9.3

'Performance Doorset Solutions Fireguard' door designs are currently being installed to flat entrances throughout the premises and WCHG provided our assessor with test information carried out by Warrington Fire for these doors. Page 32 of the field application test report states that 'if the Performance Doorset Solutions Fireguard door design, constructed in accordance with the specifications documented in this field of application report, were tested in the appropriate configuration in accordance with BS EN 1634-1:2014+A1:2018, it is our opinion that they would provide a minimum of 30 minutes integrity and insulation, as appropriate'.

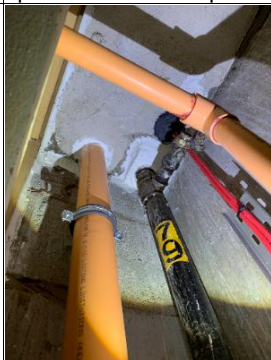
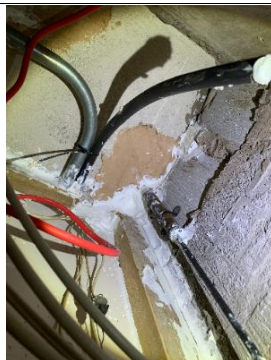
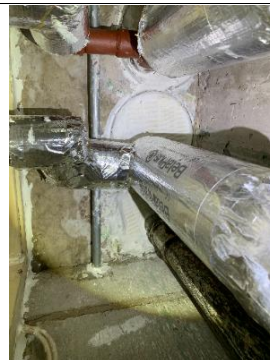
9.1, 9.5

As highlighted previously compartmentation works have been carried throughout the premises by Allied Protection Ltd. They are an accredited passive fire protection contractor and they have provided WCHG with documentary/photographic evidence of their work. Following the installation of the fire alarm system, further fire stopping was required. This was carried out by Flame Hold Ltd who are also an accredited passive fire protection contractor. They have also provided WCHG with documentary/photographic evidence of their work. The majority of the fire stopping and compartmentation work throughout the premises was observed to be of a high standard. Exceptions to these high standards have been detailed within significant finding 9.5.

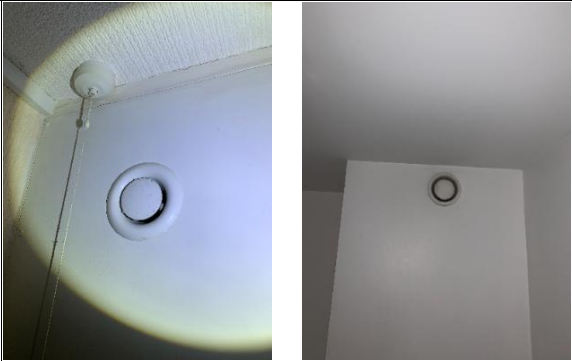
| 9.8 | <div data-bbox="236 864 810 1223"> </div> <p>WCHG have confirmed that Allied Protection Ltd has completed fire stopping and compartmentation works to prevent fire spread via the common bathroom and shower room extract shafts. They have also fitted fire rated valves with an intumescent infill in the bathrooms which are connected to the ducting and shaft. Although these valves will not prevent smoke spread into the shaft in the early stages of a fire they are considered an acceptable method of preventing fire spread. Documentary and photographic evidence is available to evidence the works carried out by Allied Protection Ltd and are held by WCHG.</p> |

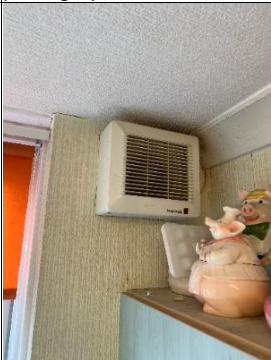
| 9.8 | <div data-bbox="236 1357 507 1715"> </div> <p>Kitchen extraction and grilles within the enclosed balcony areas of each flat appeared to lead directly to outside.</p> |

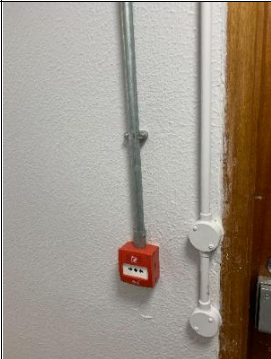
| 10.0 Fire Alarm System: Finding(s) | |
|---|--|
| 10.3-10.5 | <p>Manual call points were provided throughout the common areas which are regularly accessed by the residents. Our assessor understands that whereas detectors are silent when activated, the manual call points may be clearly audible. This may result in frequent false alarms and may result in faults or similar showing on the fire alarm.</p> |

| 10.0 Fire Alarm System: Finding(s) | |
|---|--|
| 10.3-10.5 | It is recommended that the manual call points in the common areas which are accessed by residents are removed if they result in an audible alarm sounding on activation. It is noted that where manual call points remain in areas accessible only to staff members these may remain as audible, so long as they only sound in the area of operation, not throughout the whole building. |

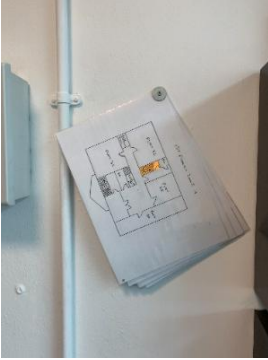
| Ref | COMMENTARY |
|---|---|
| 10.11 | <p>Suitable building plans are provided adjacent to the BS5839-1 fire alarm panel which serves the majority of the common areas. Detachable building plans are also provided by this fire alarm panel.</p> |

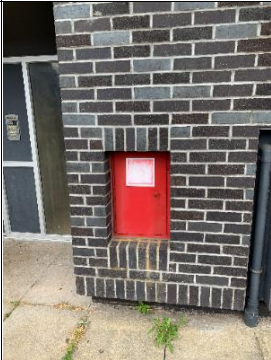
| 12.0 Fire Fighting Equipment, Systems & Fixed Installations: Finding(s) | |
|--|--|
| 12.10 | <p>The signage indicating the dry riser inlet on the building's external façade was faded.</p> |

| 12.0 Fire Fighting Equipment, Systems & Fixed Installations: Finding(s) | |
|--|--|
| 12.10 | Consider replacing the signage with that which is clearer. |

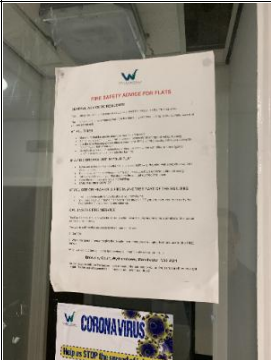
| Ref | SIGNIFICANT FINDINGS |
|---|--|
| 13.6, 13.8 | <p>A fire action notice is provided in the ground floor common area close to the lifts, however this appears to be an original 'stay put' fire action notice and does not take into account the new fire alarm/evacuation alert system. Where inaccurate information is displayed in the premises persons may be unaware of the correct action to take in the event of a fire and the facilities/equipment in the building, placing persons at risk of harm.</p> |

| Ref | SIGNIFICANT FINDINGS |
|---|--|
| 13.6, 13.8 | The fire action notice should be updated to display the initial 'stay put' policy with the additional inclusion of information relating to the EAS system and what to do on its sounding. |

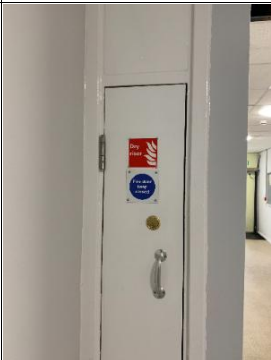
| Ref | SIGNIFICANT FINDINGS |
|---|--|
| 13.10 | <p>The cupboard adjacent to flat 25 (ground floor) has been labelled as a dry riser cupboard, however does not contain either an inlet nor an outlet. Where persons are of the impression that there is an inlet/outlet in this cupboard this may cause a delay in beginning to fight a fire, placing persons at risk of harm.</p> |

| Ref | SIGNIFICANT FINDINGS |
|---|--|
| 13.10 | It is recommended that the signage indicating that there is dry riser equipment within this cupboard is removed. |

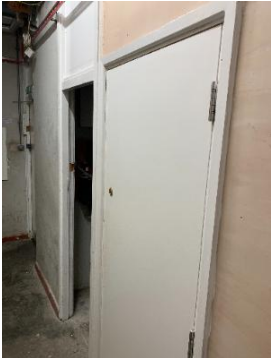
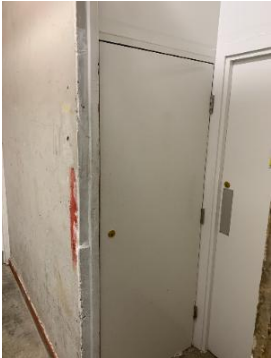
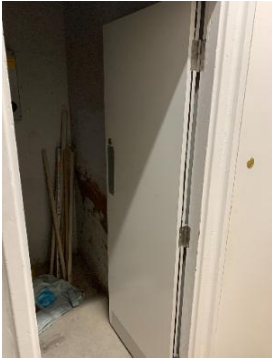
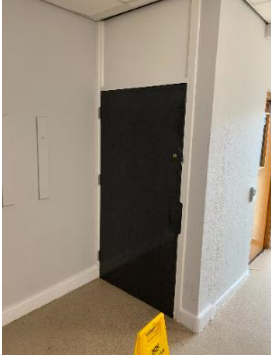
| Observation | |
|---|---|
| 13.10 | <div> </div> <div> </div> <p>Several fire doors within the building were noted as missing 'Fire Door Keep Locked' signage, detailed as follows:</p> <ol style="list-style-type: none"> 1. General store, electrical cupboard and cleaner's cupboard - Old caretaker's area ground floor. 2. Electrical cupboard currently containing combustibles which is in the main entrance lobby, near to the door into the stair serving all floors. <p>In the absence of suitable 'Fire Door Keep Locked' signage some doors may be left unsecured/ajar, compromising the adjoining routes and placing persons at risk of harm.</p> |

| Observation | |
|---|---|
| 13.10 | It is recommended that suitable 'Fire Door Keep Locked' signage is affixed to those doors highlighted above. |

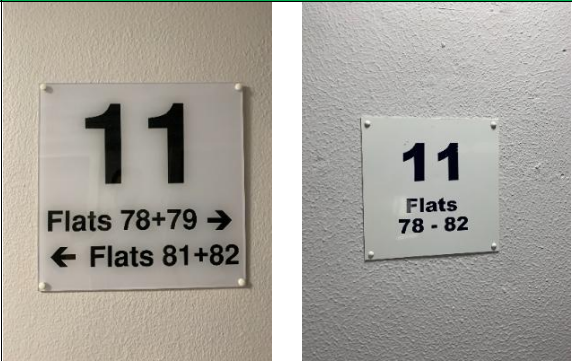
| Ref | COMMENTARY |
|---|---|
| 13.0 | <p>Wayfinding signage that has the floor number and directional signage to the flats, including flat numbers, is now displayed in the lift lobbies and on the stairway landings. These are not low level, however are considered satisfactory at present.</p> |

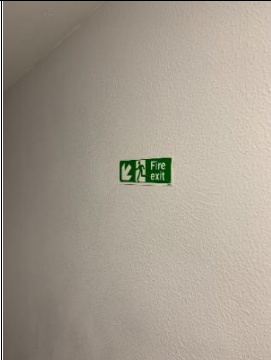
| Ref | COMMENTARY |
|---|---|
| 13.1-13.4 | <p>Directional signage was observed in the common areas. This building has a single staircase down as far as the first floor and residents will be familiar with access and egress from the building.</p> |

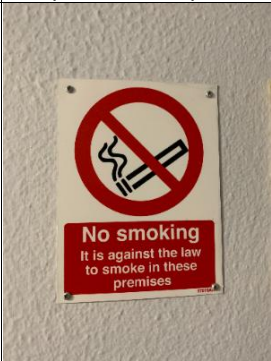
| Ref | COMMENTARY |
|---|---|
| 13.12 | <p>Suitable 'No Smoking' signage was observed in the common area.</p> |
