TOTAL FIRE GROUP LTD

Fire Risk Assessment

1-87 Edwards Court Rowlandsway Wythenshawe M22 5SE

14 June 2022

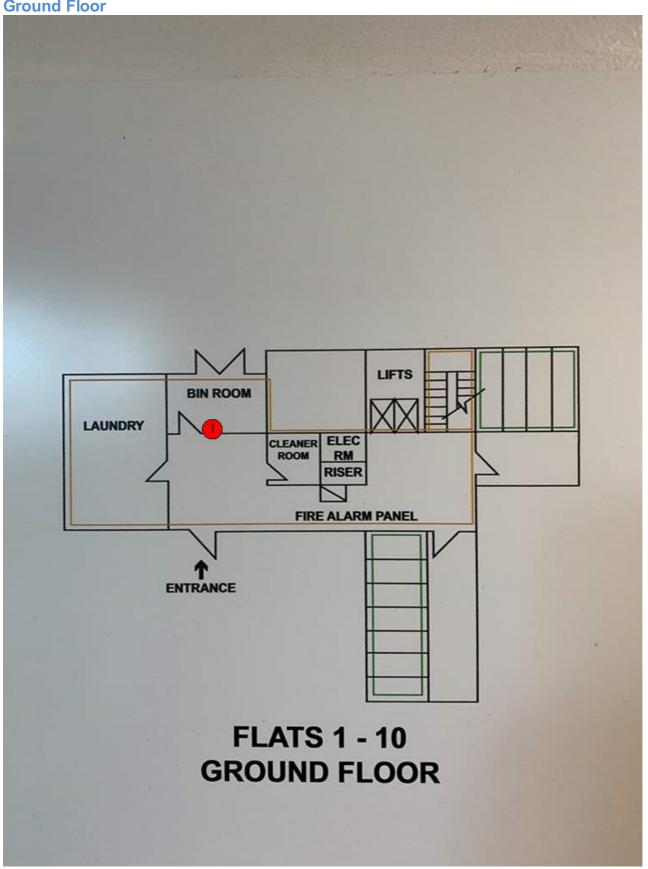
Ground Floor

Observation 9.5 Several hard plastic pipes penetrated the ceiling of the bin room and did not appear to be fire stopped with products such as intumescent collars. Should the pipes melt in the event of a fire this may leave breaches which would allow the spread of fire and other products of combustion, potentially placing persons at risk of harm. Recommended Actions Confirm that the pipes are 60 minutes fire resisting or suitably fire stop with products such as an intumescent collar. 9.5 Observation 9.5 Between the refuse chute room and the electrical room on the seventh floor are bricks with small air holes. Where these bricks enable spread of fire and products of combustion between the two areas, persons may be placed at risk of harm. Recommended Actions 9.5 It is recommended that the bricks are fire stopped to prevent passage of products of combustion between the seventh floor chute and electrical rooms Observation 9.5 A number of cable breaches were identified in cupboards around the building, where fire alarm works had previously been undertaken. Where there are breaches in compartmentation this may enable the passage of products of combustion, placing persons at risk of harm. Recommended Actions 9.5 It is recommended that the cupboards across the premises are surveyed and, where cable breaches are identified, these are fire stopped to 60 minutes fire resistance. In order to prevent re-occurrence in the future, WCHG should ensure systems of

1 The Confinement of Fire - 9.5

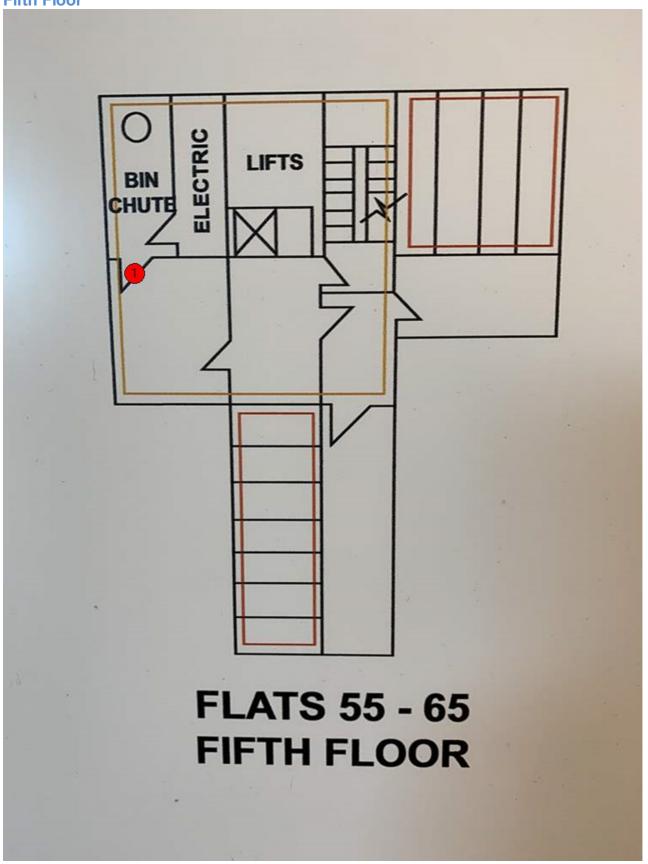
Fifth Floor

Observation 9.2 The occupant of flat 63 (fifth) has positioned some netting outside of their flat. When this flat was inspected and the door allowed to self-close, it caught in the netting which prevented self-closing. Where flat entrance doors are not effectively selfclosing, persons passing the door may be placed at risk of harm. Recommended Actions It is recommended that the netting is removed and the resident is advised against its placement on the open deck side of the 9.2 door. Observation 9.2 The bin chute room door (fifth) was not effectively self-closing. Where fire doors are not effectively self-closing this may enable the spread of products of combustion, placing persons at risk of harm. Recommended Actions 9.2 It is recommended that a competent person attends site to carry out remedial works so that the door is effectively self-closing and well fitting in its rebate. Observation 9.2 The internal doors to both the bin and the laundry rooms were being wedged open at the time of the assessment. Where doors are wedged they would enable fire and other products of combustion to spread onto the adjoining escape route, placing persons at risk of harm. Recommended Actions It is recommended that the doors are released and residents are advised against wedging the doors open. 9.2

1 The Confinement of Fire - 9.2
