TOTAL FIRE GROUP LTD

Fire Risk Assessment

1-58 Hollyhedge Court
223 Hollyhedge Road
Manchester
Greater Manchester
M22 4QD

05 July 2023

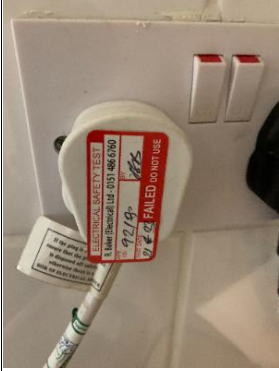
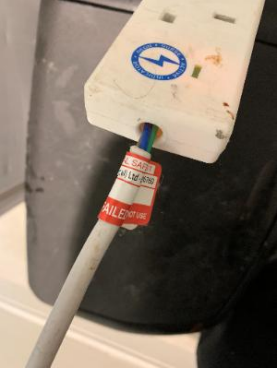
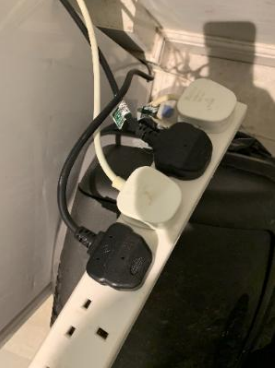
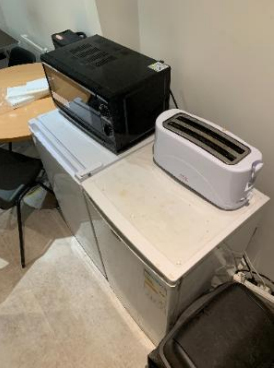
Ref	SIGNIFICANT FINDINGS
	Observation
6.5, 6.10, 6.13	<p>PAT testing labels were observed on the portable electrical appliances in the commonly used facilities (e.g. the community room and kitchenette), with the extension lead used advising that it failed and should not be used. Also, appliances are plugged into the extension lead that may exceed the designed load of the extension lead. Common causes of fire are overloading and damaged/failed electrical sockets and extensions. With the above in mind, a fire is likely which may place persons at risk of harm.</p> <p>Note: The previous FRA raised an action in relation to PAT testing not undertaken on the same appliances. The previous FRA action has been signed off as complete on 04/08/2022. PAT testing has been undertaken however the above issue has been identified.</p>

6.5, 6.10, 6.13	It is recommended that the failed extension lead is put out of use and either alternatives are sought, or additional fixed mains electrical sockets are fitted to reduce the number of extension leads and similar required.
Ref	RECOMMENDATIONS
	Observation

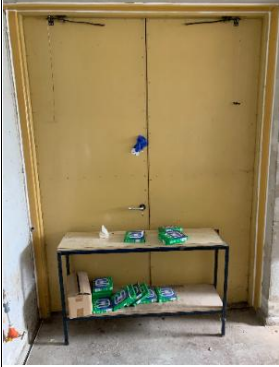
8.11	It is recommended that the door access device and push pad are assessed to ensure they open easily.
Ref	RECOMMENDATIONS
	Observation
8.11	<p>The double doors from the plant room within the caretaker area were found blocked and key-locked shut. Although an alternative exit is available back through the building, this exit leads directly to open air and would be the preferred choice if evacuation would be needed from this area.</p>

8.11	It is recommended that this exit is made available and kept clear. The doors should be unlocked when the room is occupied and work is being undertaken.

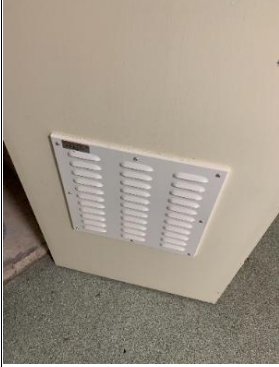
9.0 The Confinement of Fire: Finding(s)	
Ref	SIGNIFICANT FINDINGS
	Observation
9.1	<p>As previously identified; The gas service riser cupboard adjacent to flat 7 (first floor) is provided with an intumescent grille. Intumescent grilles would not prevent the spread of products of combustion prior to reaching the temperature required to seal, meaning that some products of combustion may be able to enter the escape route and place persons at risk of harm.</p> <p>Note: The previous FRA action has been signed off as complete on 12/08/2022 by Justin Gill. However, as the grille is still present and no evidence is provided to indicate what actions have been taken, the action has been reopened.</p>

9.1	It is recommended that the door is replaced/grille is sealed to 30 minutes fire resistance.
	Observation
9.1, 9.16	<p>As previously raised; The electrical cupboard adjoining the corridor that serves the community areas (ground floor) was found open and unable to lock shut. Where fire doors do not close shut, a fire or other products of combustion may be able to spread onto the escape route, placing persons at risk of harm.</p> <p>Note: The previous FRA action has been signed off as complete on 12/08/2022 by Justin Gill. However, as this door is still an issue, the action has reopened.</p>
	Recommended Actions

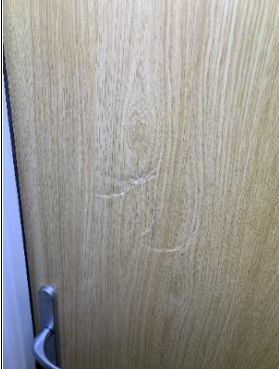
9.1, 9.16	It is recommended that the door is assessed and action is taken to ensure the door securely closes and locks.
	Observation
9.5	<p>Flat 45's entrance door seemed to be cracked in the face of the door (kick marks). Where fire doors are damaged, a fire or other products of combustion may be able to spread onto the escape route, placing persons at risk of harm.</p>

9.5	It is recommended that the door is checked by a competent person to ensure the integrity of the door has not been compromised or undertake repairs where required.

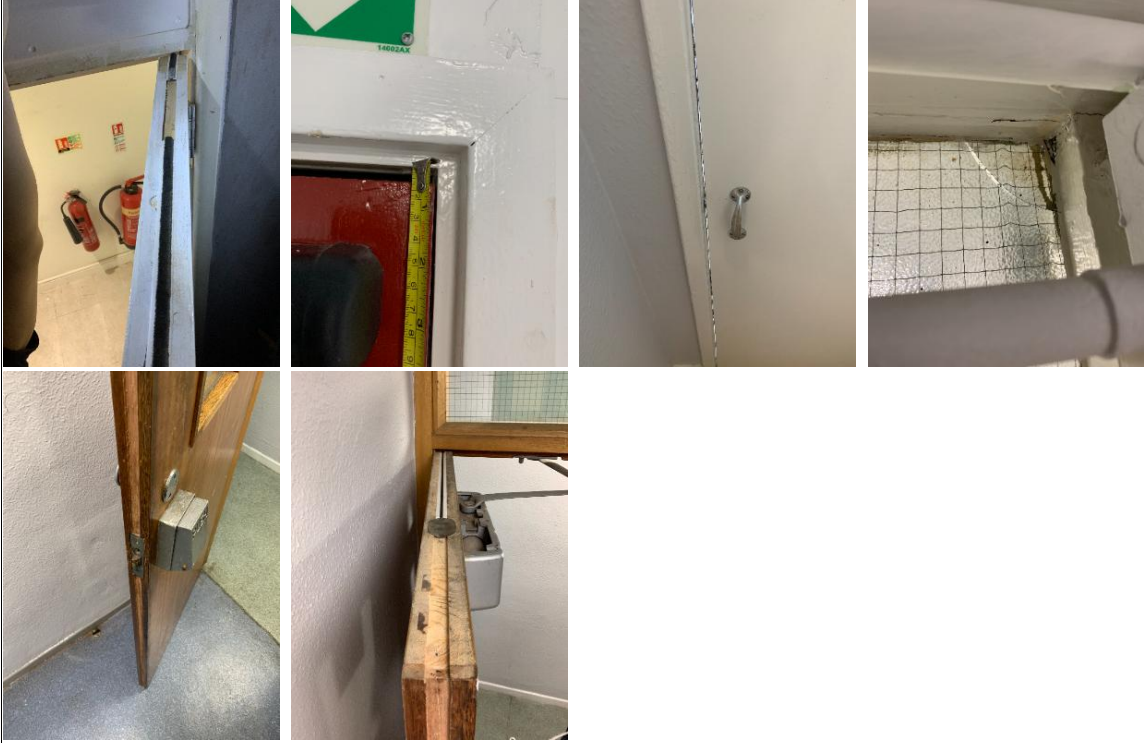
Observation
9.5-9.6	<p>Communal doors - Fire door deficiencies with communal doors were identified in this assessment. These include:</p> <ul style="list-style-type: none"> • Previously raised - Community area kitchenette - This door was not locked and did not have a self-closing device. Either keep locked and provide 'Fire Door Keep Locked' signage or install a self-closing device. • The community area electrical cupboard door was missing intumescent fire and cold smoke seals on the top edge. • The ground floor automatic door separating the lobby and staircase had a large 10mm gap at the top edge. • The majority of the bin refuse doors had gaps in the doors where daylight could be seen. The gaps didn't seem excessive, however, the cold smoke seals did not fill the gap between the door and frame. • The bin refuse door on the 9th floor was missing intumescent fire and cold smoke seals low down on the door edge. • The staircase door to floors 1 and 7 were missing intumescent fire and cold smoke seals. • The riser cupboard next to flat 32 was not closing shut. • A small crack was found on the transom glazing to the lobby door to the lift and flats on the 1st floor. <p>Where fire doors are damaged, stuck open, have gaps, or are missing components, a fire or other products of combustion may be able to spread onto the escape route, placing persons at risk of harm.</p> <p>Note: The previous FRA action in relation to the community area kitchenette was signed off as complete on 08/08/2022 by Justin Gill. However, this was not complete when observed on-site resulting in the action being re-raised.</p>

Recommended Actions
9.5-9.6	<p>It is recommended that the doors identified are repaired where required, missing components re-instated, doors are adjusted to ensure they fully close, and gaps are reduced to a tolerable level/cold smoke seals fill the gaps.</p>

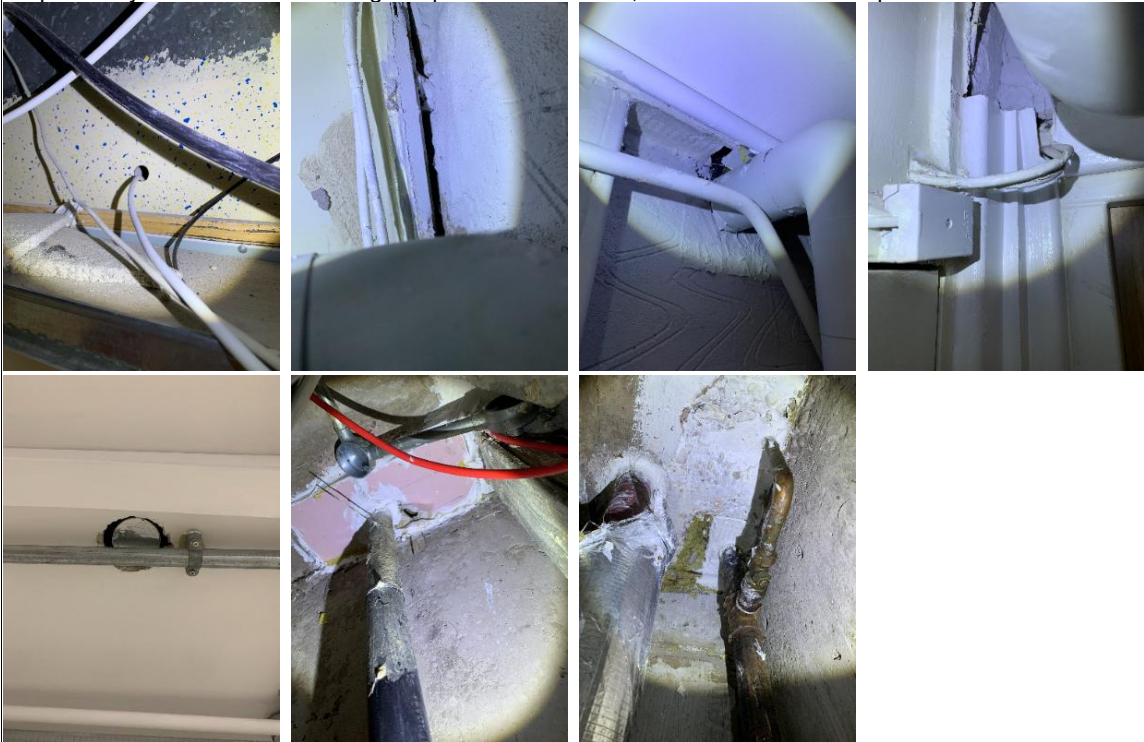
Observation
9.8	<p>As previously identified; Breaches in compartmentation were identified within the communal areas throughout the block. These include:</p> <ul style="list-style-type: none"> • Previously raised - In the wall over the community room corridor into the lift lobby, small cable breaches and breaches in metal were noted (ground floor). • Previously raised - Electrical cupboard by flat 30 small hole in existing fire stopping (sixth floor). • Previously raised - Gap in existing stopping in sprinkler valve cupboard (third floor). • Penetrations were not fully sealed or not sealed above the false ceiling on the ground floor. • Penetrations were not sealed/sealed inappropriately above a number of flat entrance doors from the communal side. • The ceiling area around a conduit junction box was not sealed in the staircase lobby on the 11th floor. • The two riser cupboards that are next to flat 43 had damaged existing fire stopping. • Penetrations were not sealed within the plastic trunking in the common areas (a couple were viewed). <p>Breaches in fire-resisting construction that are not suitably fire stopped could lead to a fire spreading beyond the compartment of fire origin and place persons at risk of harm.</p> <p>Note: The previous FRA action has been signed off as complete on 23/09/2022 by Mike Richmond. However, due to some of the previously raised actions not being complete as seen onsite, the action has been reopened.</p>

Recommended Actions
9.8	It is recommended that the areas identified are opened and checked/surveyed, and all areas are adequately fire stopped to provide the same level of fire resistance as the surrounding walls.
	Observation

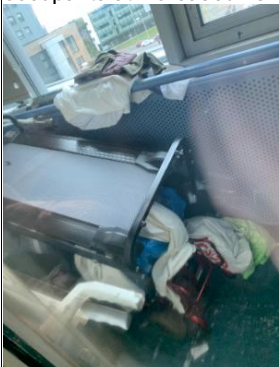
9.16, 9.27	<p>A couple of the balconies of the flats accessed appeared to have a high volume of combustibile items/rubbish or storage. Although the balconies are enclosed with glazing, the balconies would not have originally been intended to be used as storage rooms and extensions of kitchen appliances (as seen in another block), and it is not known if sprinkler protection extends to the balconies. It wasn't clear if Wythenshawe had a balcony policy in place. This may add significant fire loading to the external face of the premises should a fire breach the balcony, and a fire may spread upwards and between floors, placing the occupants at increased risk of harm from external fire spread.</p>

Recommended Actions	
9.16, 9.27	Wythenshawe ought to regularly inform the occupants that they must NOT store combustible materials or plastics on the balconies and that any ignition sources (e.g. barbecues, heaters, and the like) must not be allowed in those areas. Current policies that are in place should be re-introduced to all residents (or one should be developed if not already in existence). Further advice and guidance can be obtained from PAS 9980.
Ref	RECOMMENDATIONS
Observation

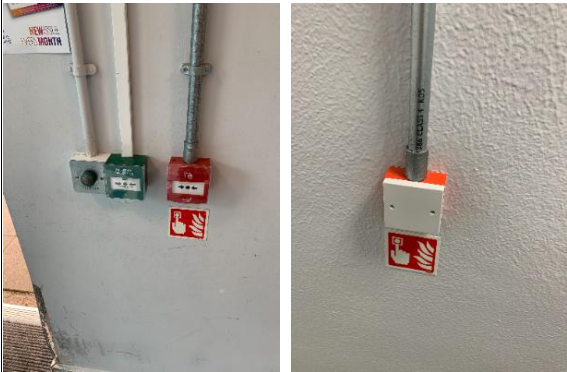
10.6	<p>As previously identified; Manual call points were provided in the ground floor common areas which are regularly accessed by the residents. Our assessor understands that whereas detectors are silent when activated, the manual call points may be clearly audible. This may result in frequent false alarms and may result in faults or similar showing on the fire alarm.</p> <p>Note: The previous FRA action has been signed off as complete on 16/09/2022 by Mike Holt. However, as the call points are still active in the ground floor communal areas, the action has been reopened. The manual call points on the upper floors within the communal areas have been blanked off.</p>

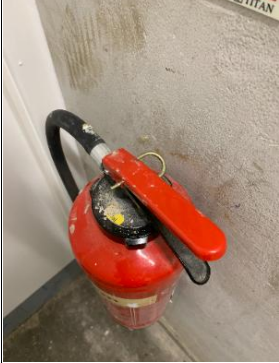
Ref	SIGNIFICANT FINDINGS
	Observation
12.5	<p>The fire extinguisher within the plant room corridor is missing its servicing tag indicating the extinguisher has been tampered with. Persons using defective equipment may enable a fire to develop and possibly compromise escape routes, endangering relevant persons and placing them at risk of harm.</p>

12.5	It is recommended that the extinguisher is checked by a competent person to ensure it is in good working order.
	Observation
12.11-12.13	<p>As previously identified. The original 'Firemen's switch' function for exclusive use by firefighters in an emergency is not confirmed.</p> <p>As previously identified; Both lifts are understood to have been fitted with a fire alarm interface that returns them to the ground floor. The previous FRA noted that WCHG had confirmed that the lifts are standard lifts. As different types of lifts provide different levels of safety and control of the lift for fighters, it is important that the correct details are available. Firefighters using a lift that does not provide a perceived level of safety would be placed at risk of harm which could place residents (relevant persons) and risk of harm due to delays in rescues.</p> <p>The original design of these lifts would have had a provision for the exclusive use of firefighters in an emergency by providing at ground level a switch in a glass fronted box marked 'FIRE SWITCH' which operates a control whereby firemen can obtain the use of the lift without interference from the landing call points.</p> <p>Note: The previous FRA action has been signed off as complete on 07/10/2022 by Joy Ashley. However, no evidence or feedback has been provided to indicate what types of lifts have been installed. This has resulted in the action reopening. In the opinion of our assessor, the lifts appear to be that of a Fireman's lift incorporating only simple means to recall the lift to a designated floor, with no complex lift controls or protection measures for fire and rescue service use, also known as a fire mans lift.</p>

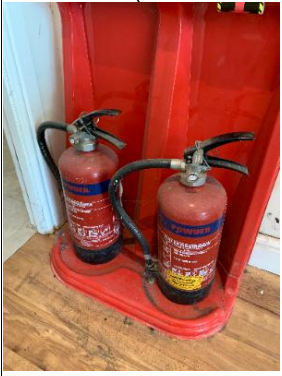
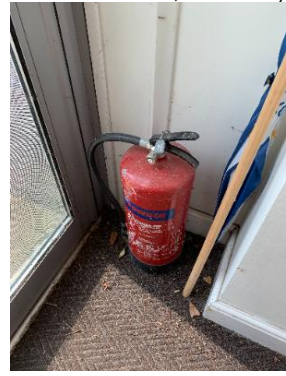
Ref	RECOMMENDATIONS
12.2	<p>Observation</p> <p>It is noted that were dry powder extinguishers provided in the community room that is now being used as an office that were dated 2015 as last service. The discharge of a powder extinguisher within buildings can cause a sudden reduction of visibility and can also impair breathing, which could temporarily jeopardize escape, rescue or other emergency action. For this reason, powder extinguishers should generally not be specified for use indoors, unless mitigated by a health and safety risk assessment (taken from BS5306 Part 8:2012; sec 5.4.3).</p> <div data-bbox="236 371 805 745">
