TOTAL FIRE GROUP LTD

Fire Risk Assessment

1-58 Hollyhedge Court
223 Hollyhedge Road
Manchester
Greater Manchester
M22 4QD

05 July 2022

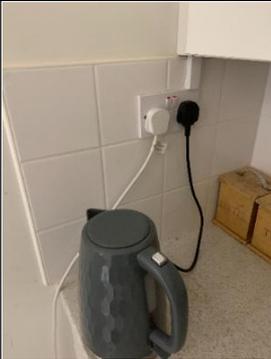
<p>No PAT testing labels were observed as fitted to any of the portable electrical appliances in the commonly used facilities (e.g. the community room and kitchenette), therefore it could not be confirmed whether or not PAT testing had been carried out.</p>
	Recommended Actions

6.5, 6.10	<p>It is recommended that systems, for example PAT testing, are put in place to ensure appliances in communally used areas are tested, repaired and maintained on a regular basis in accordance with the Electricity at Work Regulations, 1989. It is highlighted that not all electrical devices need to be the subject of an annual PAT. The Health and Safety Executive (HSE) advocates a proportionate, risk-based approach to the maintenance of portable electrical appliances within the workplace. This guidance is simple and easy to follow and can be found on the HSE website "Maintaining Portable Electrical Equipment in a low risk environment."</p>

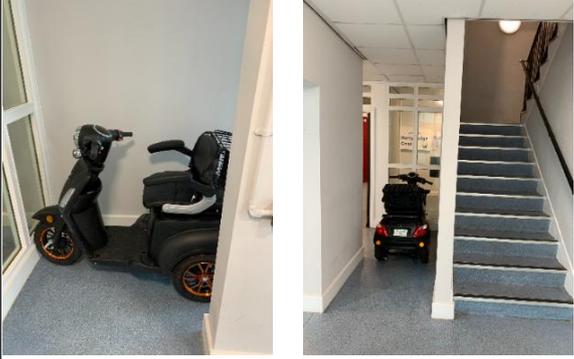
<p>A mobility scooter was being stored in the staircase enclosure at the time of the assessment, at its base. Where there is such storage this may encourage additional storage, may pose a slip/trip hazard and may contribute to the development of a fire which has spread onto the escape route, all of which may place persons at risk of harm.</p>
	Recommended Actions

8.6	Arrangements should be made for the mobility scooter to be removed from the common area and the resident to whom it belongs should be educated regarding storage in the common area accordingly.
	Observation

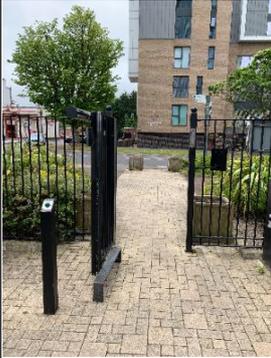
<p>The exception to commentary 8.17-8.18 with regards to provision of suitable green box emergency overrides by electromagnetically secured doors were the external gates close to the final exit from the building. It was observed that the gate is electromagnetically secured and, although a 'push button to exit' system was provided, there was no green box emergency override present. Persons must pass through this gate to reach a place of ultimate safety away from the perimeter of the building and, should this gate fail to release for some reason (e.g. residual power remaining), then persons may remain trapped behind the security fencing near to the building, placing them at risk of harm.</p>
	Recommended Actions

8.17-8.18	It is recommended that green box emergency overrides are installed adjacent to the external gates near to final exits.
Ref	RECOMMENDATIONS
	Observation

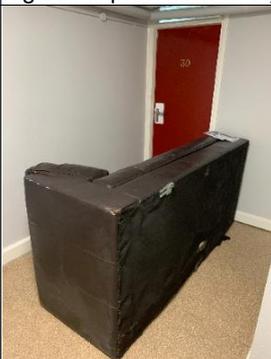
8.6

<p>A sofa was observed in the common area outside flat 30 (sixth floor) at the time of the assessment, however a contractor present informed our assessor that this flat was being emptied as it was newly void and that the sofa was soon to be removed.</p>

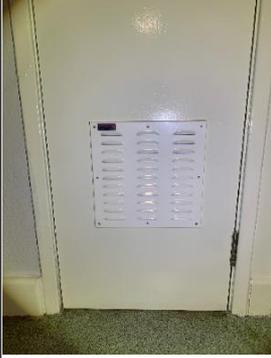
<p>The gas service riser cupboard adjacent to flat 7 (first floor) is provided with an intumescent grille. Intumescent grilles would not prevent the spread products of combustion prior to reaching the temperature required to seal, meaning that some products of combustion may be able to enter the escape route and place persons at risk of harm.</p>
	Recommended Actions

9.1	It is recommended that the door is replaced/grille is sealed to 30 minutes fire resistance.
	Observation
9.1-9.2

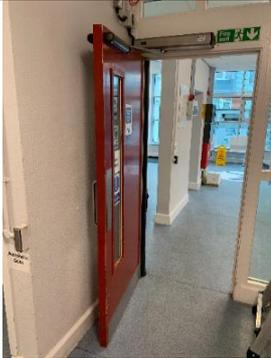
<p>3. The following doors have issues identified with regards to their ability to self-close:</p> <ol style="list-style-type: none"> 1. Community area kitchenette - This door was not locked and did not have a self-closing device. Either keep locked and provide 'Fire Door Keep Locked' signage or install a self-closing device. 2. Community room itself - This door was not locked and did not have a self-closing device. Either keep locked and provide 'Fire Door Keep Locked' signage or install a self-closing device. 3. Automatic door between the lift lobby and staircase enclosure was staying open at the time of the assessment and was not self-closing. Requires remedial works to ensure it is effectively self-closing once used. <p>In the event of a fire where self-closing devices are not present or do not function as required there is the potential for products of combustion to spread, placing persons at risk of harm.</p>

Recommended Actions
9.1-9.2	It is recommended that remedial works are carried out to each of the identified doors in the manner detailed above.

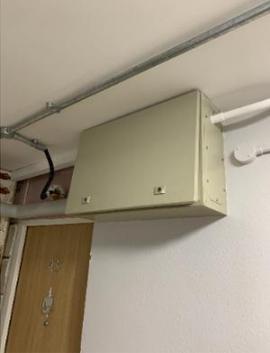
<p>5. Issues were observed relating to a number of doors and their ability to lock/secure, detailed as follows:</p> <ol style="list-style-type: none"> 1. Electrical cupboard adjoining corridor serving community areas (ground floor). 2. Electrical and sprinkler cupboards by flat 50 close but do not lock/secure (tenth floor). 3. Electrical cupboard adjacent to flat 48 closes but does not secure shut (ninth floor). 4. Sprinkler cupboard adjacent to flat 39 does not lock shut (eighth floor). 5. Metal electrical cupboard on escape route (may not be in use anymore) door outside flat 43 was ajar (eighth floor). 6. Electrical cupboard by flat 38 closes but does not lock shut (seventh floor). 7. Sprinkler valve cupboard by flat 30 does not lock (sixth floor). <p>Although closed if found open at the time of the assessment, these doors could re-open and compromise the escape route, whilst also enabling unauthorised access. This could place persons at risk of harm.</p>

Recommended Actions
9.1, 9.14	It is recommended that the locks to the doors above are replaced/repared so that they securely close and lock. It should be noted that the above issues were identified based upon checking a sample of cupboards throughout the building, therefore consideration may be given to checking the cupboards throughout the building for the same defects, carrying out repairs where necessary.
	Observation

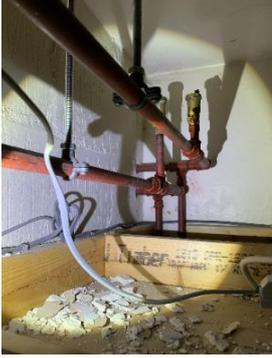
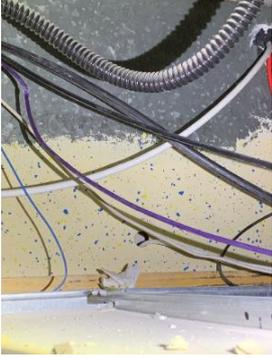
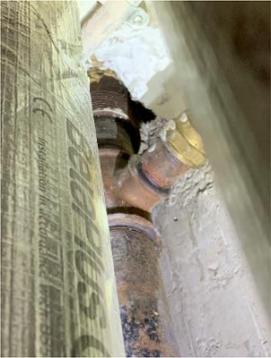
<p>9.5</p>	<p>Observation</p>

<p>1. 1. 2.</p> <p>8. 10.</p> <p>Breaches in compartmentation were observed in a number of areas within the building, detailed as follows:</p> <ol style="list-style-type: none"> 1. In the void space above the community kitchenette accessible via a hatch, to adjoining areas (ground floor). 2. In the wall over the community room corridor into the lift lobby, small cable breach and breach in metal noted (ground floor). 3. Corner of riser cupboard by flat 48 (ninth floor). 4. Electrical cupboard by flat 30 small hole in existing fire stopping (sixth floor). 5. Riser cupboard adjacent flat 26, breach in existing fire stopping (fifth floor). 6. Electrical cupboard by flat 15, breach in existing stopping (third floor). 7. Gap in existing stopping in sprinkler valve cupboard (third floor) - this is considered low risk however should be considered for remedial works whilst others are being carried out in the building. 8. Electrical cupboard by flat 13 (second floor). 9. Dry riser cupboard (first floor) behind wooden beam). 10. Service riser cupboard by flat 7 (first floor). <p>Where there are breaches in compartmentation these may enable the spread of products of combustion to different areas, placing persons at risk of harm.</p> <p>Recommended Actions</p> <p>It is recommended that the identified breaches in compartmentation are fire stopped by a competent person to 60 minutes fire resistance. It should be noted that the breaches identified are from a sample (albeit rather large) of the riser cupboards throughout the building and consideration should be given to investigating the remaining riser cupboards, applying fire stopping where appropriate, if there is reason to believe that other breaches may be present.</p> <p>Observation</p>

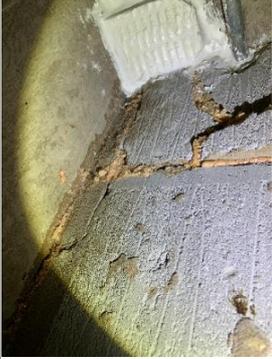
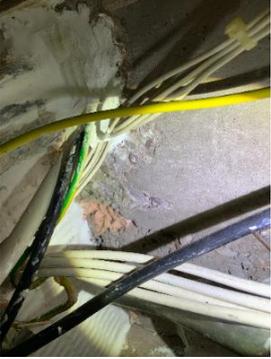
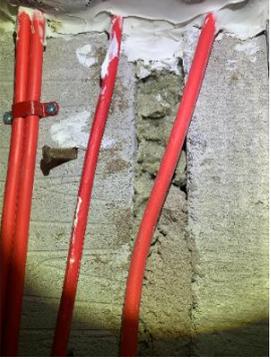
<p>9.5</p> <p>In many of the electrical and riser cupboards inspected throughout the building, some form of foam appears to have been used to fill gaps. It could not be confirmed whether the foam was fire resisting or if it had been applied in a manner which would provide suitable means of fire stopping to the areas. Where unsuitable products are used for the purpose of fire stopping this may enable the spread of a fire/products of combustion, placing persons at risk of harm.</p> <p>Recommended Actions</p> <p>Confirm the foam is fire resisting/applied appropriately in line with manufacturer's and best practice guidelines or use a competent person to reapply appropriate fire stopping products (60 minutes fire resistance) to these areas.</p>

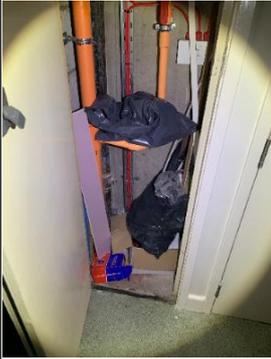
Observation	
9.14

<p>The sprinkler valve cupboard adjacent to flat 25 was being used for storage of combustible waste at the time of the assessment. Where such waste is present it may contribute to the development of a fire which has spread to the cupboard, placing persons at risk of harm.</p>
Recommended Actions	
9.14	It is recommended that the cupboard is checked and, if still present, the waste is removed.
Ref	RECOMMENDATIONS
	None.

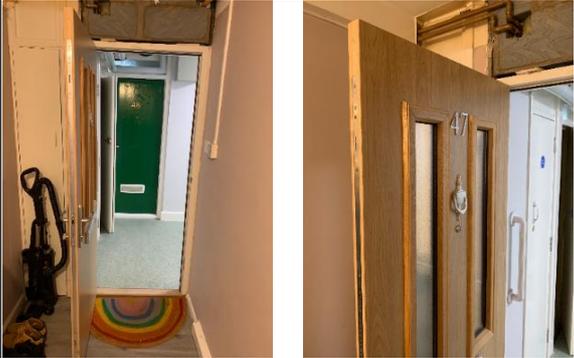
9.1-9.3

<p>Flat entrance door replacements were being carried out throughout the premises at the time of the assessment. Our assessor accessed several flats where these doors had been replaced and it was observed that the doors were FD30s with self-closing metal letterboxes approximately midway down their length. It was observed that none of the fire doors had yet been fitted with self-closing devices and the site manager (spoken to whilst assessing Brownley Court 1 day prior) confirmed that a contractor was due shortly to install these across the premises.</p>

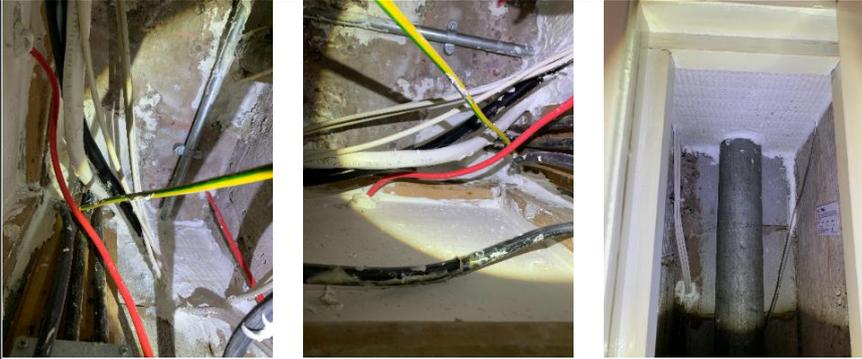
9.1, 9.5

As highlighted previously compartmentation works have been carried throughout the premises by Allied Protection Ltd. They are an accredited passive fire protection contractor and they have provided WCHG with documentary/photographic evidence of their work. Following the installation of the fire alarm system, further fire stopping was required. This was carried out by Flame Hold Ltd who are also an accredited passive fire protection contractor. They have also provided WCHG with documentary/photographic evidence of their work. The majority of the fire stopping and compartmentation work throughout the premises was observed to be of a high standard. Exceptions to these high standards have been detailed within significant finding 9.5.

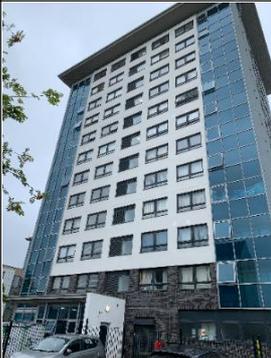
9.13

A product sheet certificate has been provided to our assessor for the external wall insulations (EWI) system fitted to the building. This is a TERMOK8 external wall insulating render system comprising of mechanically fixed mineral wool dual density or mineral wool lamella insulation slabs, with supplementary adhesive, reinforced basecoat and either render or brick slip finishes. The product certification states a reaction to fire classification of A2-s1, d0 in accordance with EN 13501-1, which exceeds the minimum requirements for a building with a storey above 18m as detailed in Section 10.6 of Approved Document B Volume 1 (this minimum requirement is A2-s3, d2).
