TOTAL FIRE GROUP LTD

Fire Risk Assessment

Moorcot Court
Bideford Drive
Wythenshawe
Manchester
M23 0QW

16 June 2022

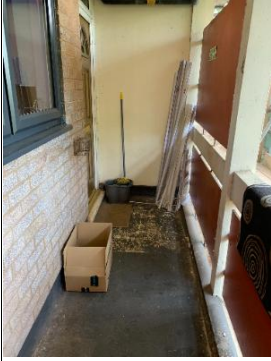
<p>Storage was observed on the open deck area by flat 15 (second floor). It is acknowledged that this is the 'end of row' open deck flat and persons would not have to pass it, however this could encourage other residents to store items on the open deck near to their flats, in turn placing persons at risk of harm.</p>
	Recommended Actions

8.6	It is recommended that the storage is removed from the open deck serving flats, with the resident advised accordingly.
	Observation
8.17-8.18

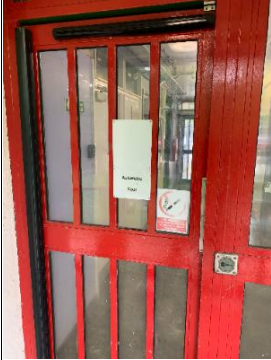
<p>The ground floor flats and plant are accessed to the rear of the building. Persons in this area must pass back through the ground floor lift lobby to reach the street and ultimate safety, as access to the rear of the building is fenced in and is padlocked in order to prevent unauthorised access. It was noted that although the electromagnetically secured door from rear of the building leading back into the lift lobby had a fob point for access however no accompanying green box override. In the absence of a suitable override, there is the potential for persons to become trapped at the rear of the building, placing them at risk of harm.</p>
	Recommended Actions

8.17-8.18	Confirm that the electromagnetically secured door back into the common area is double poled and would fail on activation of the common fire alarm (guaranteeing access), provide a suitable green box override or provide a means of ensuring persons at the rear of the building could reach ultimate safety on the street to the front at all material times.
Ref	RECOMMENDATIONS
	None.

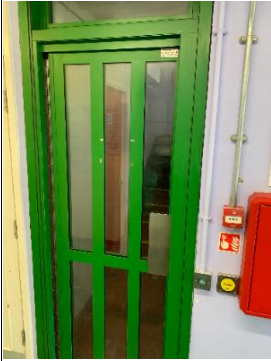
Observation
9.1

<p>A security door is fitted between the ground floor lift lobby and the laundry room. It could not be confirmed whether this will provide sufficient fire resistance and, where this is the case, persons may be placed at risk of harm.</p>
	Recommended Actions

9.1	The door to the laundry should be to FD30s standard and it is recommended that this standard is confirmed or remedial works are carried out to ensure such a standard is provided.
	Observation

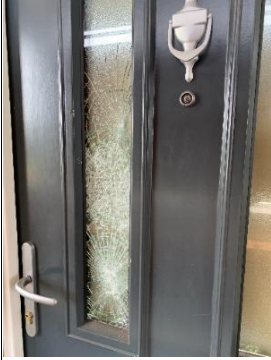
Observation
9.1-9.2

<p>The glazing within the flat entrance door to flat 53 was smashed. Where glazing is damaged this may affect the door's performance, placing persons at risk of harm in the event of a fire.</p>
	Recommended Actions

9.1-9.2	It is recommended that a competent person attends site to carry out remedial/replacement works as appropriate.

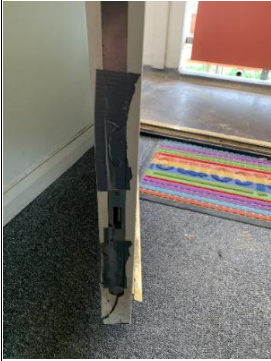
Observation	
9.2

<p>Minor damage was observed towards the base of flat 51's (sixth) entrance door. It could not be confirmed whether or not this minor damage would affect the door's performance, however if it would then this has the potential to place persons at risk of harm.</p>
Recommended Actions

9.2	It is recommended that a competent person attends site to inspect the door and determine whether or not repairs are required. Where required this should be organised and completed promptly.
Observation

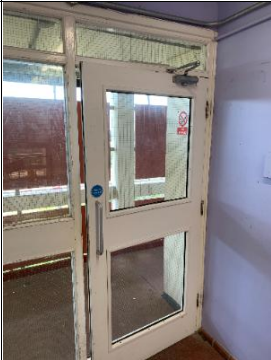
<p>The fire door between the lift lobby and the open deck and eighth floor level was not effectively self-closing. Where doors are not effectively self-closing they may enable products of combustion to spread onto the adjoining escape route, placing persons at risk of harm.</p>
Recommended Actions

9.2	It is recommended that remedial works are carried out by a competent person so as to ensure the door is effectively self-closing.
Observation	
9.2

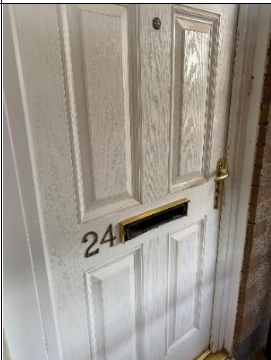
<p>As detailed in the previous fire risk assessment, the letterbox to flat 24 was missing. Where the fire door set is compromised it may not provide adequate protection to the adjoining escape route, placing persons at risk of harm.</p>
Recommended Actions

9.2	It is recommended that a competent person attends site to carry out appropriate replacement/repair to replace the letterbox.

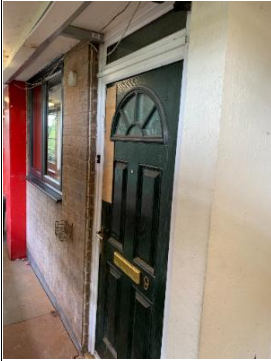
Observation
9.2

<p>As was detailed at the time of the previous fire risk assessment, the flat entrance door to flat 9 had been boarded to cover damage. Where damaged, fire door sets may not afford the required standard of protection to the adjoining escape route, placing persons at risk of harm.</p>
	Recommended Actions

9.2	It is recommended that the door is replaced/repaired as appropriate so that it affords 30 minutes protection to the adjoining escape route.
	Observation

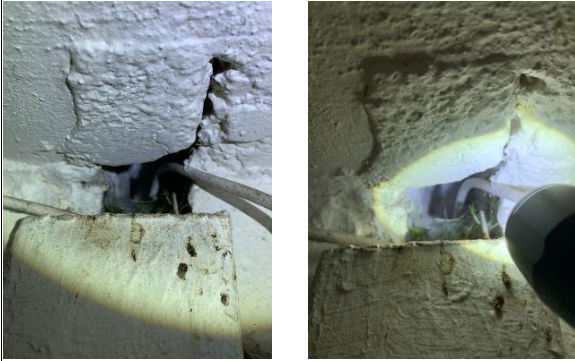
<p>A breach in the concrete ceiling on the open deck near to flat 34 appeared to lead into the flat. Where there are such breaches in compartmentation this may enable the spread of products of combustion, placing persons at risk of harm.</p>
	Recommended Actions

9.5	It is recommended that the breach is fire stopped to 60 minutes fire resistance.
	Observation
9.14

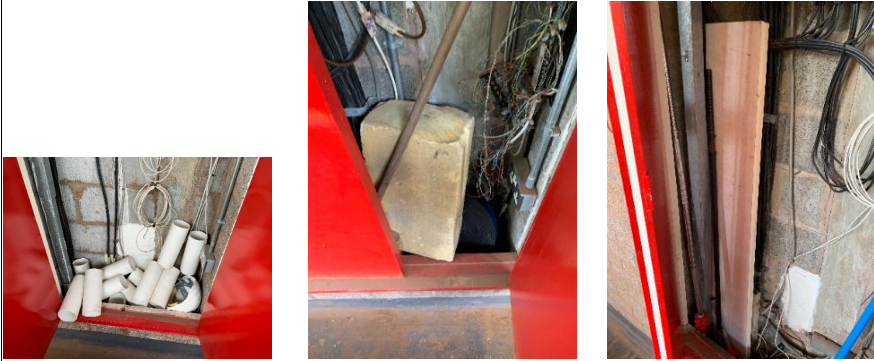
Observation	
9.14

<p>Combustibles were observed as stored within a number of service riser cupboards on the premises. Where combustibles are stored within risers they may provide a means of fuelling a fire which has spread into the riser areas, placing persons at risk of harm.</p>
Recommended Actions

9.14	The service riser cupboards should be surveyed and should be cleared where any storage/waste is identified.
Ref	RECOMMENDATIONS
Observation	
9.13

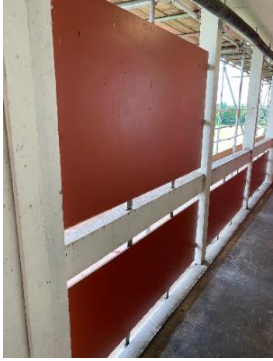
<p>2.</p> <p>As recommended at the time of the previous fire risk assessment, a number of works relating to the building's external façade were observed to be in the process of being undertaken. Moorcot Court had been scaffolded in order to carry out the following works:</p> <ol style="list-style-type: none"> 1. Roof replacement. 2. Walkway balcony panels replacement (currently appear timber and to be replaced with steel panels). 3. Window replacements containing spandrel panels. 4. Water pipe boxing risers to be replaced with steel framed construction. 5. All associated fire stopping relating to any penetrations that were previously hidden and undetected. <p>It has been confirmed to our assessor that the replacement spandrel panels in the new window frames are manufactured by 'Proteus' and the model is 'SP' which is A2-s1, d0 to BS EN-13501.</p>

Recommended Actions	
9.13	Ensure all Regulation 38 information relating to the work being carried out is obtained by WCHG and is held on secure data systems.
Observation

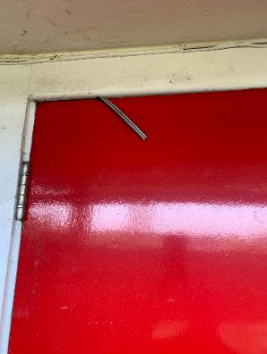
<p>The strip and seal on the top edge of the electrical cupboard (fifth floor) was loose and appeared to be coming off. The service riser cupboard by flat 43 (fifth floor) was missing a strip and seal.</p>

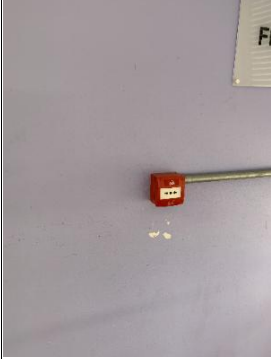
<p>Manual call points were provided throughout the common areas which are regularly accessed by the residents. Our assessor understands that whereas detectors are silent when activated, the manual call points are clearly audible. This may result in frequent false alarms and may result in faults or similar showing on the fire alarm panel.</p>
	Recommended Actions

10.3-10.5	It is recommended that the manual call points in the common areas which are accessed by residents are removed if they result in an audible alarm sounding on activation. It is noted that where manual call points remain in areas accessible only to staff members these may remain as audible, so long as they only sound in staff/plant areas, not throughout the whole building.

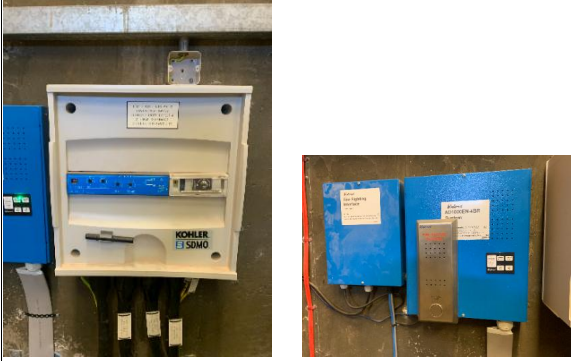
<p>When visiting the premises, it was clear that one of the two lifts serving the building was a firefighting lift of some sort. When our assessor was gathering information relating to this building, it was communicated that neither of the lifts had any firefighting functions. It could therefore not be confirmed that WCHG were fully aware of the types of lift present in the building and their capabilities with regards to firefighting. As different types of lifts provide different levels of safety and control of the lift for fighters, it is important that the correct details are available. Firefighters using a lift that does not provide a perceived level of safety would be placed at risk of harm which in turn may delay their operations placing residents (relevant persons) at risk of harm</p>

Recommended Actions
12.6	The standard of the two lifts should be confirmed and the details should be available for the Fire and Rescue Service to ensure that they are aware of the standard of both lifts. Although supporting information relating to the lifts was confirmed to be provided in the premises information box, this supporting information was viewed (in excel spreadsheet form) and does not appear to indicate that one of the lifts has firefighting capabilities. It should be ensured that information provided to the Fire Service clearly outlines the lift's capabilities in relation to firefighting.
Ref	RECOMMENDATIONS
	Observation

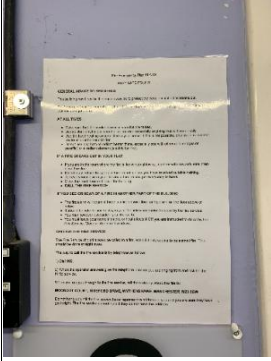
<p>An old version of the fire action notice showing incorrect instructions is displayed on the ground floor adjacent to the fire alarm panel, specifically stating that the fire alarm will sound if there is a fire on a certain floor (it is understood the system is now silent unless the Fire Service takes control). Persons reading this notice may take the wrong actions should a fire occur. This would place themselves and others at risk of harm.</p>
	Recommended Actions
13.8	The old fire action notice displayed on the ground floor should be replaced with the new version of the notice, which accurately details the building's facilities and evacuation strategy.
Ref	RECOMMENDATIONS
	None.
