TOTAL FIRE GROUP LTD

Fire Risk Assessment

Village 135
3 Hollyhedge Court Road
Wythenshawe
Manchester
M22 4GW

08 February 2022

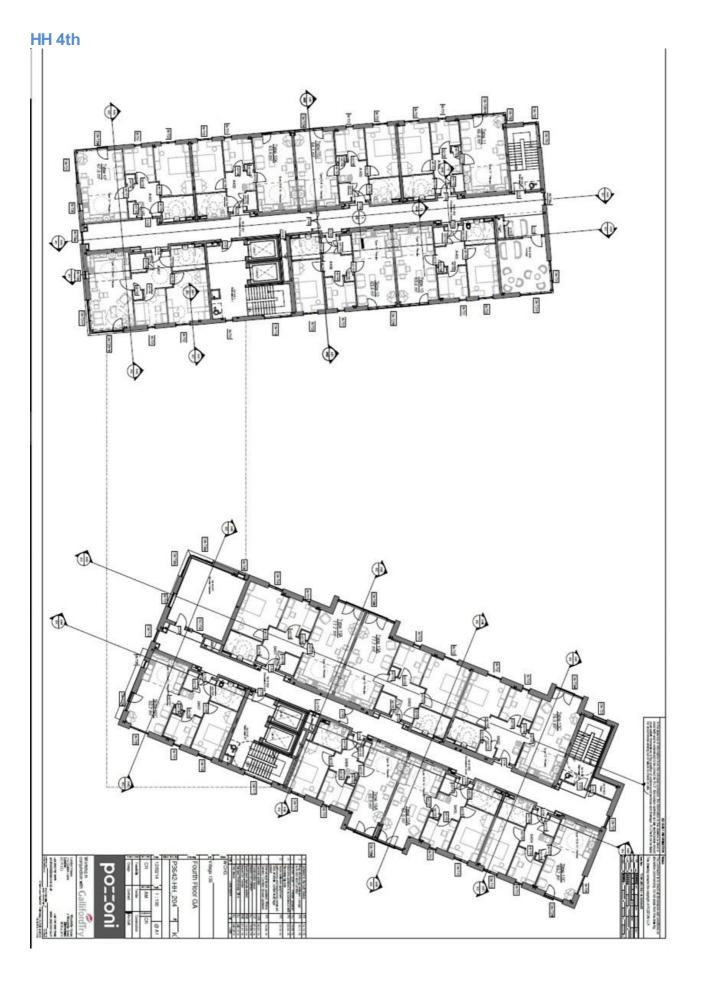
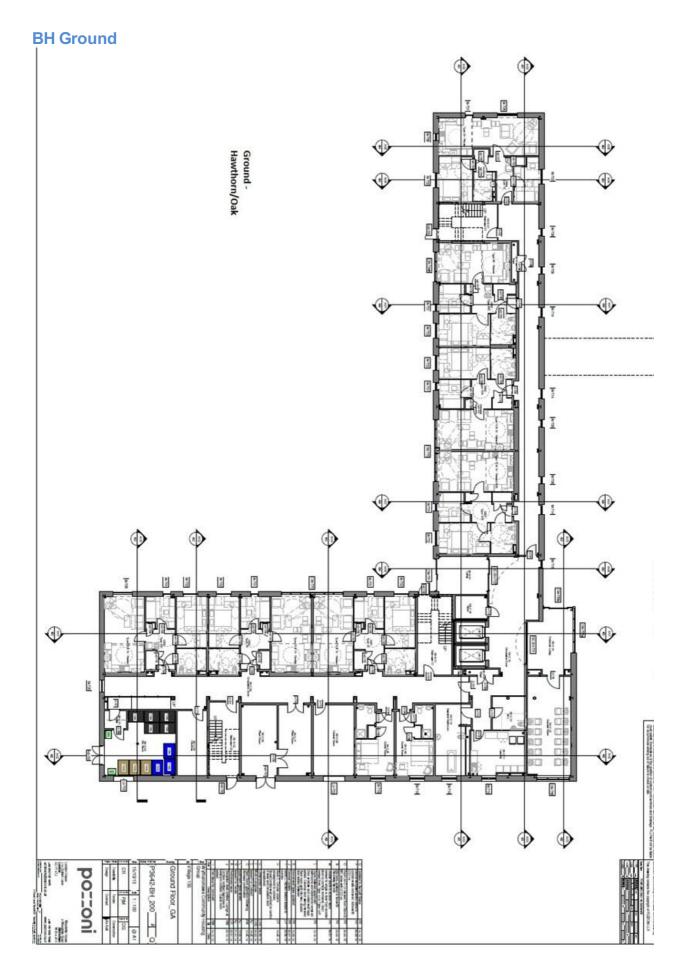
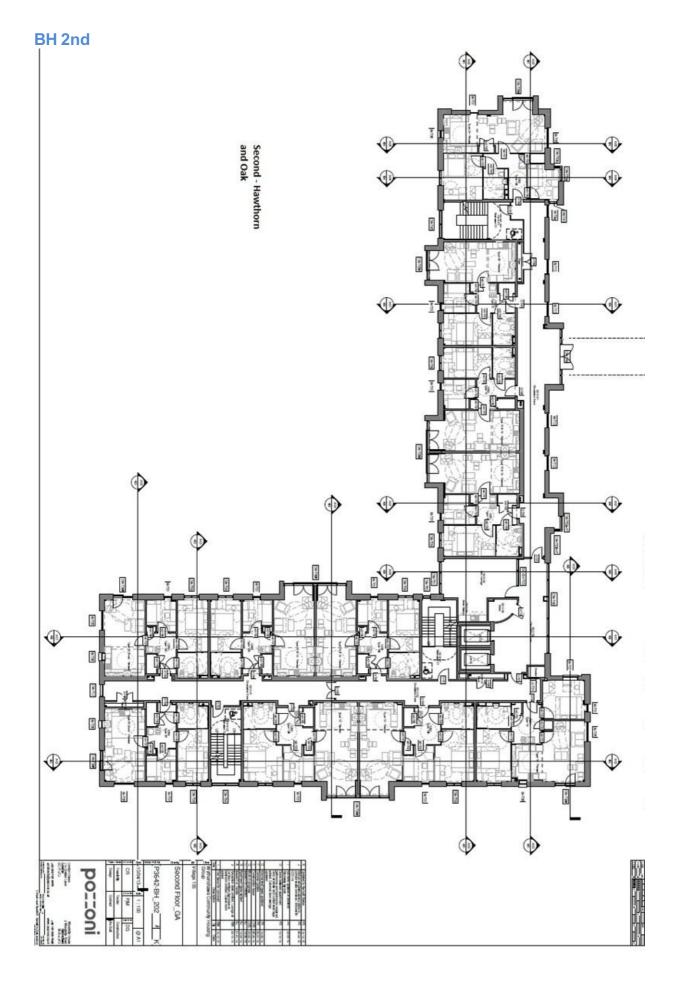
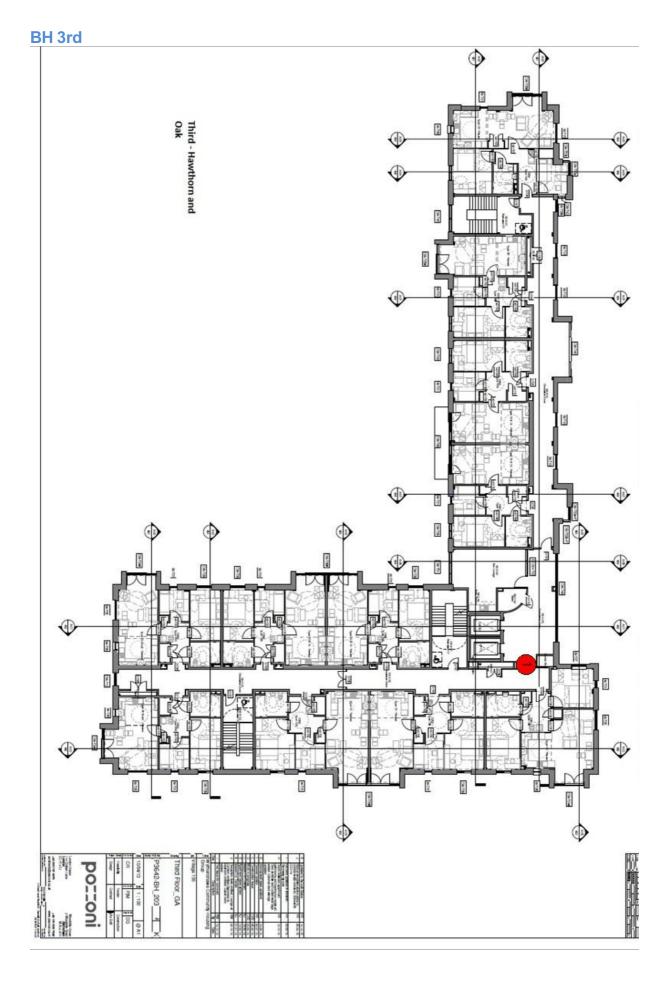
1 The Confinement of Fire - 9.5

9.1, 9.5 It was noted and seen in many areas that remedial compartmentation and fire stopping works have been carried out since the initial construction phase, by Air Fire Control during November 2017 and Allied Protection Services during April 2018. Many areas above the false ceilings, in ancillary service rooms and in riser shafts, where pipes and services pass through compartment walls / ceilings, were seen to have been fire stopped and appropriately compartmented with fire resisting materials.
