TOTAL FIRE GROUP LTD

Fire Risk Assessment

West View Court
West View Road
Wythenshawe
Manchester
M22 4LQ

01 June 2023

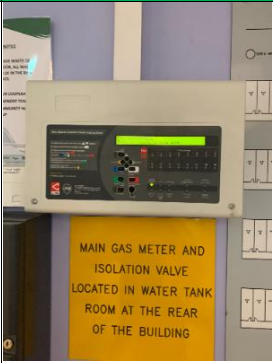
Ref	COMMENTARY
6.0

<p>The main gas and electric isolation valve is housed inside the water tank/pump room on the ground floor, which is externally accessed. Signage indicating the location of the gas cut off is displayed by signage in the main entrance lift lobby.</p>

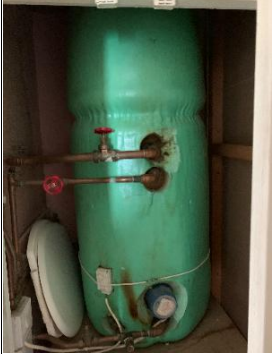
6.20

<p>WCHG have confirmed to TFG that gas boiler systems are on an annual servicing programme with a competent contractor, with records to evidence this practice held centrally by WCHG. Heating vessels are provided to individual flats.</p>

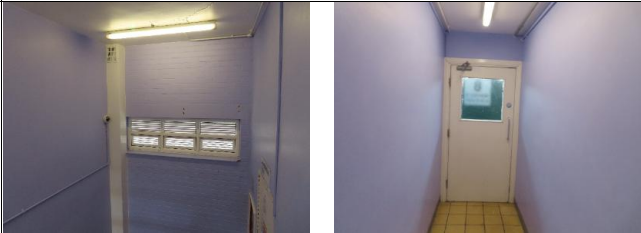
<p>Smoke ventilation in the stairway is provided by permanently open vents (POVs) on each stair half landing. These vents together provide an area in excess of the 1m² required. In addition, the doorway from the stairway onto the uppermost open walkway can be opened for additional ventilation if required. This arrangement is considered acceptable by our assessor, after taking into account the layout of the premises and the open deck access.</p>

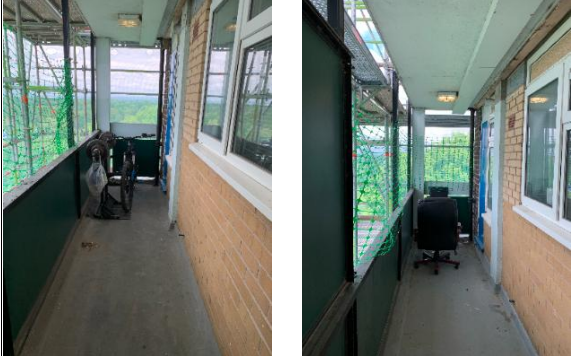
8.7

Storage was observed at the ends of the open decks on the second, sixth and seventh floors. On discussion with Tom Porter (Building Safety Officer for WCHG) it was communicated that WCHG policy is to keep the open decks free of storage, with a letter being sent out to residents and the residents having 3 days to remove the storage before WCHG remove it themselves.

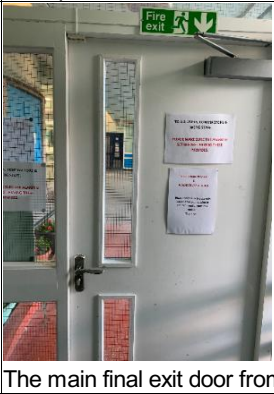
8.11, 8.13

8.12	The main final exit door from the community room is thumb turn operated, with the rear exit being push bar operated.	
8.12	The exit doors are used on a regular basis by the residents. Any problems would be reported to WCHG. The exit routes are also used regularly by the caretakers/cleaners and it is reasonable to assume they would report any defects for repair. The rear exit door from the community room was in good condition and this is also regularly opened to check its operation.

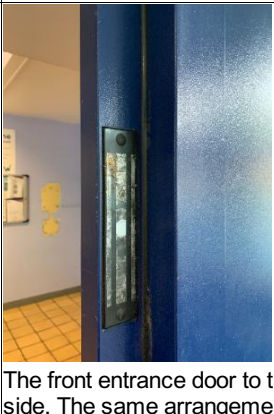
8.18-8.19

<p>Adjudging by the provisions within the sample flats accessed, thumb turn type opening devices are fitted to the internal side of resident flat entrance doors.</p> <p>The front entrance door to the residential premises is electromagnetic, with an emergency override provided on the escape side. The same arrangement is present from the laundry back into the main entrance foyer.</p>

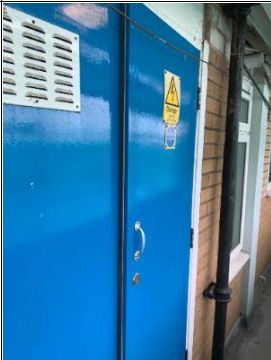
<p>The riser cupboards between flats 49/50 and 29/30 could not be fully closed. Where riser cupboards cannot fully close this compromises the protection of the open deck, potentially placing persons at risk of harm.</p>
	Recommended Actions

9.5	It is recommended that the specified riser cupboards are attended to so that they are able to fully close and secure into place.
	Observation
9.8

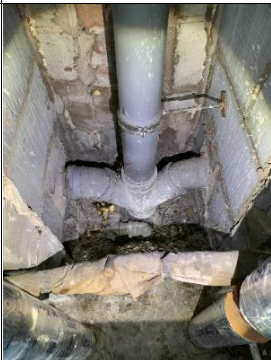
<p>Although fire stopping in the riser cupboards was generally of a high standard, there was no evidence of intumescent collars or wraps being fitted where plastic soil pipe stacks passed horizontally between the risers and the flats. A completion certificate for compartmentation and fire stopping works carried out by Knightsbridge Fire Group was provided to our assessor, however on inspection of the pictures within the report no evidence of such works was visible. Diagram 9.1 of Approved Document B 2019 with 2020 and 2022 amendments shows that where soil stack pipes enter a riser they should be fire stopped appropriately. Where there is potential for a fire to spread from a flat into the riser cupboard via the soil stack, persons may be placed at risk of harm.</p>

Recommended Actions
9.8	It is recommended that intumescent wraps/collars or another appropriate fire stopping product is used to prevent fire spread between the flats and riser cupboards.

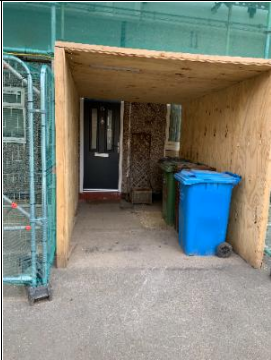
<p>It was seen that the plastic wheelie bins outside of Flat 1A close to the entrance door, partially due to the presence of scaffolding. It may be possible for a fire involving the bins to spread to the surrounding construction.</p>
	Recommended Actions
9.17-9.18	The bins ought to be moved away from the construction and if possible relocated a few metres away from anything which could contribute to the development of a fire.

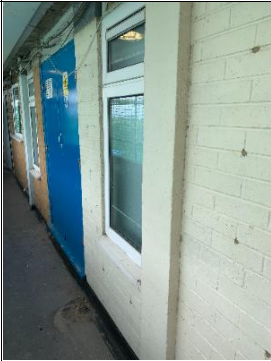
9.1

<p>The bathroom windows from residential flats are non fire resisting and are not fixed, with them opening below a height of 1.1m. Although non fire resisting and non fixed windows are not usually accepted on single direction open decks below a height of 1.1m, this arrangement has been accepted due to:</p> <ul style="list-style-type: none"> • Sprinklers being installed throughout each residential flat. • The common, monitored fire alarm system extending into the flats. • The bathrooms being low risk rooms in which it is very unlikely a fire would begin.

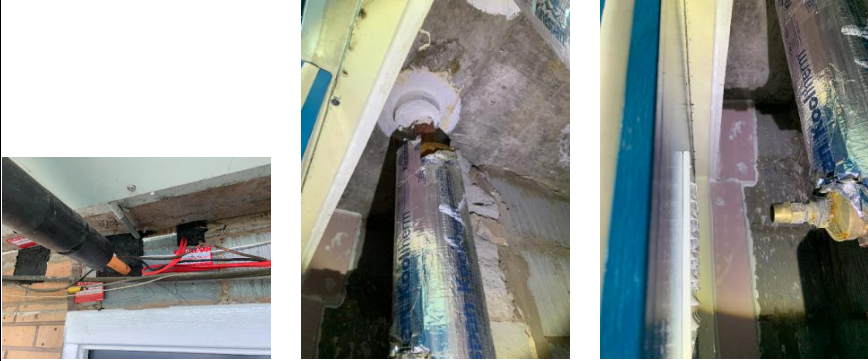
9.8

<p>It has been highlighted in previous Fire Risk Assessments that compartmentation works have been carried throughout the premises by Allied Protection Ltd (circa July 2017). They are an accredited passive fire protection contractor and they have provided WCHG with documentary/photographic evidence of their work. Following the installation of the common fire alarm system, further fire stopping was required. This was carried out by Flame Hold Ltd, another accredited passive fire protection contractor who has also provided WCHG with documentary/photographic evidence of their work. Additionally, it was noted during the course of this FRA that remedial fire stopping and compartmentation works have been carried out by Alpha Fire Solutions, accredited contractors (during April 2022) following the installation of the sprinklers and new flat entrance doors. It is indicated by labelling that the extent of the fire stopping works incorporates spaces such as behind sprinkler trunking, however this was not confirmed due to this fire risk assessment being non-destructive. Note: WCHG has implemented annual compartmentation inspections by an accredited passive fire protection contractor.</p>

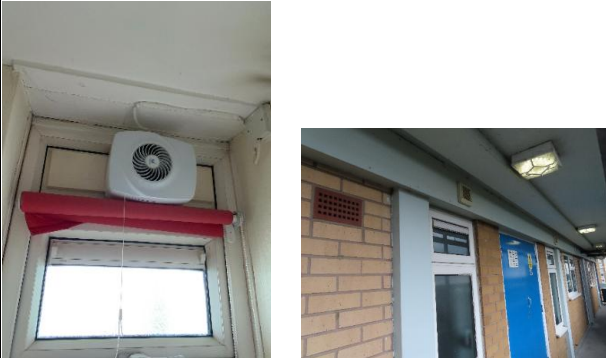
9.11

<p>Kitchen/Bathroom Extraction:</p> <p>It was noted that the kitchen and bathroom ventilation in the flats seen is extracted directly to the outside via powered fans installed within the walls above the windows of the flats and which were not common to any other flats. The extraction was at a height of above 1.1m. It is reasonable to assume that all the flats in the block have similar provisions installed.</p>

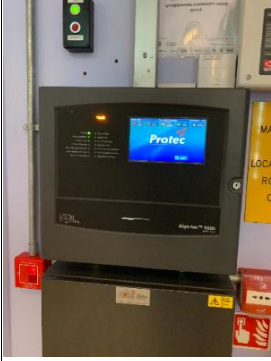
<p>The fire alarm panel in the residential ground floor lift lobby was showing a fault in the pump house at the time of the assessment. Where the fire alarm system is not fully functional, a fire which would otherwise be communicated to the monitoring centre would not be, enabling development and potentially placing persons at risk of harm.</p>
	Recommended Actions

10.1	A competent person should attend the premises to carry out remedial works in order to ensure the fire alarm system is fully operational.
Ref	RECOMMENDATIONS
	Observation

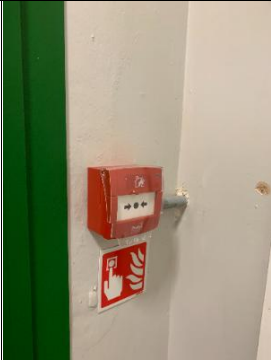
<p>Although, as previously recommended, the majority of manual call points in the escape routes have been covered and removed from use, two remain, these by the main entrance to the building and in the laundry lobby.</p>
	Recommended Actions

10.9	<p>It is recommended that the manual call points by the main entrance door and laundry are removed from use in order to reduce the potential for false activation.</p> <p>Note - Manual call points in staff controlled/plant areas and the community room may remain due to the reduced potential for false activation.</p>

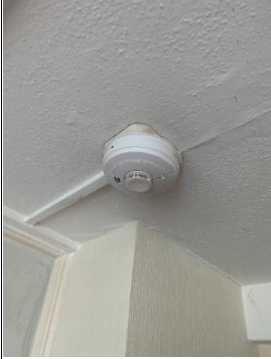
10.2

<p>Adjudging by the provisions within those flats sampled at the time of the assessment, BS5839-6 Grade D LD2 fire alarm systems are installed which also incorporate the living room (smoke in hallway/corridors and living room plus heat in the kitchen).</p>

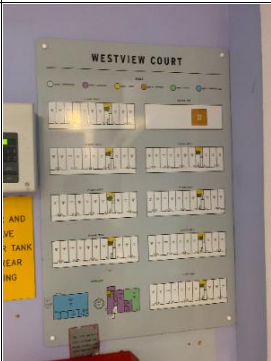
10.13

<p>A suitable zone plan was observed by the common fire alarm panel in the ground floor lift lobby, which also displayed the building layout.</p>

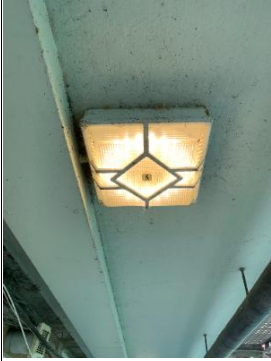
<p>Emergency lighting is installed on the common escape routes including the open decks and appears to be in good working order. It was also seen to be installed within the roof service areas, lift motor room and biomass heating room. It was not possible to ascertain the exact level of illumination, but the coverage appeared to be satisfactory.</p>

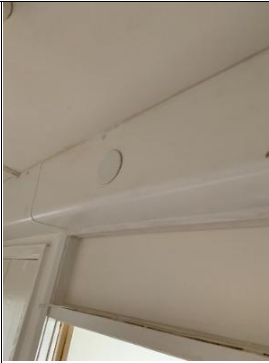
12.8-12.10

A BS9251 sprinkler system has been installed. In each flat, there are concealed sprinkler heads located in the hallway, bedroom, the living room, and the kitchen (essentially all rooms except the bathroom). In addition, there are also sprinkler heads located in the ground floor laundry and community room. A pump and water tank for the sprinkler system has been provided. The system is maintained and serviced by an approved contractor on an annual basis, with records to evidence this practice held centrally by WCHG.

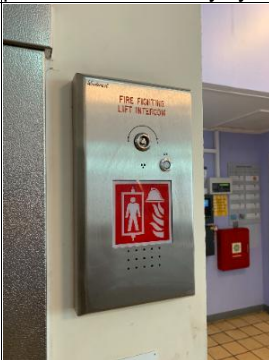
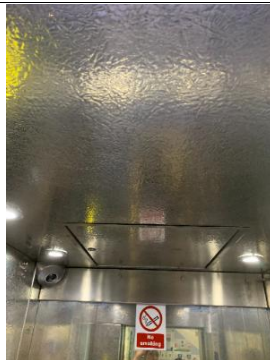
12.10-12.11

One of the lifts on the premises appears to be a standard passenger lift, whereas the other appears to be a fire-fighting lift. The fire-fighting lift has a switch by to return the lift to ground floor level and also an intercom for communications. Within the lift was a hatch in the ceiling. It was confirmed to our assessor that the lift defaults to ground floor on activation of the common fire alarm system and that the switch to manually return the lift to ground floor is tested monthly in line with the Fire Safety (England) Regulations 2022. Records to evidence such testing are held centrally by WCHG. It was communicated that all keys required for the operation of the lift have been provided to the Fire and Rescue Service and are also held in the SIB. It was also communicated that the fire-fighting lift can continue to be used by firefighters without having to reset the alarm, if sounding audibly.

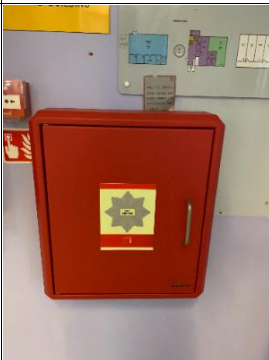
12.15-12.16

The Secure Information Box (SIB) is located by the main entrance to the building, in the lift lobby. Access was not available to the SIB, however Tom Porter (Building Safety Officer for WCHG) confirmed that the contents were the same in each tower block, and a SIB had been accessed in another WCHG for our assessor to take note of the contents. The following information are held in WCHG SIBs.

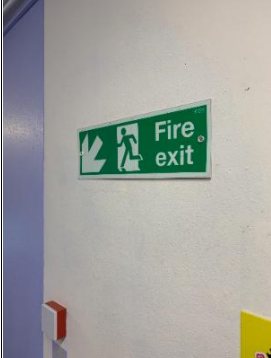
<p>Some standard directional and fire exit signage was observed on the common escape route.</p>
13.6	<p>Article 15 of the Regulatory Reform (Fire Safety) Order 2005 requires the responsible person to establish appropriate procedures including safety drills to be followed in the event of serious and imminent danger to relevant persons.</p>
13.6, 13.8

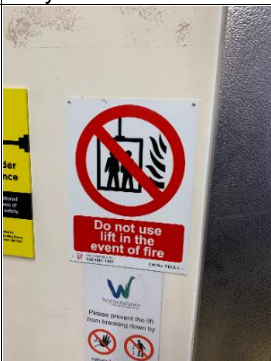
<p>Suitable 'Do Not Use in the Event of a Fire' signage was observed by the lifts.</p>
13.12

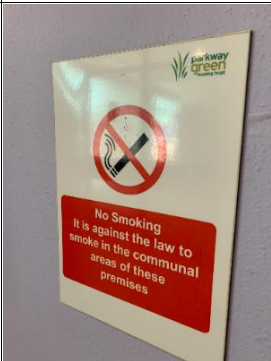
<p>'No Smoking' signage was observed on the premises, in the common areas.</p>

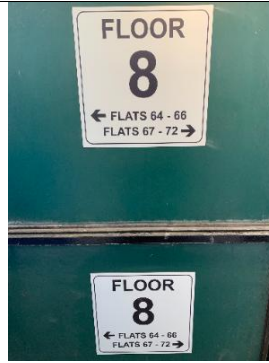
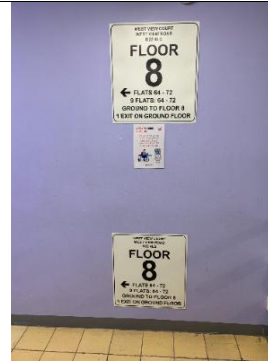
13.15

Wayfinding signage was observed on the staircase landings and on the open decks which indicated the floor level and the flats on that floor. Such signage was also observed in the lift lobby at ground floor level.

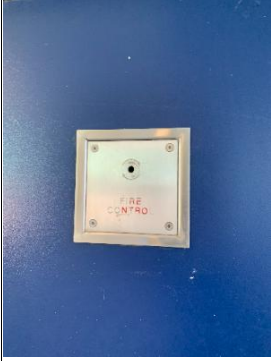
<p>The building is provided with a drop switch for Fire Service access by the main entrance and our assessor was informed that this is not currently being tested on a regular basis. Where facilities for use by the Fire Service are not adequately maintained this may result in delayed access to the building, placing persons at risk of harm.</p>
	Recommended Actions

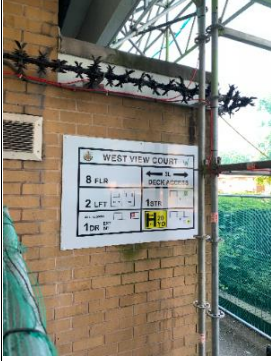
<p>Signage indicating certain provisions of the building is displayed externally, which may be used to assist attending Fire and Rescue Service personnel.</p>
