# TOTAL FIRE GROUP LTD

## Fire Risk Assessment

25-82 Brownley Court  
Wythenshawe  
Manchester  
Greater Manchester  
M22 4QH

01 June 2026

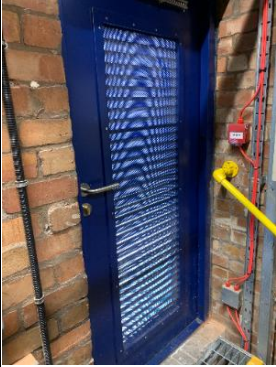
| Ref | COMMENTARY |
|---|---|
| 8.2 | <p>It was noted in the previous fire risk assessment that a louvred door provides a means of permanent ventilation to the lift motor room.</p> |

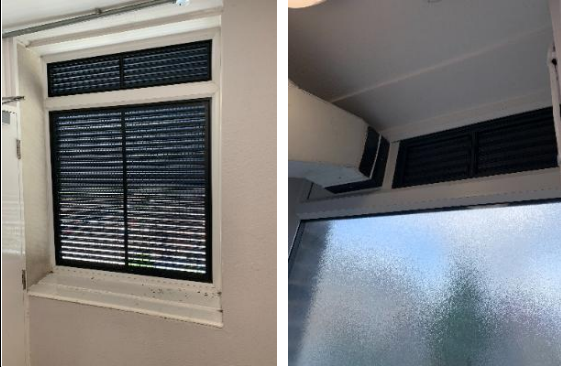
| Ref | COMMENTARY |
|---|---|
| 8.2 | <p>The corridor between the lobby serving flats and the staircase is provided with permanent ventilation, as is the refuse chute room.</p> |

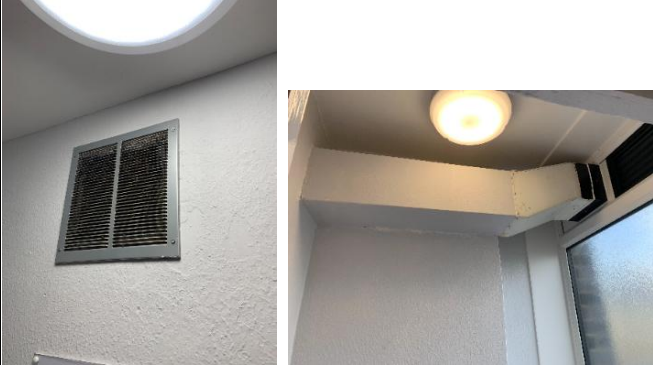
| Ref | COMMENTARY |
|---|---|
| 8.2 | <p>The below photographs show an example of the means of smoke ventilation in the stairway of the premises. The layout is the same on all floors from the first floor upwards. The vent on the stairs leads into the metal ducting which in turn vents direct to outside, passing through the refuse chute room on its way. A previous FRA confirmed that WCHG have engaged third parties to confirm that this method of smoke ventilation is adequate. Smoke modelling calculations have been provided by a fire engineer who concluded that provided new grilles were fitted and the ducting was cleaned that the existing provisions for smoke ventilation are satisfactory. Also previously advised is that in addition, the ducting has been inspected by another third party who confirmed that they were fit for purpose. Although not viewed on this assessment, it is understood that WCHG have documentary evidence available issued by the third parties.</p> |

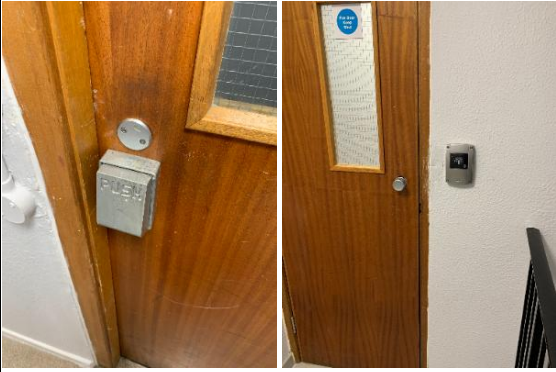
| 8.17 | <p>Electromechanically secured doors separate the staircase from the corridors serving flats and these require fob access in the direction towards the flats. In the direction of escape, a suitable push pad device is provided leading into the stairs.</p> |

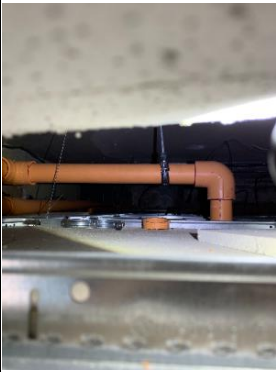
| Ref | COMMENTARY |
|---|---|
| 9.1, 9.5-9.6 | <p>The room created under the alternative stairway serving ground and first floor houses the pump and water tank for the sprinkler system. The wall between this room and the entrance hallway does not continue to true ceiling height and the <b>fire door into the room is not fitted with intumescent strips and cold smoke seals</b>. As this room is therefore effectively not separated from the adjoining staircase escape route and contains electrical equipment, it was recommended in a previous Fire Risk Assessment that this room should be separated from the escape route to true ceiling height by fire resisting construction and that the fire door should be provided with intumescent strips, cold smoke seals and the appropriate signage. Following the receipt of the previous Fire Risk Assessment, WCHG informed Total Fire Group that prior to the installation of the sprinkler system they had sought advice from a fire safety company, High Rise Fire Safety Ltd in regard to compartmentation. Their advice was that the risk of a fire in the sprinkler tank room is very low and provided that the room is kept sterile and checked on a regular basis there is no requirement for the room to be separated from the escape route by fire resisting construction.</p> <p>During this assessment, no access to the area was gained, however, it is reasonable to assume that the situation remains unchanged. The advice provided by Total Fire Group remains the same, however, WCHG has decided to follow the advice of High Rise Fire Safety Ltd. The area at the time of the assessment is provided with signage informing persons not to store any items in this location.</p> <p>Photo reused:</p> |

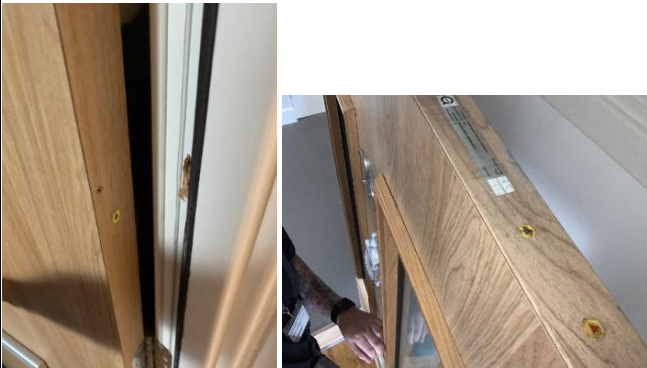
| Ref | COMMENTARY |
|---|---|
| 9.1, 9.5-9.6 | <p>A sample of flat entrance doors were accessed and visually inspected. The entrance doors accessed appeared to be robust timber doors certified to FD30, and installed with intumescent fire and cold smoke seals, and a self-closer. A label was provided on the top door edge, and BM Trada door plugs were also installed in the door edges. It is reasonable to assume that the remaining flat entrance doors are of the same door assembly and furniture as they all visually appeared to be the same. Test evidence of each fire door's performance was not available, however, one was observed as part of a previous action.</p> |

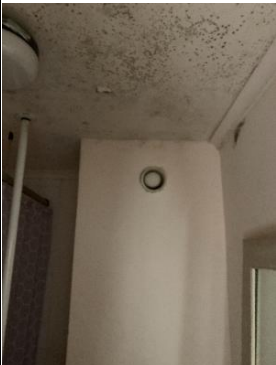
| 9.12 | <p>A previous FRA confirmed that WCHG have confirmed that Allied Protection Ltd has completed fire stopping and compartmentation works to prevent fire spread via the common bathroom and shower room extract shafts. They have also fitted fire-rated valves with an intumescent infill in the bathrooms which are connected to the ducting and shaft. Although these valves will not prevent smoke spread into the shaft in the early stages of a fire they are considered an acceptable method of preventing fire spread. Documentary and photographic evidence is available to evidence the works carried out by Allied Protection Ltd and are held by WCHG. These were not viewed on this assessment.</p> |

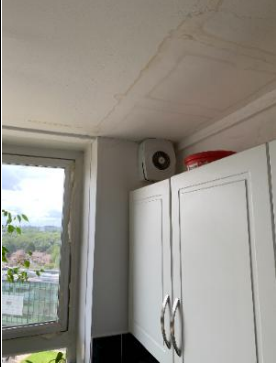
| 9.12 | <p>It was noted that the kitchen ventilation in the flats seen is extracted directly to the outside, via a powered fan, which was not common to any other flats. It is assumed that all the flats in the block have similar provisions installed.</p> |

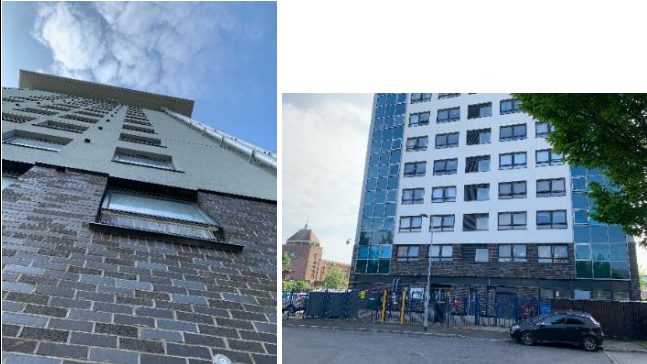
| 9.28-9.29 | <p><b>The previous FRA confirmed the below in relation to the external cladding system on the building. No changes have been advised:</b></p> <p>A product sheet certificate has been provided to our assessor for the external wall insulations (EWI) system fitted to the building. This is a TERMOK8 external wall insulating render system comprising of mechanically fixed mineral wool dual density or mineral wool lamella insulation slabs, with supplementary adhesive, reinforced basecoat and either render or brick slip finishes. The product certification states a reaction to fire classification of A2-s1, d0 in accordance with EN 13501-1, which exceeds the minimum requirements for a building with a storey above 18m as detailed in Section 10.6 of Approved Document B Volume 1 (this minimum requirement is A2-s3, d2).</p> <p>In addition to the provision of this product sheet, WCHG provided our assessor with an external façade report for the building, carried out by 'High Rise Fire Safety' in 02/2018. This certification states on page 5 of the report that 'The cladding affixed to the external façade of the premises is made up of layers of materials that individually, and collectively, have limited or non-combustible fire ratings as defined in Appendix A (A6 &amp; A7) of Approved Document B of the Building Regulations'. The report then goes on to confirm that the cladding will not contribute to fire spread on the building.</p> <p>Previous fire risk assessments have confirmed that the enclosed balconies have curtain wall glazing which is aluminium framed with clear and opaque glazing throughout.</p> |

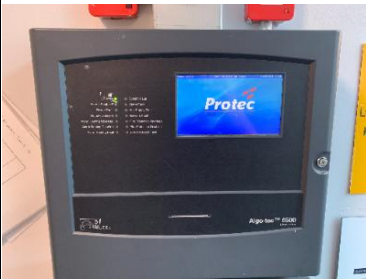
| 10.0 Automatic Fire Detection: Finding(s) | |
|---|---|
| 10.1, 10.4-10.6 | <p>The common area fire alarm and detection system incorporated smoke detection throughout commonly used areas (except the biomass boiler room as noted on the previous FRA - see another commentary 10.1, 10.4-10.6), and heat detection in the hallways of each resident flat. The fire alarm panel for the system is located at the ground floor level of the alternative staircase which only serves the ground and first floor and apart from the disablement noted above, was healthy at the time of the assessment. It was previously confirmed that the system is addressable. This may be confirmed within the installation and commissioning certificate issued at the time of installation. Further detail regarding the fire alarm system and its purpose within the building is provided in commentary 12.14.</p> |

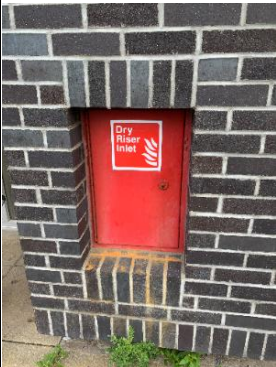
| Ref | COMMENTARY |
|---|---|
| 12.6 | The dry riser inlet is located on the building's external façade.<br> |

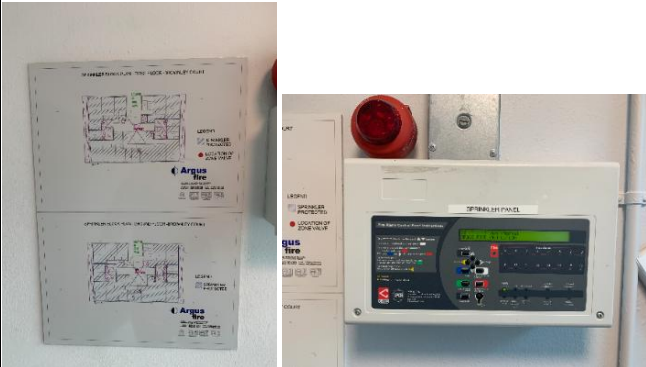
| Ref | COMMENTARY |
|---|---|
| 12.8 | <b>As noted on the previous FRA:</b><br>A BS9251 sprinkler system has been installed. In each flat, there are concealed sprinkler heads located in the hallway, each bedroom, the lounge, and the kitchen. In addition, there are also sprinkler heads located in some ground floor plant areas. There are control valves for each floor in riser cupboards that adjoin the lift lobbies. A pump and water tank for the sprinkler system have been provided in the sprinkler tank room which adjoins the alternative stair serving ground and first floors, at ground floor level. A sprinkler panel and plan are provided by the fire alarm panel. The previous FRA confirmed that the system is maintained and serviced by an approved contractor on a quarterly basis and contractors also attend weekly to visually check the sprinkler system.<br> |

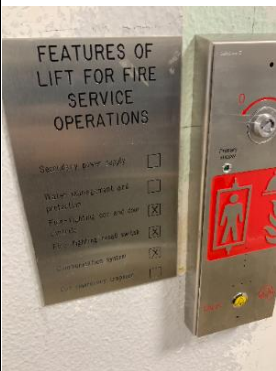
| 12.11-12.13 | <p>The previous fire risk assessment noted that the original 'Firemen's Switch' function for exclusive use by firefighters in an emergency was not confirmed. This action has been completed. The new lift has had the following alterations;</p> <ul style="list-style-type: none"> <li>• Fire-fighting car and door controls.</li> <li>• Fire-fighting recall switch.</li> <li>• Communication system.</li> </ul> <p>The function of the lift is noted on a metal plaque on the ground floor. WCHG have confirmed that the lifts will continue to be tested monthly. WCHG have confirmed that all information required and all keys will be provided to the Fire Service and will continue to be held in the SIB.</p> |
