# TOTAL FIRE GROUP LTD

## Fire Risk Assessment

Village 135  
3 Hollyhedge Court Road  
Wythenshawe  
Manchester  
M22 4GW

12 January 2026

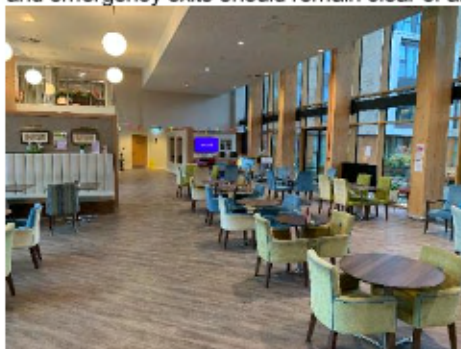
| Ref | COMMENTARY |
|---|---|
| 7.2 | <p>Article 22 of the Order requires co-operation and coordination between responsible persons, and therefore, all responsible persons should work together to ensure suitable and sufficient standards are achieved and maintained.</p> <p>From the original fire strategy report, the occupancy of the communal Hub space is based on a floor space factor of 1.5 m<sup>2</sup> per person. However, the initial proposal for the kitchen serving this area is designed for up to 100 persons. Based on the floor space and the 1m<sup>2</sup> per person, the Hub is considered to safely accommodate up to 220 persons, depending on furniture layout (floor space factor is 220m<sup>2</sup>, with x4 final exits at a minimum of 850mm door width). All normal and emergency exits should remain clear of any furniture or obstructions for their full width across the exits and on approach.</p> |

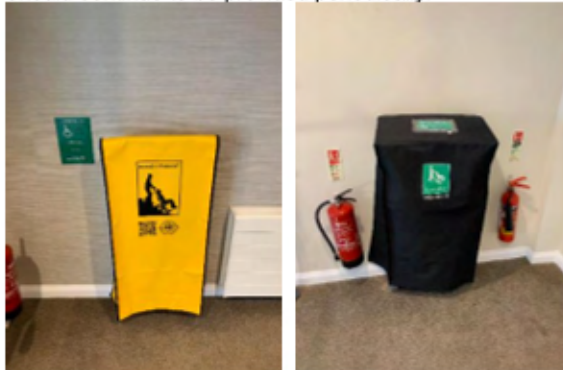
- 7.7 Each alternative escape staircase is provided with at least one chair, for use by those who require assistance using the stairs in the event of a fire. It is understood that staff are trained in their use. Refresher training for the use of the evacuation chairs should continue to be provided periodically.

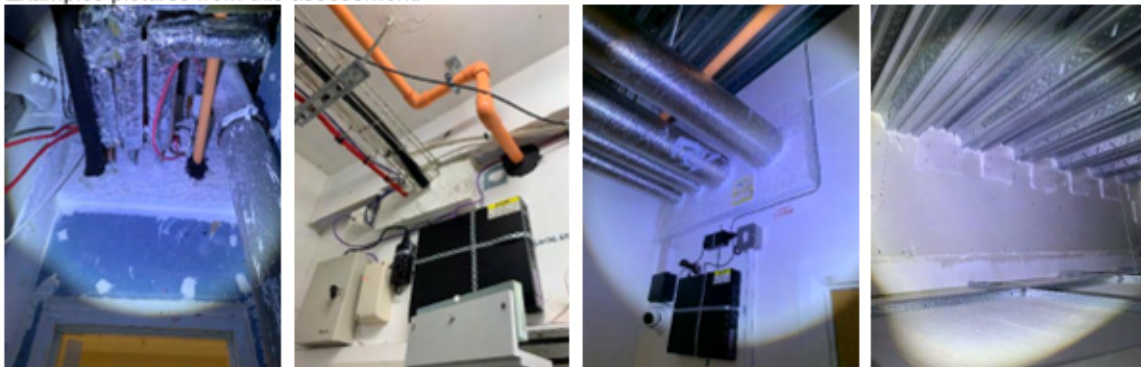
**Retained information for historical purposes:** Galliford Try (GT) and Tenos have been working closely for an extended period of time in order to carry out a type 4 compartmentation and fire stopping survey throughout the premises. There have been several surveys carried out since the construction was finished in 2017, with the latest carried out by Tenos, following which it was identified that a full building survey was required. This has been carried out by GT, with GT applying the fire-stopping works where any breaches or deficiencies are identified. Our assessor was informed that this work is complete; however, the completed works are still to be checked before sign-off by GT. A certificate/statement is to be issued on completion, together with the information recorded electronically of locations and materials used for ongoing maintenance and inspection.

Examples pictures from this assessment:

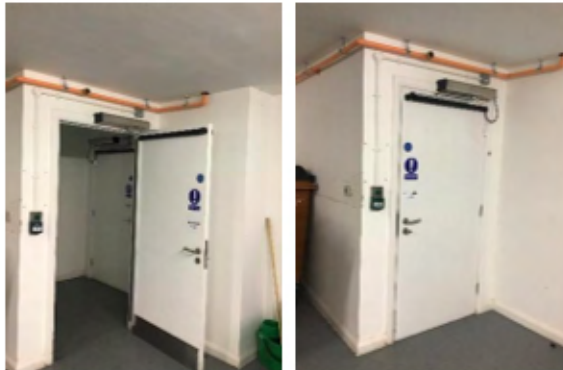
9.5 The fire-resisting doors to the refuse storage rooms have had power-assisted opening devices fitted to assist the residents when navigating the small spaces within the lobbies to the refuse rooms. They are operated by presenting a key fob to open the doors that remain open for a suitable time to allow the refuse to be deposited and then close automatically. There are fail-safe exit buttons internally, and it is understood that the devices are linked to the fire alarm and are disabled if a fire alarm activation occurs.

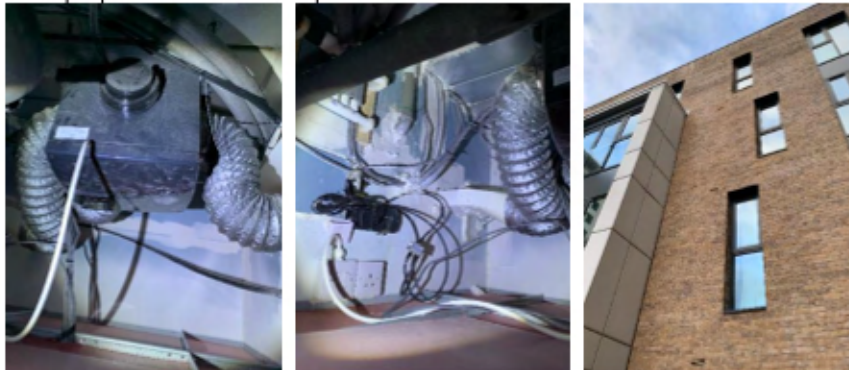
**Retained information for historical purposes:** Both Keith Bryant (Project Manager for Galliford Try) and a WCHG building consultant, who met with a previous TFG fire risk assessor, have confirmed that the ventilation ducting passes through the ceiling cavities directly to the outside and is independent of each apartment.

Example pictures from a void space accessed above a flat:

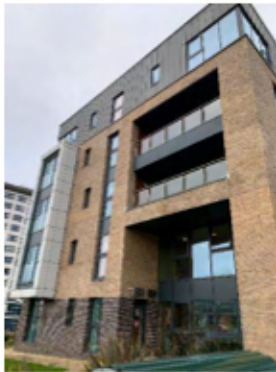
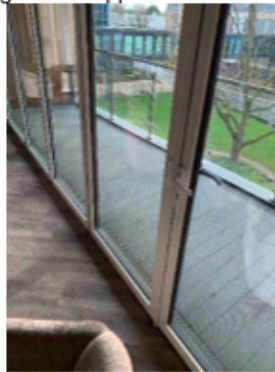
9.27-9.29

- 9.27 It was noted that there are two balconies on the Cedar block, adjacent to the rooftop garden area. The use of these areas is controlled by the premises management team, and access is only allowed at certain times. It is understood that residents do not have general access to these areas. Sources of ignition should not be permitted in these areas, and the storage of combustibles on the balconies should be closely controlled, with access through the patio doors opening onto the balcony also controlled. The current arrangements appeared to be controlled.

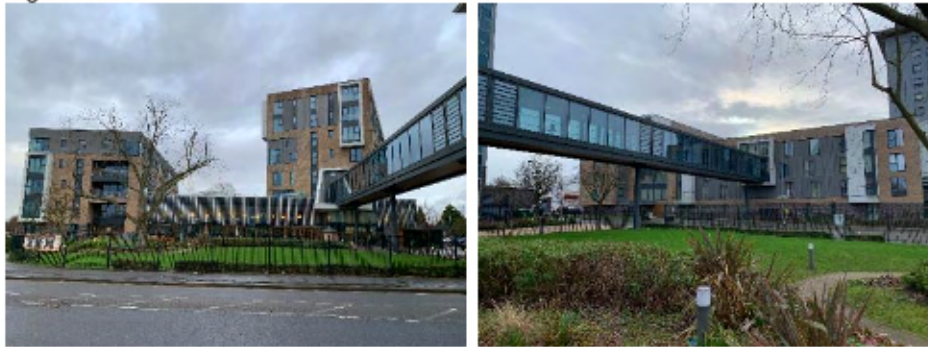
The person consulted advised that the original external wall material, determined not to comply with the latest recommendations, has been replaced with material conforming to A1 or A2. This documentation was not viewed or given to our assessor. However, the current fire strategy document in section 7 notes the following:

- Zinc cladding
- 2mm aluminium cassette in light and Anthracite grey
- Prodema Prodex "Rustik" rainscreen
- Anthracite grey aluminium louvres
- Anodised Aluminium Brise Soleil
- Rockpanel Woods (A2-s1-d0)
- Zinc Quartz Standing seam

As noted in their standard responses, any requirements to undertake further inspections on External Wall systems or cladding are passed to a project manager in the Investment Team to engage a competent and qualified consultant to carry out an assessment and provide a report. Also noted is that all EWS information requested by the fire service (HRBs) is sent on a regular basis.

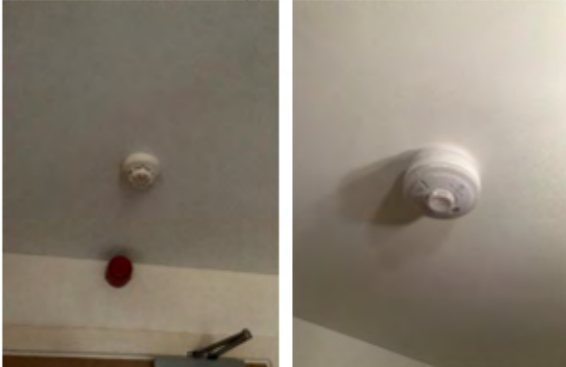
| Ref | COMMENTARY |
|---|---|
| 10.1-10.2,<br>10.4-10.8 | <p>The system now installed within each apartment appears to conform to BS 5839-6 to at least Grade D, category LD1 standard, with either optical smoke or multi-sensor detectors installed in all habitable rooms except the kitchen area, where a heat detector is provided. The systems are linked to the 'Dect' care call phones, with each member of care staff carrying a receiver and call point in the reception/office.</p> <p>A fully addressable BS 5839-1 fire detection and warning system is installed within the common areas, which appears to be to a minimum of L2 standard, with a linked heat detector and separate sounder located in the hallway of each flat. This may be confirmed within the installation and commissioning certificate issued at the time of installation.</p> <p>It was stated that the automatic fire detection and warning system installed in the common areas sounds an alarm to initiate a simultaneous evacuation of all the common areas within the individual block of activation. It was previously stated that work was ongoing to reconfigure the fire warning system to enable the communal area sounders within escape corridors and staircases to remain silent on activation in support of the stay-put strategy. The Hub and other communal rooms and work spaces will retain active sounders to alert persons in those areas in the event of a fire. However, see the above recommendation, as it appears that activations occur within the flats as well as the communal areas.</p> |

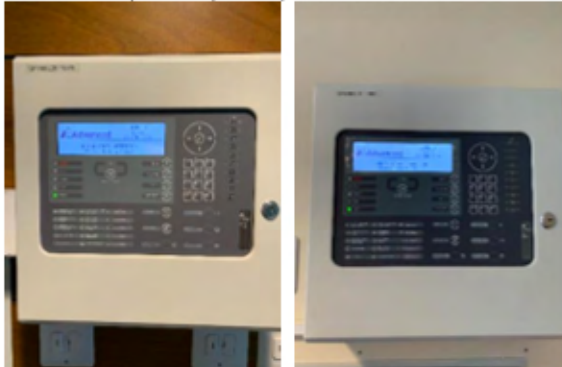
- 10.1, 10.13 Fire alarm panels are provided in the entrance foyer to the Hub and the entrance foyer to Block C. A repeater panel is provided by the ground floor corridor exit from Block A. Suitable fire alarm zone plans are provided adjacent to each alarm panel in the blocks, except the repeater panel in Block A.

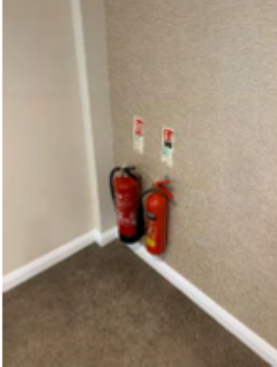
| Ref | COMMENTARY |
|---|---|
| 12.1-12.3 | <p>Portable firefighting equipment would not be generally sited in the corridors to flats as this may pose a risk to residents leaving their flat on fire and returning with a fire extinguisher, placing them at increased risk as they are not trained. However, the property is staffed 24 hours a day, with trained staff responding to any fire alarm, and the current availability of firefighting equipment is considered suitable. The accommodation area extinguishers are generally sited in stairwells and not in the immediate vicinity of flat entrance doors. The firefighting equipment is in the form of water (or foam) and CO2 stations throughout. Such extinguisher points are also provided in higher risk areas such as refuse rooms, electrical rooms and the like.</p> |

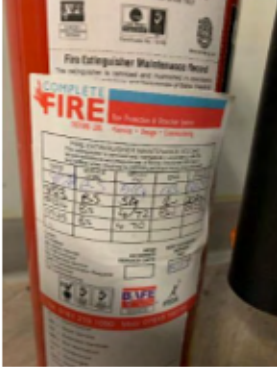
| Ref | COMMENTARY |
|---|---|
| 12.4-12.5 | <p>WCHG have confirmed via their standard responses that appropriate checks are carried out on a monthly basis for firefighting equipment, and that all firefighting equipment is serviced by a qualified engineer every 12 months, with this last having been carried out in 09/2025.</p> |

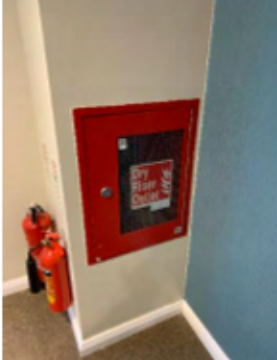
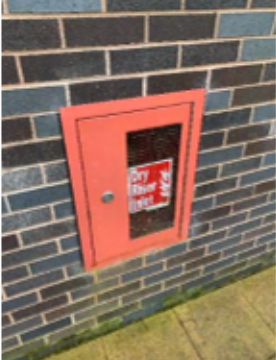
| Ref | COMMENTARY |
|---|---|
| 12.6-12.8 | <p>Firefighter dry rising mains are located in each block, so as to provide a firefighting facility due to the size and layout of the blocks. The inlets are located on the external façade, and the outlets are located at each level of one of the staircases per block. WCHG have confirmed that where firefighting and firefighter facilities are provided, these are tested and maintained, which includes dry/wet risers, sprinklers, secure information boxes, and wayfinding signage.</p> |

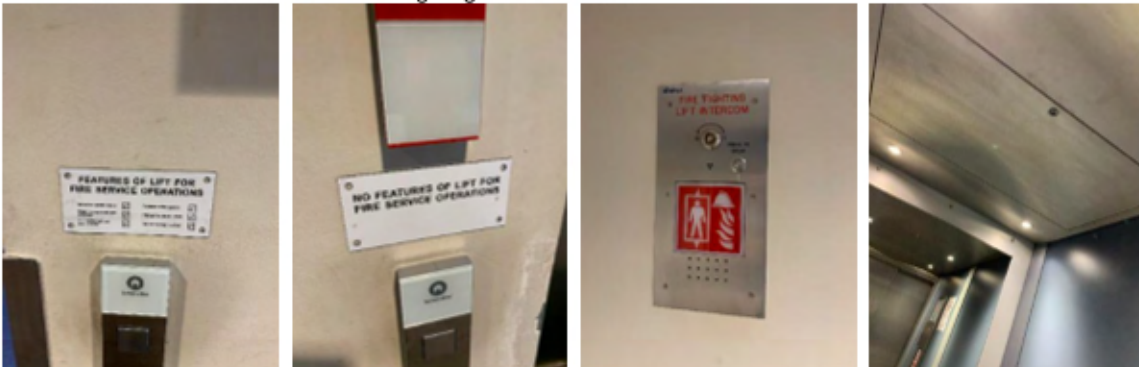
WCHG confirmed as part of their standard responses that lift controls are functional, tested and maintained, and that there is a policy to report any defects to the lifts to the fire and rescue service. This is undertaken on the Building Safety Management System

Block B Cedar LH lift is installed as a firefighting lift and labelled.

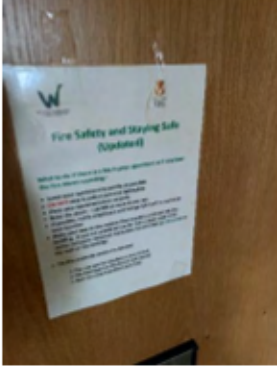
| Ref | COMMENTARY |
|---|---|
| 13.6-13.8 | <p>Fire action notices are displayed in appropriate locations, such as in staff work areas and service rooms and also on the inside of the apartment/flat entrance doors, so as to remind the staff and residents. Suitable action notices were also previously seen on the inside of guest bedrooms. Residents are also made aware of the fire procedures through regular updates from the management team. It was also noted that there are no fire action notices by the manual call points within the communal areas inside the premises; however, TFG has previously been informed that the reason for this was the constant presence of staff on site 24 hrs per day and the fact that any alarm activation would be attended and managed by the staff present.</p> |

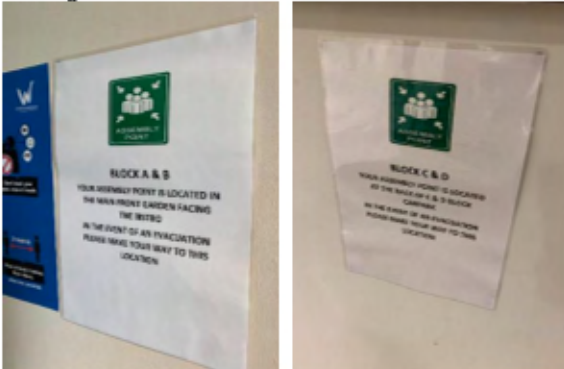
| Ref | COMMENTARY |
|---|---|
| 13.11 | External Fire Assembly Point signs are displayed in the appropriate locations. |

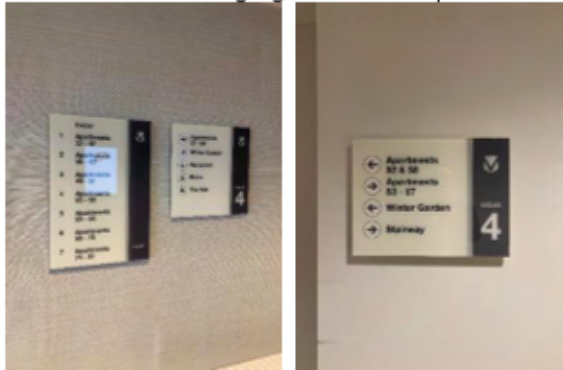
13.15-13.16 On-site observations showed that some form of wayfinding signage has been installed, which is not quite in line with current guidance (see the above finding).
