# TOTAL FIRE GROUP LTD

## Fire Risk Assessment

1-58 Benchill Court  
Wythenshawe  
Manchester  
Greater Manchester  
M22 4GL

04 June 2025

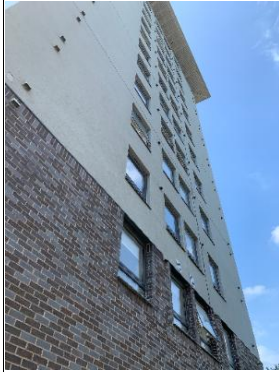
In addition to the provision of this product sheet, WCHG provided our assessor with an external façade report for the building, carried out by 'High Rise Fire Safety' in 02/2018. This certification states on page 5 of the report that 'The cladding affixed to the external façade of the premises is made up of layers of materials that individually, and collectively, have limited or non-combustible fire ratings as defined in Appendix A (A6 & A7) of Approved Document B of the Building Regulations'. The report then goes on to confirm that the cladding will not contribute to fire spread on the building.

Previous fire risk assessments have confirmed that the enclosed balconies have curtain wall glazing which is aluminium framed with clear and opaque glazing throughout.

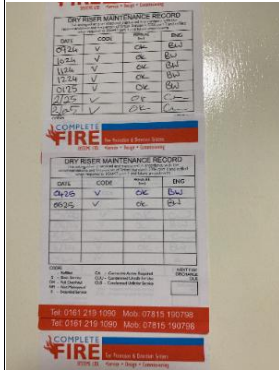
- 12.8 As part of their standard response, WCHG confirmed that where firefighting and firefighter facilities are provided, they are tested and maintained. The labels observed in the riser cupboards on site noted that the latest service was done on 05/2025 by Complete Fire Systems Ltd in line with BS9990:2015. There appears to be a monthly check undertaken. All the doors to the outlets were secured and labelled. Several Dry Riser cupboards were opened and the outlets were seen to be in good condition.
- The dry riser inlet is on the building's external façade and outlets are provided at each floor level on the upper floors, adjacent to the lift lobbies.

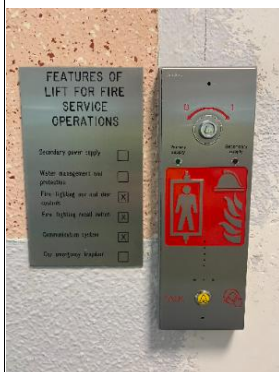
- 12.11-12.13 The previous fire risk assessment noted that the original 'Firemen's Switch' function for exclusive use by firefighters in an emergency was not confirmed. This action has been completed. The new lift has had the following alterations;
- Fire-fighting car and door controls.
  - Fire-fighting recall switch.
  - Communication system.

The function of the lift is noted on a metal plaque on the ground floor. WCHG have confirmed that the lifts will continue to be tested monthly. WCHG have confirmed that all information required and all keys will be provided to the Fire Service and will continue to be held in the SIB.
