TOTAL FIRE GROUP LTD

Fire Risk Assessment

Bagnall Court
Shawcross Lane
Greenway
Manchester
M22 4LT

06 June 2022

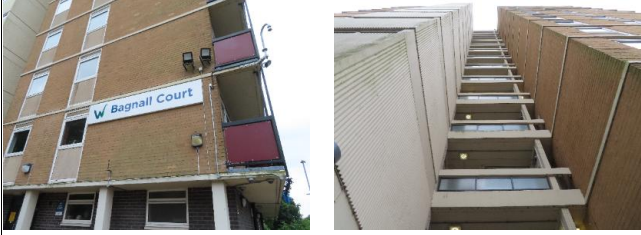
9.13	<p>For Information; The assessment of the fire performance of the external wall construction and any cladding is excluded from this fire risk assessment. Where it is determined that a detailed assessment of an external wall is required, PAS 9980 should be used for these requirements. A separate assessment should only be completed by a competent and suitably qualified person. The consultant has followed Fire Industry Association (FIA) Guidance note of June 2020. (See the Limitations in Section 1.0 of this FRA.) See also the findings above at Section 9.13 that were included in the previous FRAs. The majority of the external walls are constructed of brick and cement based mortar and concrete slabs.</p>
