TOTAL FIRE GROUP LTD

Fire Risk Assessment

1-58 Benchill Court
Wythenshawe
Manchester
Greater Manchester
M22 4GL

04 July 2023

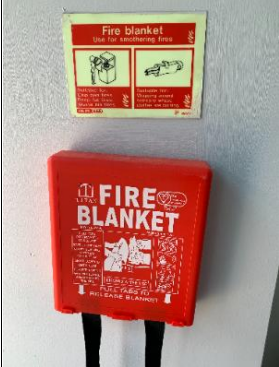
6.16	Suitable electrical hazard signage was provided to service riser cupboards, where appropriate.
6.17, 6.19	<p>Only refreshment facilities including a microwave and kettle are provided in the community room and a fire blanket was observed as present in this area.</p>

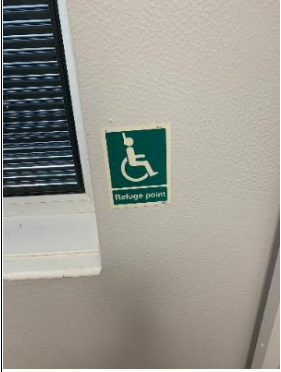
7.6	<p>Refuge signage is provided in the corridors between lobbies serving flats and the staircase. This is consistent with Section 70.11 of the Fire Safety in Purpose Built Blocks of Flats guidance, which states:</p> <p>'Many older and disabled residents will find it difficult to use stairs in the event of a fire, and additional measures may need to be considered. These could include temporary safe refuge areas or spaces within existing protected lobbies and stairs'.</p> <p>It should be noted that these areas may be considered <u>TEMPORARY</u> refuge areas only and persons should not be encouraged to wait in these areas for rescue.</p>

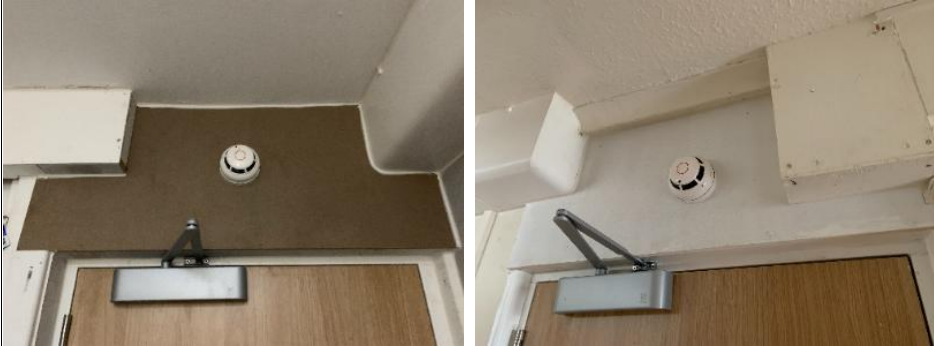
9.1, 9.5-9.6	<p>The previous FRA raised an action in relation to flat entrance door replacements that were being carried out in a neighboring property that would be undertaken on this property and for them to be upgraded to an FD30s standard as well as the panels above the doors. The previous FRA action has been signed off as complete on 02/02/2023. Onsite observations showed that all flat entrance doors were of the same visual appearance, and the ones accessed had self-closing devices installed along with panels/blockwork above doors installed. See 9.1, 9.5-9.6 commentary for further details on doors accessed. Evidence was also attached to the action to show the type of doors installed which state an FD30s standard.</p>

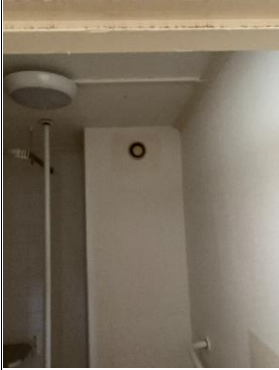
9.11	<p>The previous FRA confirmed that WCHG have confirmed that Allied Protection Ltd has completed fire stopping and compartmentation works to prevent fire spread via the common bathroom and shower room extract shafts. They have also fitted fire rated valves with an intumescent infill in the bathrooms which are connected to the ducting and shaft. Although these valves will not prevent smoke spread into the shaft in the early stages of a fire they are considered an acceptable method of preventing fire spread. Documentary and photographic evidence is available to evidence the works carried out by Allied Protection Ltd and are held by WCHG. These were not viewed on this assessment.</p>

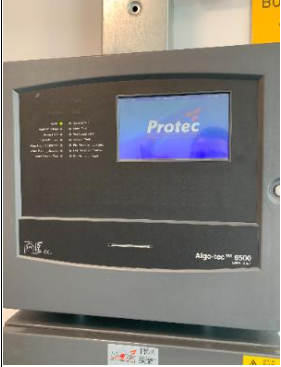
10.1, 10.4-10.6	<p>The common area fire alarm and detection system incorporated smoke detection throughout commonly used areas (except the biomass boiler room - see another commentary 10.1, 10.4-10.6) and heat detection in the hallways of each resident flat. The fire alarm panel for the system is located at the ground floor level in the staircase enclosure. It was previously confirmed that the system is addressable. This may be confirmed within the installation and commissioning certificate issued at the time of installation. Further detail regarding the fire alarm system and its purpose within the building is provided in commentary 12.14.</p>

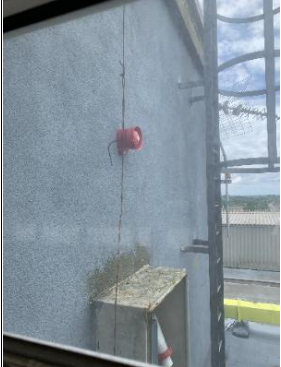
10.12	<p>The previous FRA raised an action in relation to there being no confirmation on whether a sounder linked to the fire alarm system was provided on the roof, nor could it be confirmed that, where provided, such a sounder is programmed to be audible. The previous FRA action has been signed off as complete on 16/09/2022 by Mike Holt. Although access was not gained to the roof on this assessment, the roof area was observed from the observation area with which a sounder was seen. Red cabling could also be seen penetrating the lift motor room walls to the roof area in this block indicating the fire alarm system extends to this area. Due to the action being signed off as complete, it is reasonable to assume that the sounder has been confirmed as audible as previously recommended.</p>

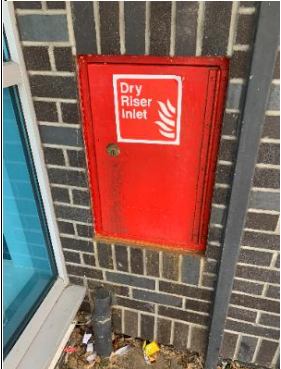
12.6	The previous FRA raised an action in relation to no signage indicating the dry riser inlet on the building's external façade. The previous FRA action has been signed off as complete on 16/08/2022. New signage has now been installed.

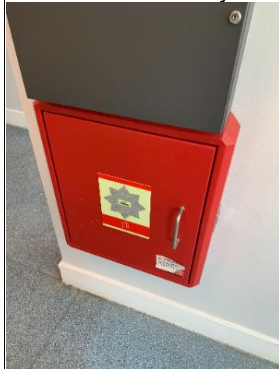
SIB in the entrance foyer:

12.6, 12.15-12.16 As part of their standard responses, WCHG maintains Secure Information Boxes (SIB). Although not accessed, it was seen that a SIB has been installed in the entrance foyer. It is reasonable to assume the fire service carries a key to gain access to the box. It must be noted that the responsibility for providing and updating the information with regard to any vulnerable tenants remains with WCHG.

Therefore, WCHG should ensure that the information stored in the SIB is correct in line with current guidance, kept up-to-date, and regularly reviewed.

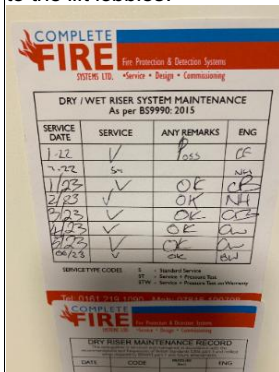
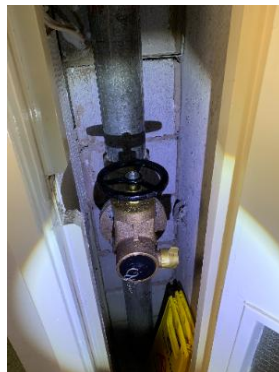
12.8 As part of their standard response, WCHG confirmed that where firefighting and firefighter facilities are provided, they are tested and maintained. The labels observed in the riser cupboards on site noted that the latest service was done on 06/2023 by Complete Fire Systems Ltd in line with BS9990:2015. There appears to be a monthly check undertaken. All the doors to the outlets were secured and labeled. Several Dry Riser cupboards were opened and the outlets were seen to be in good condition.

The dry riser inlet is on the building's external façade and outlets are provided at each floor level on the upper floors, adjacent to the lift lobbies.

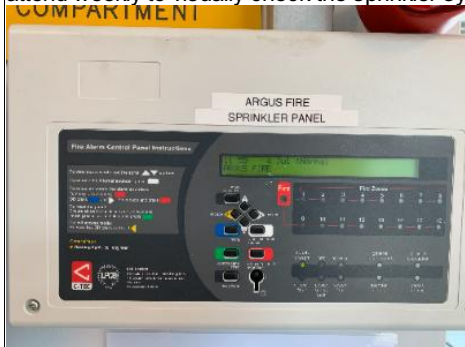
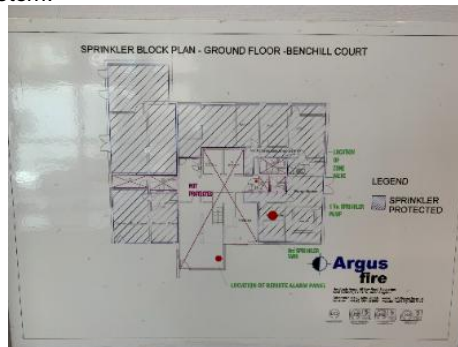
12.8-12.9 **As noted on the previous FRA:**
A BS9251 sprinkler system has been installed. In each flat, there are concealed sprinkler heads located in the hallway, each bedroom, the lounge, and the kitchen. In addition, there are also sprinkler heads located in some ground floor plant and community areas. There are control valves for each floor in riser cupboards that adjoin the lift lobbies. A pump and water tank for the sprinkler system have been provided in the sprinkler tank room which is within the old caretaker's area. A sprinkler panel and plan are provided by the fire alarm panel in the staircase enclosure at the ground floor level. The previous FRA confirmed that the system is maintained and serviced by an approved contractor on a quarterly basis and contractors also attend weekly to visually check the sprinkler system.

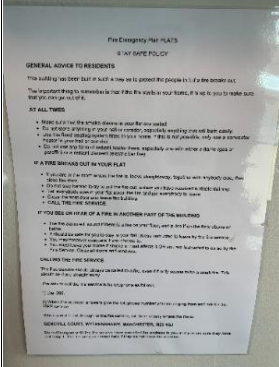
13.6, 13.8	<p>A suitable 'stay safe' fire action notice was provided in the common area by the main entrance. This captures the 'stay safe' essence of the fire strategy whilst incorporating instructions should residents hear the BS8629 Evacuation Alert System sound on their floor, and that it will pulse on the floor above and below.</p>

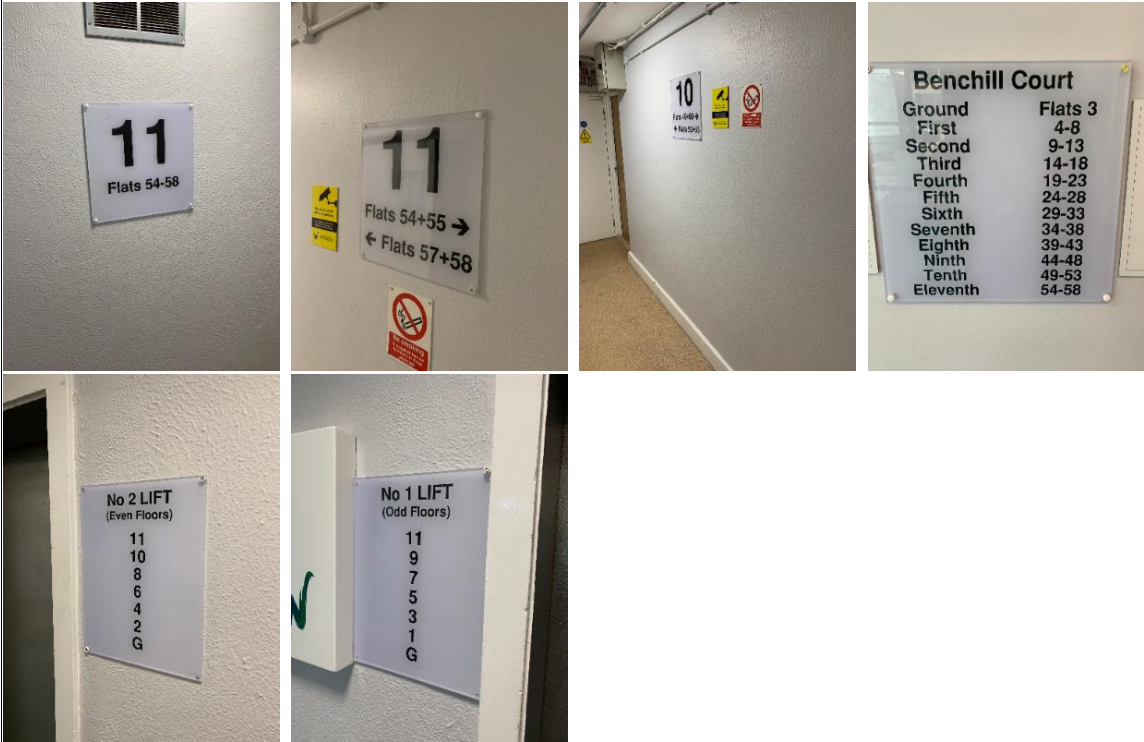
13.12	Suitable 'No Smoking' signage was observed in the common area.
13.15-13.16	<p>Wayfinding signage that has the floor number and directional signage to the flats, including flat numbers, is displayed in the lift lobbies and on the stairway landings. They appear to be mounted at the recommended height as per ABD and are all visible and in good condition.</p> <p>Supplementary signage is also present, with signage outside the lift areas to show which flats are on each floor and which floors the two lifts access.</p>

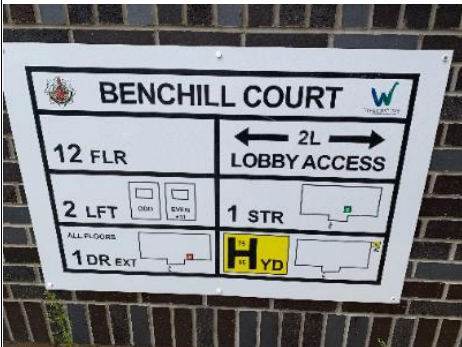
14.11	<p>A building information board showing key building facilities is present by the main entrance. This shows:</p> <ul style="list-style-type: none"> • Number of floors. • Stating the 'lobby access' nature of the building. • Number of lifts. • Number of stairs. • Number of dry risers. • Location of nearest fire hydrant.

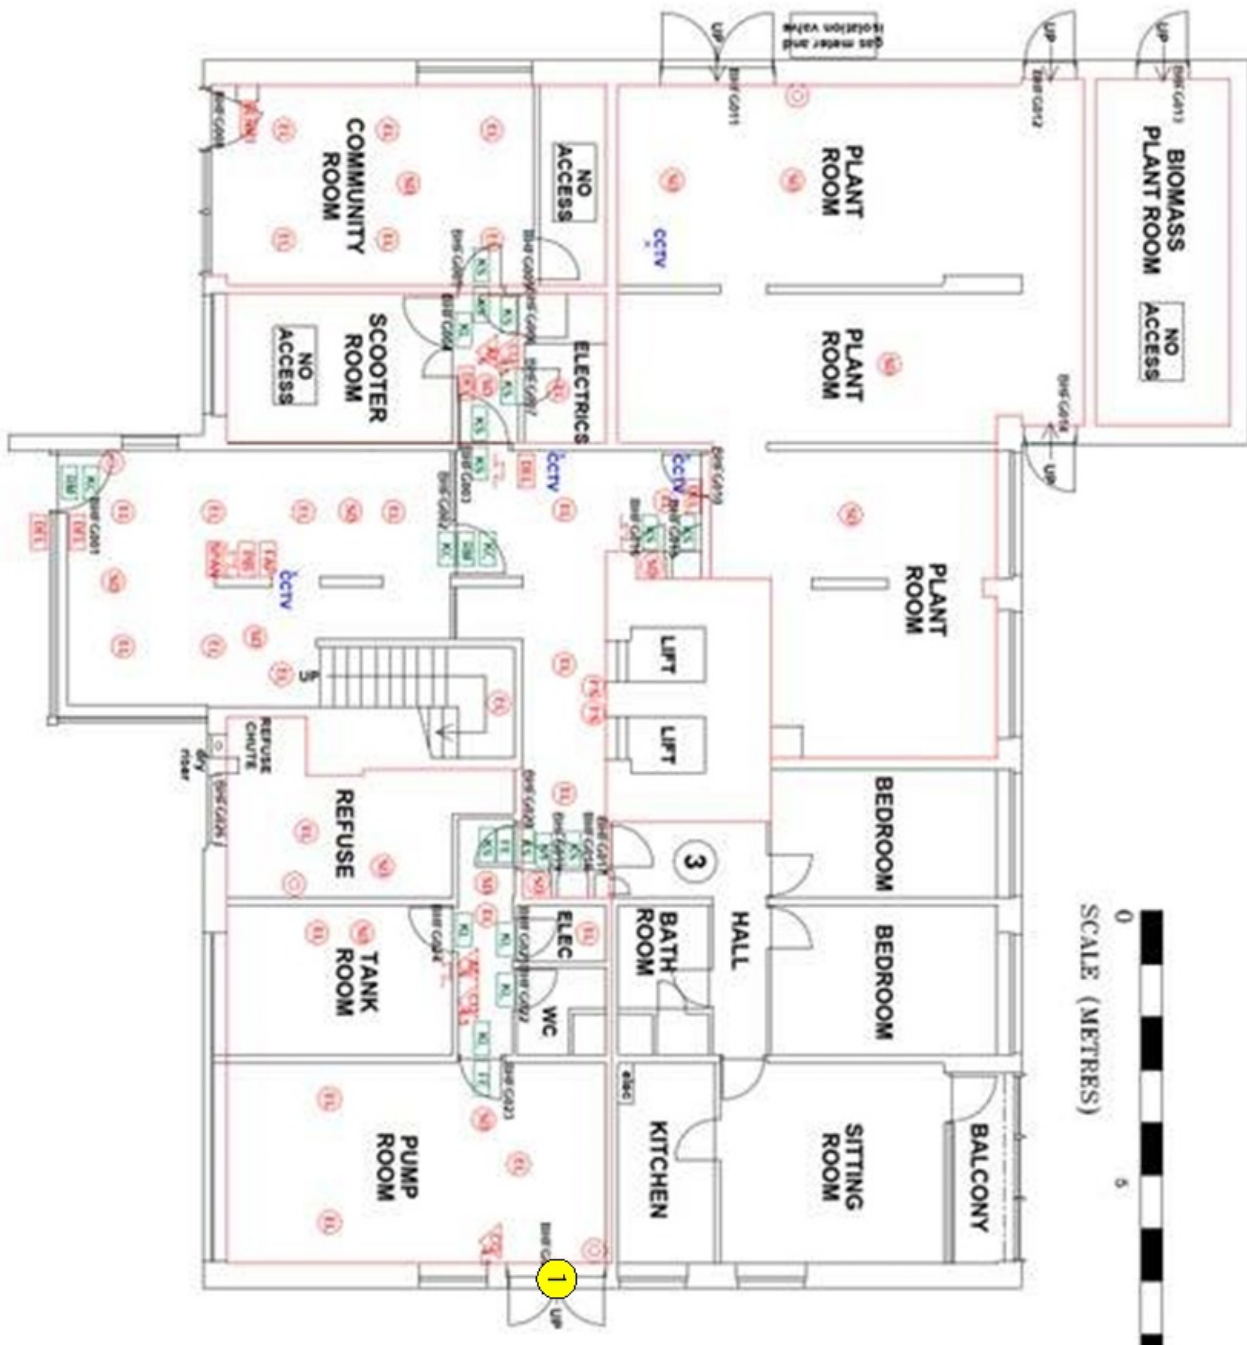
Ground Floor

FRARef	Observation	Recommended Action	Risk Rating	Contractor Completed
8.11	The double doors from the plant room within the caretaker area were found blocked and key-locked shut.	It is recommended that this exit is made available and kept clear. The doors should be unlocked when the room is occupied and work is being undertaken.	Moderate

1 Means of Escape - 8.11
