TOTAL FIRE GROUP LTD

Fire Risk Assessment

1-58 Hollyhedge Court
223 Hollyhedge Road
Manchester
Greater Manchester
M22 4QD

05 July 2023

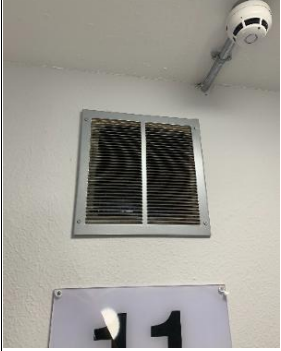
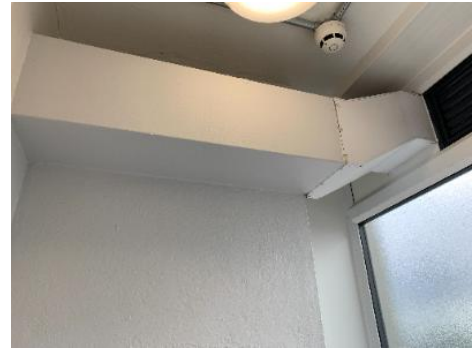
Ref	COMMENTARY
8.2	<p>The below photographs show an example of the means of smoke ventilation in the stairway of the premises. The layout is the same on all floors from the first floor upwards. The vent on the stairs leads into the metal ducting which in turn vents direct to outside, passing through the refuse chute room on its way. The previous FRA confirmed that WCHG have engaged third parties to confirm that this method of smoke ventilation is adequate. Smoke modeling calculations have been provided by a fire engineer that concluded that provided new grilles were fitted and the ducting was cleaned that the existing provisions for smoke ventilation are satisfactory. In addition, the ducting has been inspected by another third party who confirmed that they were fit for purpose. Although not viewed on this assessment, it is understood that WCHG have documentary evidence available issued by the third-parties.</p> <div data-bbox="236 443 517 792">

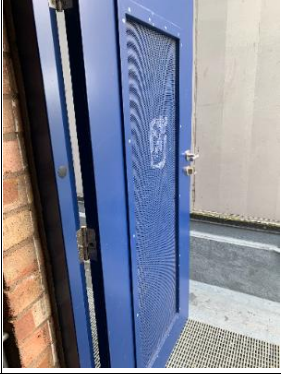
8.2	<p>A louvered door provides a means of permanent ventilation to the lift motor room.</p> <div data-bbox="236 824 517 1196">

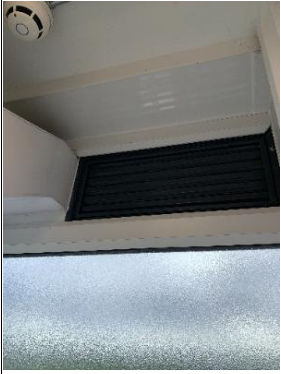
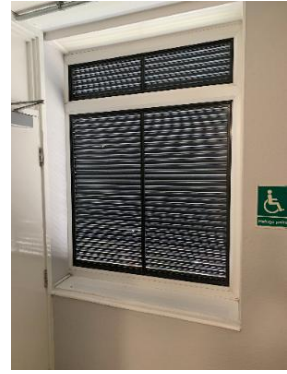
</div>
8.2	<p>The corridor between the lobby serving flats and the staircase is provided with permanent ventilation, as is the refuse chute room.</p> <div data-bbox="236 1249 517 1621">

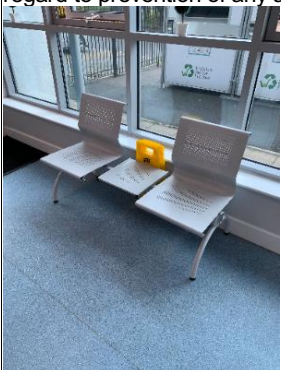
8.7	<p>A metal bench is located in the main entrance lobby, where the staircase serving all of the floors discharges. The presence of this item is not considered to significantly increase the risk to life of the residents, however, close attention should be paid with regard to prevention of any additional items being placed in the area.</p> <div data-bbox="236 1697 517 2065">

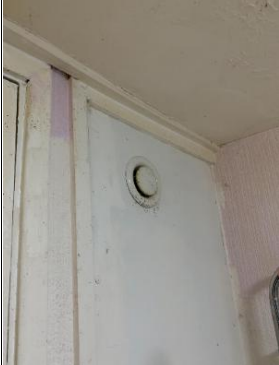
9.11	<p>The previous FRA confirmed that WCHG have confirmed that Allied Protection Ltd has completed fire stopping and compartmentation works to prevent fire spread via the common bathroom and shower room extract shafts. They have also fitted fire rated valves with an intumescent infill in the bathrooms which are connected to the ducting and shaft. Although these valves will not prevent smoke spread into the shaft in the early stages of a fire they are considered an acceptable method of preventing fire spread. Documentary and photographic evidence is available to evidence the works carried out by Allied Protection Ltd and are held by WCHG. These were not viewed on this assessment.</p>

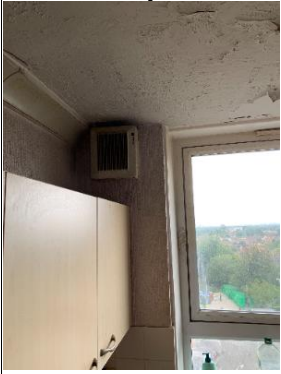
9.11	<p>It was noted that the kitchen ventilation in the flats seen is extracted directly to the outside, via a powered fan, which was not common to any other flats. It is assumed that all the flats in the block have similar provisions installed.</p>

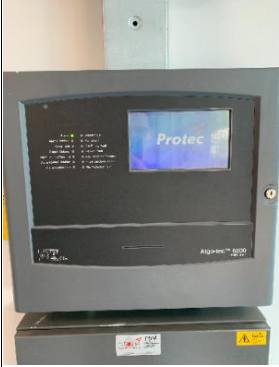
10.1, 10.4-10.6	<p>The common area fire alarm and detection system incorporated smoke detection throughout the majority (except the biomass boiler room - see another commentary 10.1, 10.4-10.6) and heat detection in the hallways of each resident flat. It was noted that in this building, detection linked to the common BS5839-1 system was only provided in the corridor serving the community room areas, but not within each of the rooms adjoining this corridor. Instead, BS5839-6 Grade D interlinked detection was provided in this room to provide early warning to the occupants of those rooms. This is considered satisfactory. The fire alarm panel for the BS5839-1 fire alarm system is located at ground floor level in the staircase enclosure. It was previously confirmed that the system is addressable. Further detail regarding the fire alarm system and its purpose within the building is provided in commentary 12.14.</p>

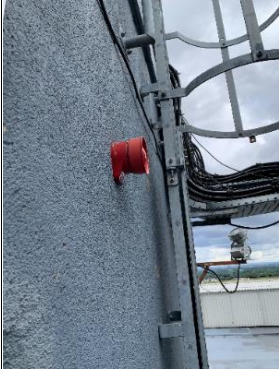
10.12	<p>The previous FRA raised an action in relation to there being no confirmation on whether a sounder linked to the fire alarm system was provided on the roof, nor could it be confirmed that, where provided, such a sounder is programmed to be audible. The previous FRA action has been signed off as complete on 16/09/2022 by Mike Holt. Threshold access was gained to the roof on this assessment with which a sounder was seen. Red cabling could also be seen penetrating the lift motor room walls to the roof area in this block indicating the fire alarm system extends to this area. Due to the action being signed off as complete, it is reasonable to assume that the sounder has been confirmed as audible as previously recommended.</p>

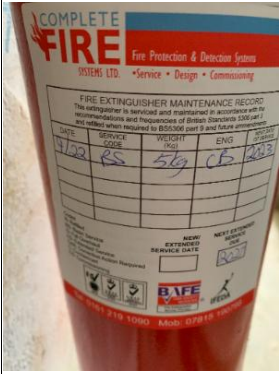
12.4-12.5	<p>It is understood that firefighting equipment is inspected on a monthly basis and was last serviced by Complete Fire Systems Ltd on 09/2022.</p>

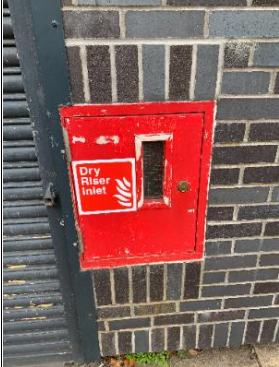
12.6	<p>The previous FRA raised an action in relation to no signage indicating the dry riser inlet on the building's external façade. The previous FRA action has been signed off as complete on 16/08/2022 by Mike Holt. New signage has now been installed.</p>

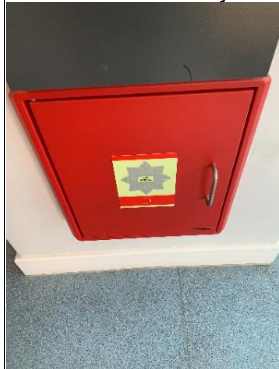
SIB in the entrance foyer:

12.6, 12.15-12.16 As part of their standard responses, WCHG maintains Secure Information Boxes (SIB). Although not accessed, it was seen that a SIB has been installed in the entrance foyer. It is reasonable to assume the fire service carries a key to gain access to the box. It must be noted that the responsibility for providing and updating the information with regard to any vulnerable tenants remains with WCHG.

Therefore, WCHG should ensure that the information stored in the SIB is correct in line with current guidance, kept up-to-date, and regularly reviewed.

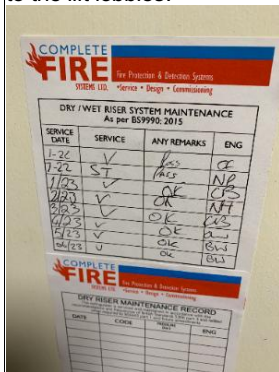
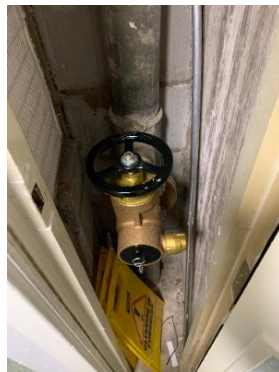
12.8 As part of their standard response, WCHG confirmed that where firefighting and firefighter facilities are provided, they are tested and maintained. The labels observed in the riser cupboards on site noted that the latest service was done on 06/2023 by Complete Fire Systems Ltd in line with BS9990:2015. There appears to be a monthly check undertaken. All the doors to the outlets were secured and labeled. Several Dry Riser cupboards were opened and the outlets were seen to be in good condition.

The dry riser inlet is on the building's external façade and outlets are provided at each floor level on the upper floors, adjacent to the lift lobbies.

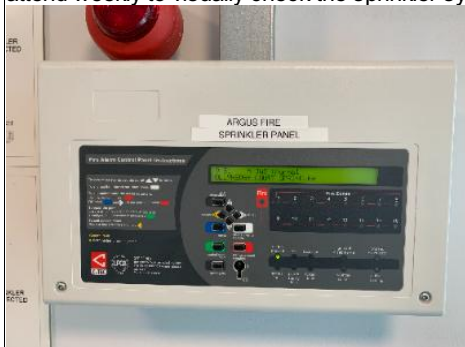
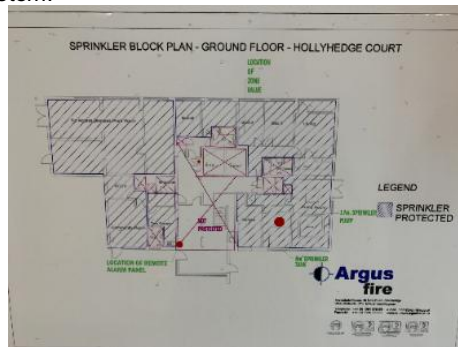
12.8-12.9 **As noted on the previous FRA:**
A BS9251 sprinkler system has been installed. In each flat, there are concealed sprinkler heads located in the hallway, each bedroom, the lounge, and the kitchen. In addition, there are also sprinkler heads located in some ground floor plant and community areas. There are control valves for each floor in riser cupboards that adjoin the lift lobbies. A pump and water tank for the sprinkler system have been provided in the sprinkler tank room which is within the old caretaker's area. A sprinkler panel and plan are provided by the fire alarm panel in the staircase enclosure at the ground floor level. The previous FRA confirmed that the system is maintained and serviced by an approved contractor on a quarterly basis and contractors also attend weekly to visually check the sprinkler system.

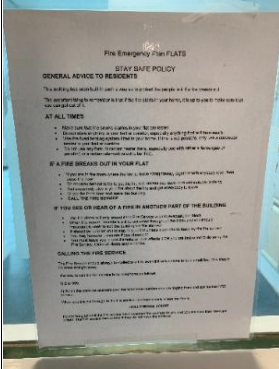
13.6, 13.8	A suitable 'stay safe' fire action notice was provided in the common area by the main entrance. This captures the 'stay put' essence of the fire strategy whilst incorporating instructions should residents hear the BS8629 Evacuation Alert System sound.

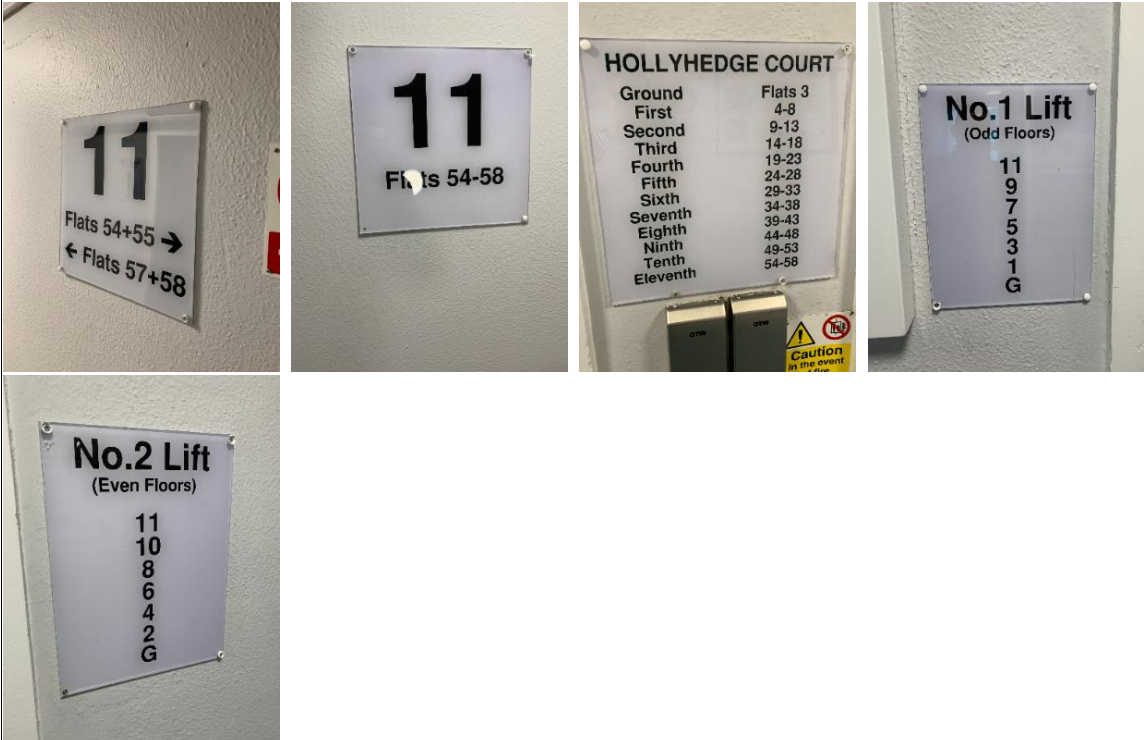
13.12	Suitable 'No Smoking' signage was observed in the common area.
13.15-13.16	Wayfinding signage that has the floor number and directional signage to the flats, including flat numbers, is displayed in the lift lobbies and on the stairway landings. They appear to be mounted at the recommended height as per ABD and are all visible and in good condition. Supplementary signage is also present, with signage outside the lift areas to show which flats are on each floor and which floors the two lifts access.

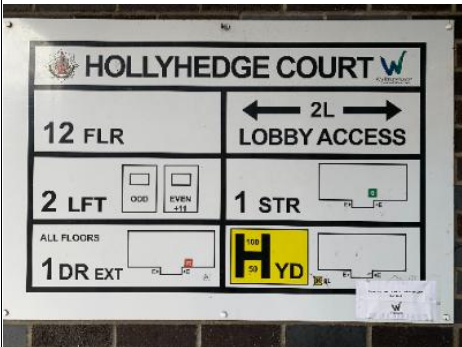
14.11	<p>A building information board showing key building facilities is present by the main entrance. This shows:</p> <ul style="list-style-type: none"> • Number of floors. • Stating the 'lobby access' nature of the building. • Number of lifts. • Number of stairs. • Number of dry risers. • Location of nearest fire hydrant.
