TOTAL FIRE GROUP LTD

Fire Risk Assessment

1-58 Hollyhedge Court
223 Hollyhedge Road
Manchester
Greater Manchester
M22 4QD

05 July 2022

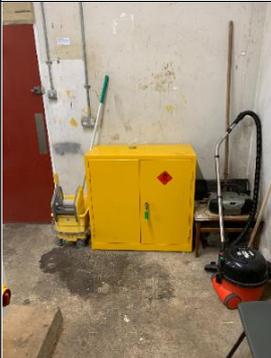
<p>A clearly identifiable, metal COSHH cupboard is located in the water tank and pump room, which is situated within the restricted access old caretaker's area.</p>

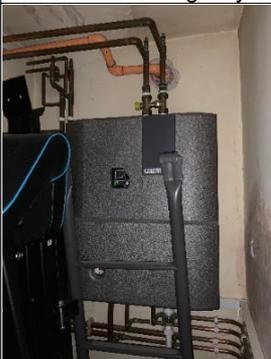
6.1

<p data-bbox="236 831 1453 891">The flats are heated by a communal biomass heating system with a gas backup. Water heater vessels are installed within cupboards in flat bathrooms.</p>

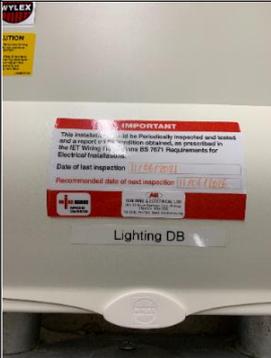
6.6

<p data-bbox="236 1249 1497 1332">WCHG informed our assessor that fixed electrical installations on the premises were last serviced on 11/06/2021 and this was reflected by labels affixed to electrical installations observed on the premises, as shown in the photograph. It was confirmed to our assessor that both the common area and the flat electrical installations are serviced on a 5 yearly basis.</p>

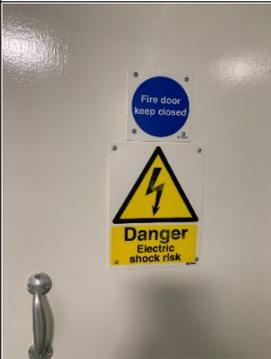
6.16

<p data-bbox="236 1691 1177 1720">Suitable electrical hazard signage was provided to service riser cupboards, where appropriate.</p>
6.17	Only refreshment facilities are provided in the community kitchenette on the ground floor, such as a kettle and fridge.

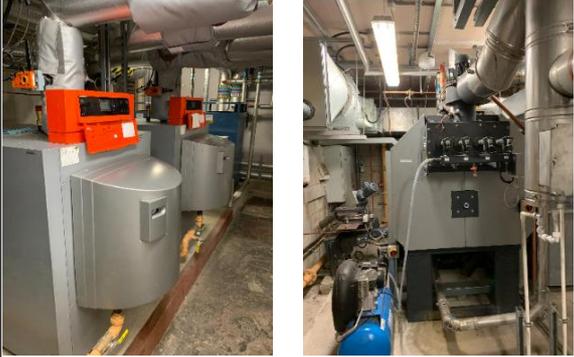
6.20	<p>Biomass and gas heating systems on the premises are serviced on an annual basis, with this last having been carried out on 16/05/2022.</p>	
6.20	<p>There are 2 lifts in the building, one that serves odd floors and one which serves evens. Both of the lifts serve the top floor and the ground floor. The lifts are serviced on a monthly basis by a competent person and are also checked on a weekly basis to ensure they default to ground floor level on activation of the common BS5839-1 fire alarm system.</p>	
6.20	<p>Lightning protection is installed and is serviced annually by a competent person. The last service date was 04/2022.</p>	
6.22	<p>There are no solar or PV systems fitted to this building.</p>

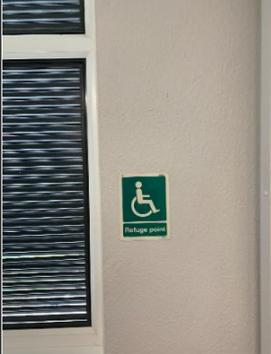
7.6

<p>Refuge signage is provided in the corridors between lobbies serving flats and the staircase. This is consistent with Section 70.11 of the Fire Safety in Purpose Built Blocks of Flats guidance, which states: 'Many older and disabled residents will find it difficult to use stairs in the event of a fire, and additional measures may need to be considered. These could include temporary safe refuge areas or spaces within existing protected lobbies and stairs'. It should be noted that these areas may be considered TEMPORARY refuge areas only and persons should not be encouraged to wait in these areas for rescue.</p>

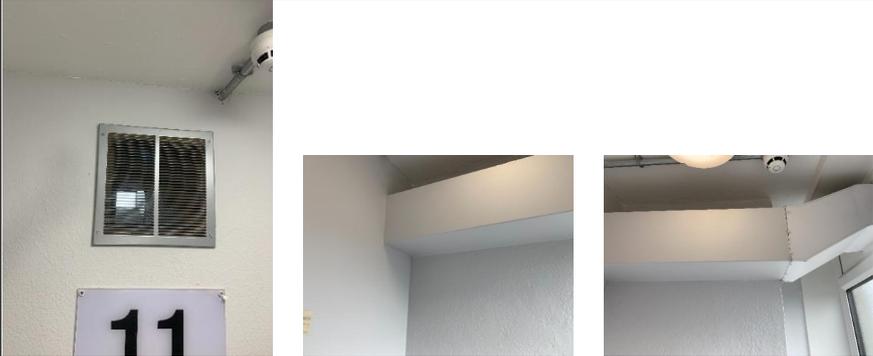
Ref	COMMENTARY
8.5

<p>The above photographs show an example of the means of smoke ventilation in the stairway of the premises. The layout is the same on all floors from the first floor upwards. The vent on the stairs leads into the metal ducting which in turn vents direct to outside, passing through the refuse chute room on its way. WCHG have engaged third parties to confirm that this method of smoke ventilation is adequate. Smoke modelling calculations have been provided by a fire engineer that concluded that provided new grilles were fitted and the ducting was cleaned that the existing provisions for smoke ventilation are satisfactory. In addition, the ducting has been inspected by another third party who confirmed that they were fit for purpose. WCHG have documentary evidence available issued by the third-parties.</p>

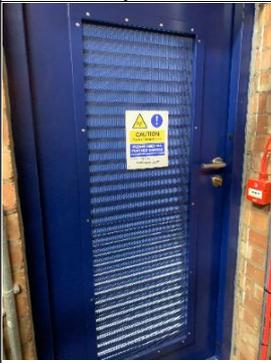
<p>A louvred door provides a means of permanent ventilation to the lift motor room.</p>
8.5

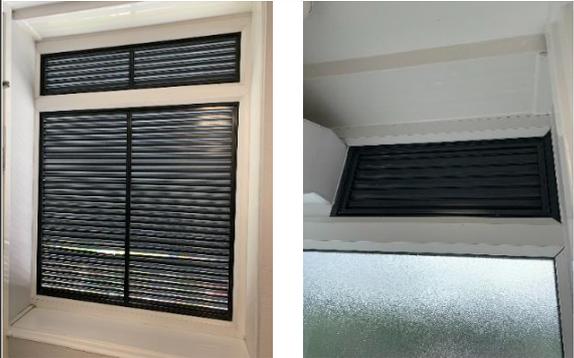
<p>The corridor between the lobby serving flats and the staircase is provided with permanent ventilation, as is the refuse chute room.</p>

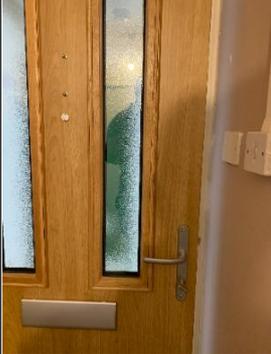
8.10, 8.12

<p>The fastenings on the internal side of the existing flat entrance doors were key operated, however our assessor has observed the new flat entrance doors which were in the process of being installed and these were provided with thumb turn devices.</p>

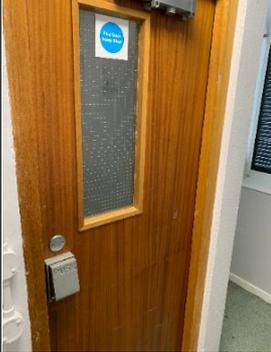
8.16	It was noted at the time of the assessment that none of the doors between the staircase and the corridors serving flats were electromechanically secured (as is normally intended), with the exception of the second floor. It could be that this is due to the presence of the faults on the fire alarm panel whilst contractors carry out work on the premises however this could not be confirmed at the time of the assessment.
	Recommended Actions

<p>Electromechanically secured doors separate the staircase from the corridors serving flats and these require fob access in the direction towards the flats. In the direction of escape, a suitable push pad device is provided leading into the stair.</p>

8.16	In order to prevent unauthorised access to the flats from the stair, ensure all of the doors into these areas electromechanically secure when not in use, as intended. Where there is an issue with the second floor electromechanical lock jamming this should be rectified.

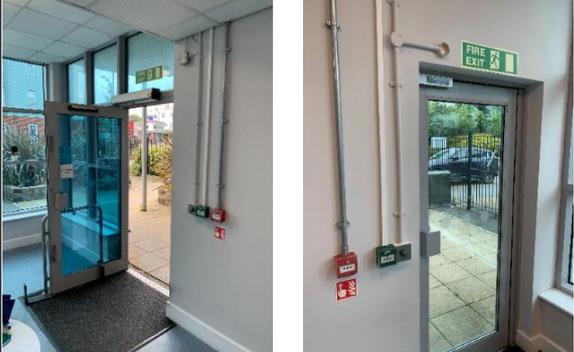
8.17-8.18

<p>Two final exit doors from the building, both located at the base of the staircase serving the upper floors, were electromagnetically secured and were accompanied by suitable green box emergency overrides. It was confirmed that secured doors (whether electromechanical or electromagnetic) are configured to release upon activation of the fire alarm system.</p>

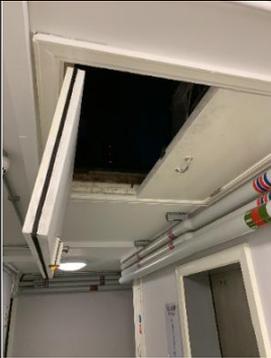
9.1

<p>As was recommended at the time of the previous fire risk assessment, a new fire resisting hatch appears to have been installed between the eleventh floor and the lift motor room.</p>

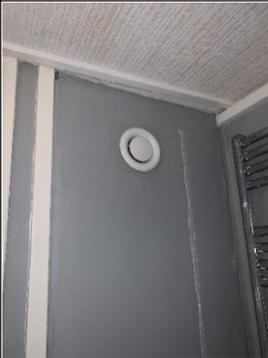
9.8

WCHG have confirmed that Allied Protection Ltd has completed fire stopping and compartmentation works to prevent fire spread via the common bathroom and shower room extract shafts. They have also fitted fire rated valves with an intumescent infill in the bathrooms which are connected to the ducting and shaft. Although these valves will not prevent smoke spread into the shaft in the early stages of a fire they are considered an acceptable method of preventing fire spread. Documentary and photographic evidence is available to evidence the works carried out by Allied Protection Ltd and are held by WCHG.

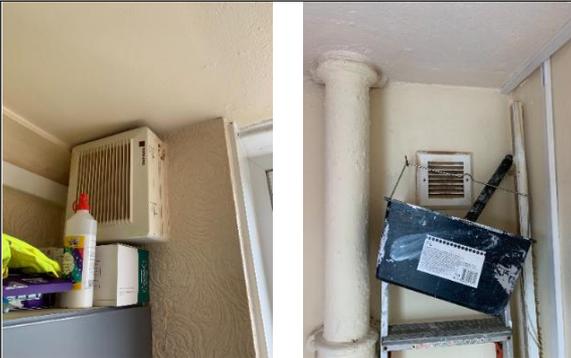
9.8

Kitchen extraction and grilles within the enclosed balcony areas of each flat appeared to lead directly to outside.

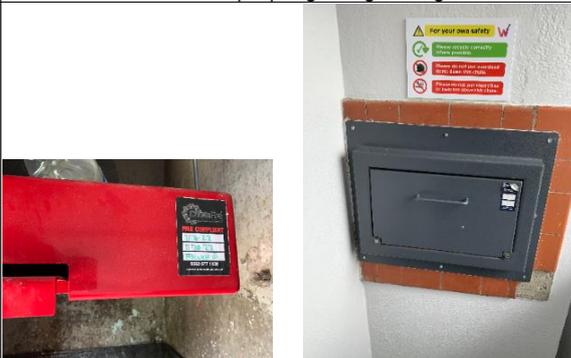
9.14

In the externally accessed bin room on the ground floor, the bin in use is located adjacent to a lid that has a fusible link and closes should a fire occur within the bin, in order to prevent fire spread up the chute. The fusible link is checked six monthly by an appointed contractor, with a label indicating that this was last carried out on 11/04/2022.

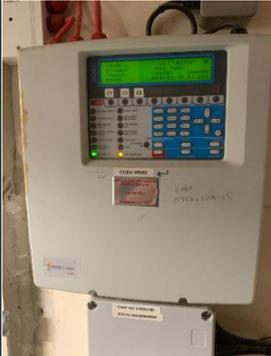
10.1	The BS5839-1 fire alarm system was showing 7 faults at the time of the assessment.
10.1-10.7

<p>The biomass boiler room has its own BS5389-1 Category L5 system. This system consists only of automatic detection/manual call points within the biomass boiler room. It was confirmed to our assessor that this fire alarm system is not linked to the BS5839-1 fire alarm system which spans throughout the rest of the common areas, however this system is itself monitored. This would result in early summoning of the Fire and Rescue Service on its activation. The fire alarm panel for this system is within the biomass boiler room and was showing as healthy at the time of the assessment.</p>

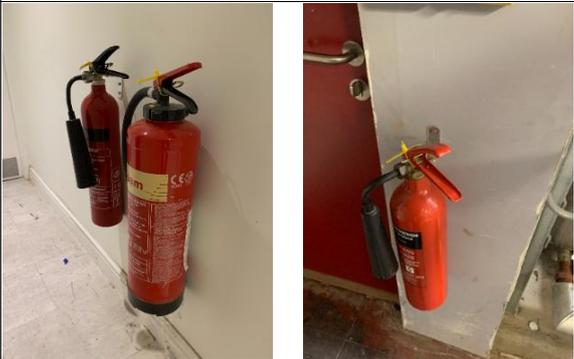
12.1-12.3

<p>CO2 and foam firefighting equipment is provided in the corridor serving the community facilities. The same is present in the old caretaker's areas. CO2 firefighting equipment is also installed in areas of specific risk such as the biomass boiler room and lift motor room.</p>

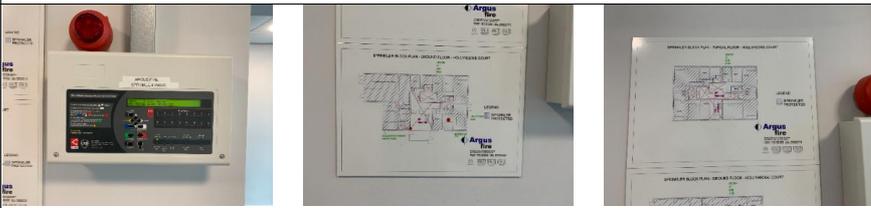
12.6-12.9

<p>A BS9251 sprinkler system has been installed. In each flat, there are concealed sprinkler heads located in the hallway, each bedroom, the lounge, any enclosed balcony and the kitchen. In addition, there are also sprinkler heads located in some ground floor plant and community areas. There are control valves for each floor in riser cupboards which adjoin the lift lobbies. A pump and water tank for the sprinkler system have been provided in the sprinkler tank room which is within the old caretaker's area. A sprinkler panel and plan are provided by the fire alarm panel in the staircase enclosure at ground floor level. The system is maintained and serviced by an approved contractor on a quarterly basis and Argus also attend weekly to visually check the sprinkler system.</p>

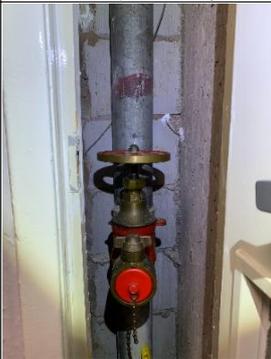
12.8, 12.10

<p>The dry rising main is both pressure tested and visually inspected annually with six months between the two visits. The tests and inspections are carried out by an approved contractor. Records are kept on WCHG systems. The last pressure test took place on 08/07/2021 (now due). The dry riser inlet is on the building's external façade and outlets are provided at each floor level on the upper floors, adjacent to the lift lobbies.</p>

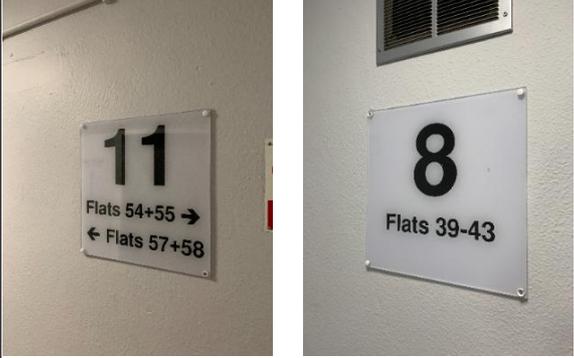
<p>Wayfinding signage that has the floor number and directional signage to the flats, including flat numbers, is now displayed in the lift lobbies and on the stairway landings. These are not low level, however are considered satisfactory at present.</p>

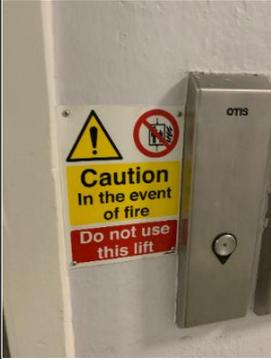
13.0

<p>Suitable 'Do Not Use Lift in the Event of Fire' signage is provided within the lift lobbies.</p>
13.1-13.4	Directional signage was observed in the common areas. This building has a single staircase serving the upper floors and residents will be familiar with access and egress from the building.

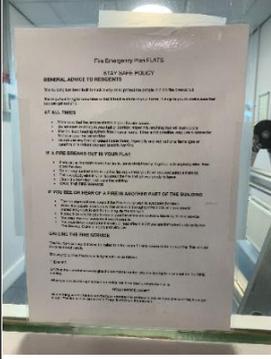
13.6, 13.8

<p>A suitable 'stay safe' fire action notice was provided in the common area by the main entrance. This captures the 'stay put' essence of the fire strategy whilst incorporating instructions should residents hear the BS8629 Evacuation Alert System sound.</p>

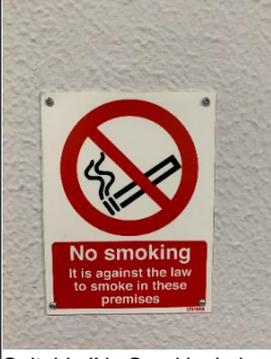
13.12

<p>Suitable 'No Smoking' signage was observed in the common area.</p>
