TOTAL FIRE GROUP LTD

Fire Risk Assessment

Moorcot Court
Bideford Drive
Wythenshawe
Manchester
M23 0QW

16 June 2022

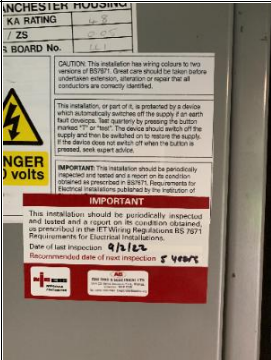
6.6

<p>WCHG have informed our assessor that servicing for the electrical installations for the building was last carried out on 19/11/2017, however some labels on site which displayed a date of 09/02/2022 (as pictured above). All records and certification relating to such servicing is stored on WCHG systems.</p>

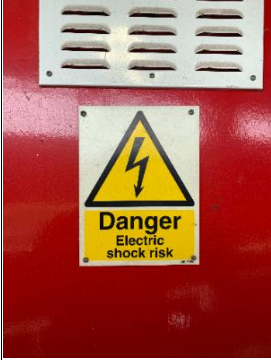
6.19

<p>Suitable hazard signage was fitted to service risers across the premises.</p>
6.20	<p>All gas installations have safety checks carried out on a 10 month rolling programme of work. The lifts are serviced on a monthly basis. Laundry equipment is also maintained under a service contract. All records relating to this testing and maintenance is held centrally on WCHG systems.</p>

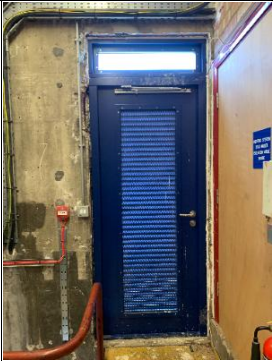
<p>The door onto the roof from the lift motor room provides a means of permanent ventilation.</p>
8.5

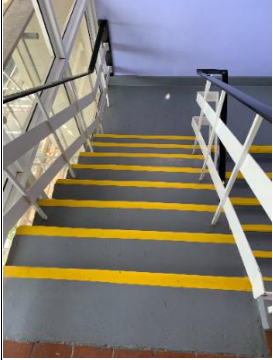
<p>Steps on the internal staircase are nosed, ensuring clear visibility for those using them.</p>

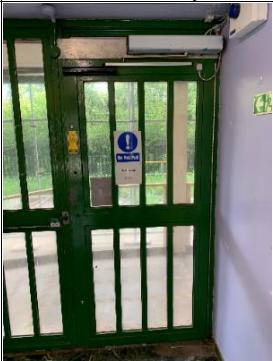
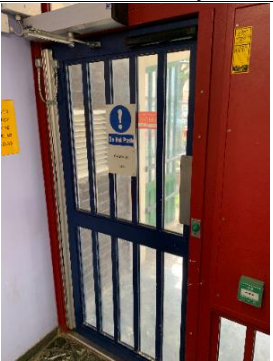
<p>The ground floor flats and plant are accessed to the rear of the building. Persons in this area must pass back through the ground floor lift lobby to reach the street and ultimate safety, as access to the rear of the building is fenced in and is padlocked in order to prevent unauthorised access. It was noted that although the electromagnetically secured door from rear of the building leading back into the lift lobby had a fob point for access however no accompanying green box override. In the absence of a suitable override, there is the potential for persons to become trapped at the rear of the building, placing them at risk of harm.</p>
	Recommended Actions

<p>The front (to street) and the rear (to plant and ground floor flats) exits from the ground floor lift lobby are automatic and are electromagnetically secured. From the internal lift lobby side these exits are provided with suitable green box overrides.</p>

8.17-8.18	Confirm that the electromagnetically secured door back into the common area is double poled and would fail on activation of the common fire alarm (guaranteeing access), provide a suitable green box override or provide a means of ensuring persons at the rear of the building could reach ultimate safety on the street to the front at all material times.
Ref	RECOMMENDATIONS
	None.

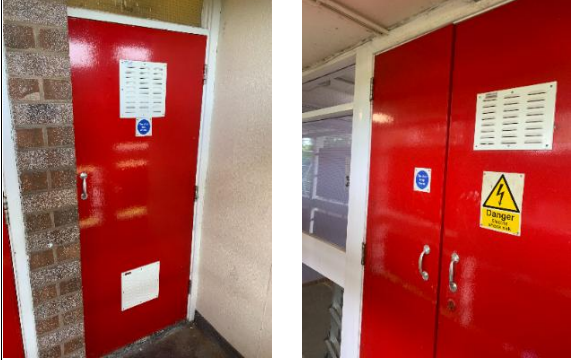
Ref	COMMENTARY
9.1

<p>Service risers and refuse chute rooms adjoining the open deck areas are provided with high and low level intumescent grilles. Although these will not seal in the early stages of a potential fire, therefore enabling passage of smoke and other products of combustion, the flats are accessed via open deck therefore this is considered acceptable.</p>

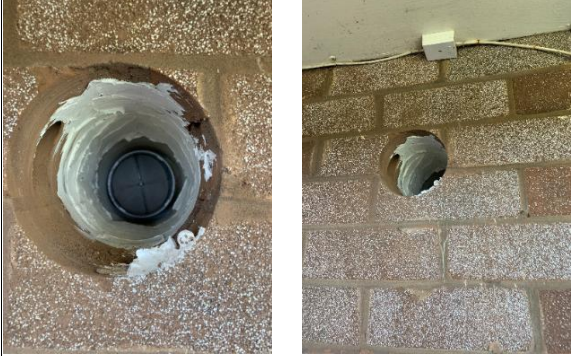
9.8

<p>In the flats that were viewed during this and previous Fire Risk Assessments, it was confirmed that the ventilation arrangements for the kitchen and bathroom were located on the external wall onto the open deck and did not pass through any other compartmentation. The extraction passes out of the flats at high level, therefore does not affect persons escaping past. It was observed at the time of the assessment that vents were being lined with fire stopping materials.</p>

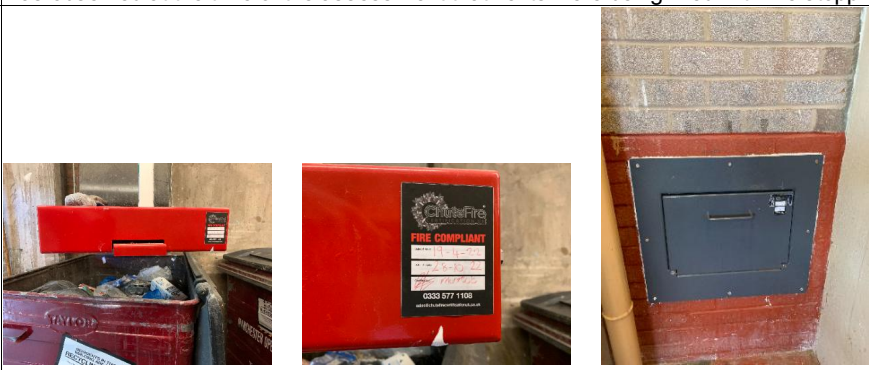
9.14

<p>In the bin room on the ground floor, the bin in use is located adjacent to a lid that has a fusible link which enables the lid to self-close over the bin should a fire occur. This is to prevent the fire, smoke and toxic gases spreading up the chute. The fusible link is checked annually by an appointed contractor and a label indicated that this was last carried out on 19/04/2022.</p>

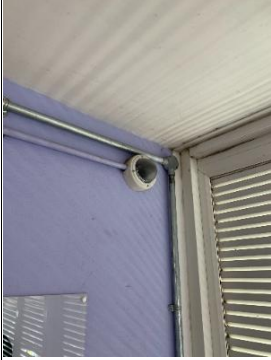
9.15	Recycling bins for the premises are located in the secured, fenced ground floor deck area to the rear of the premises.
9.15

<p>CCTV is provided in the common areas, including on the open decks.</p>

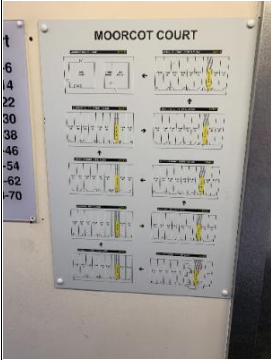
10.11

<p>A suitable building and zone plan is provided adjacent to the fire alarm panel.</p>
10.12-10.14	The fire alarm/emergency alert system is tested weekly by the staff from WCHG's Facilities Department. A record of the test is kept electronically on WCHG's systems. The maintenance of the system is carried out by an approved contractor and is also recorded (last carried out 04/05/2022).
