Fire Risk Assessment (Review)

Village 135
3 Hollyhedge Court Road
Wythenshawe
Manchester
M22 4GW

22 February 2021

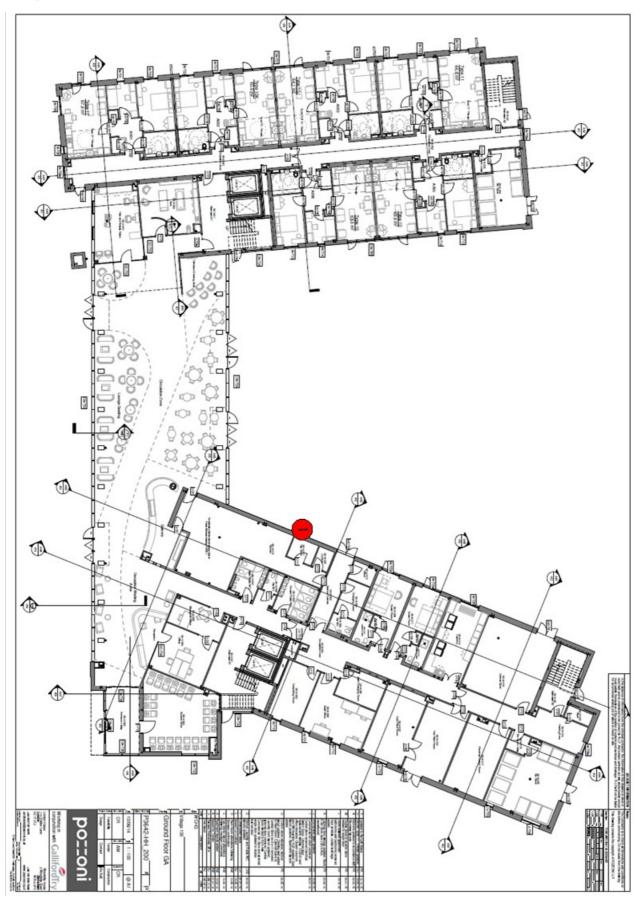
HH ground

1 The Confinement of Fire - 9.13

9.13	Following guidance from the Ministry of Housing Communities and Local Government (MHCLG), investigations into the external cladding system have begun and are continuing at the time of this FRA. See Section 9.13 for full details.	Should WCHG require the "Stay Put" fire strategy to be implemented on completion of the remedial measures it is highly recommended that Blocks C & D are examined and included in the remedial measures for Blocks A & B.	P2 - previously identified		Amanda Seals

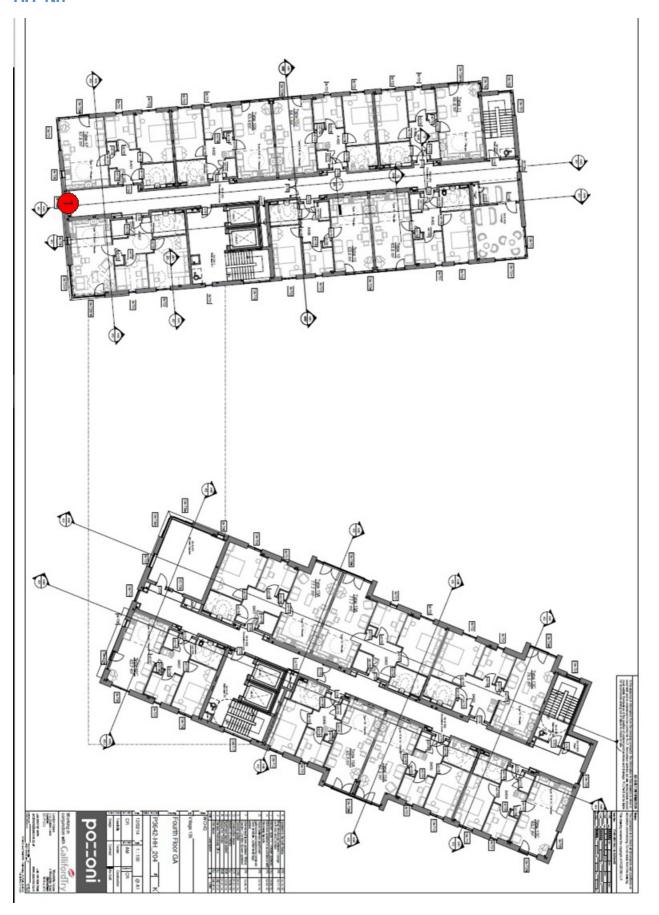
HH 4th

1 Escape - 8.5

FRARef	Hazard or Defect	Action Required	Hazard Priority	Risk Rating	Action By	Review Date	Contractor Completed
8.5	end of the residential corridors were fitted with AOVs. The manual opening handles had been removed and it was assumed that this was for safety reasons.	on the corridors can be opened during an emergency for the purposes of smoke ventilation or that they are suitably fitted with AOVs linked to the smoke detection or take remedial actions to remedy the findings.	P2	Moderate

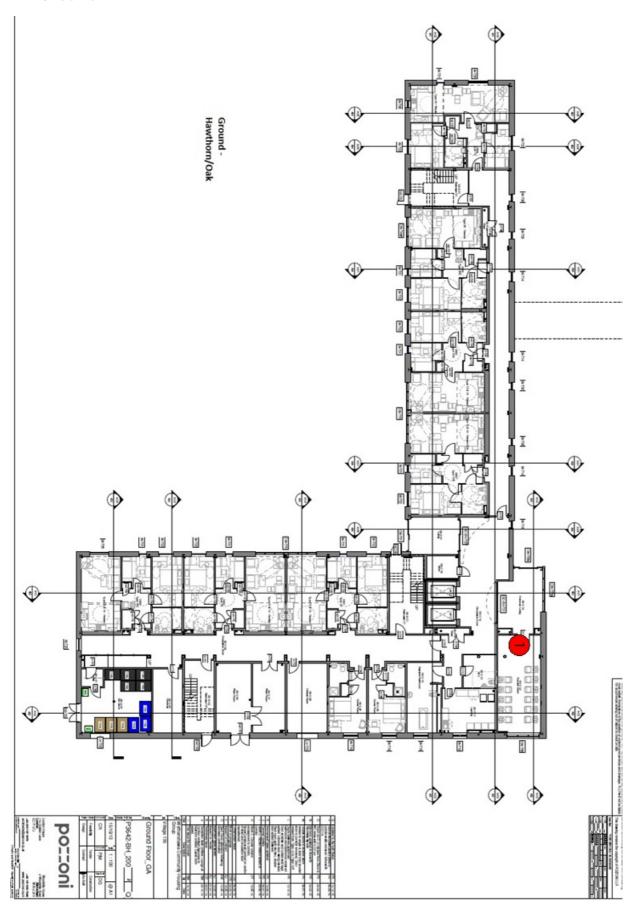
BH Ground

1 The Confinement of Fire - 9.14

9.14	It was seen that some wiring above the false ceiling in the Scooter Store of Oak and Hawthorn blocks has not been correctly secured in place. Lots of loose wiring was seen.	Arrange for a suitably qualified person to survey the ceiling void and carry out remedial works, so as to ensure that the wiring and any electrical apparatus is correctly fixed in place.	P2	Moderate

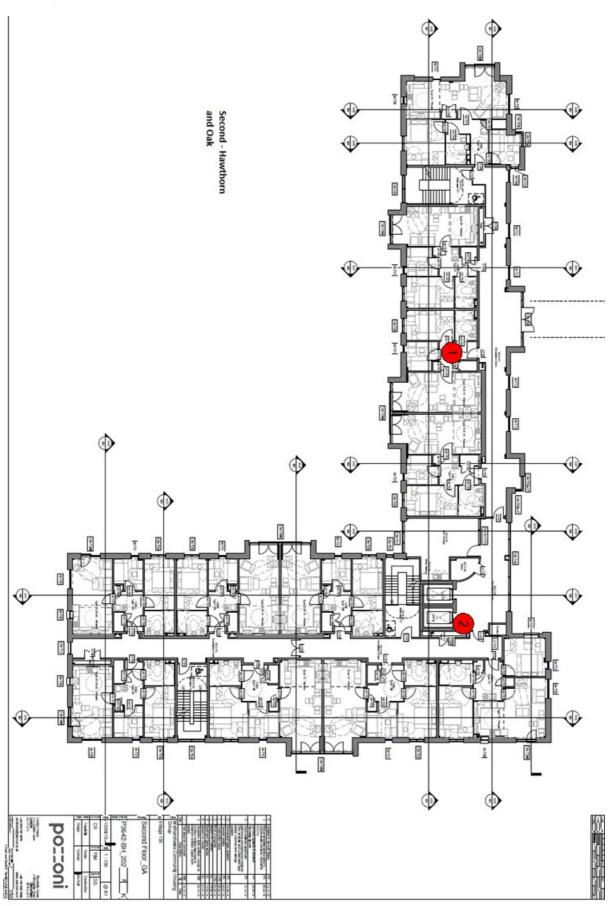
BH 2nd

1 Fire Alarm System - 10.3, 10.5

10.3, 10.5	It was noted that in the flats / apartments accessed, only a single BS 5839, Part 6 type smoke detector was fitted	Current guidance advises that within sheltered housing and extra care properties, it would be necessary to upgrade the detection in the flats as a	P2	Moderate
