# TOTAL FIRE GROUP LTD

## Fire Risk Assessment

Bagnall Court  
Greenway  
Manchester  
M22 4LT

25 March 2026

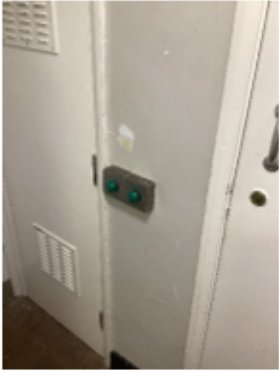
| Ref | FINDINGS |
|---|---|
| 8.21 | The signage for the emergency override within the laundry room has been removed and both buttons are the same design and colour. |

| Ref | FINDINGS |
|---|---|
| 8.21 | It is recommended that signage be installed to indicate which button is the emergency override. |

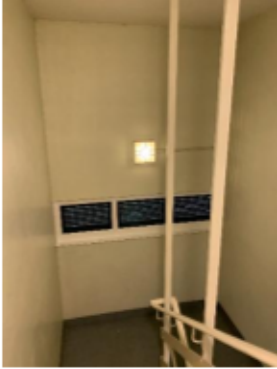
| Ref | COMMENTARY |
|---|---|
| 8.2 | Smoke ventilation in the stairway is provided by three permanently open vents (POVs) on the half landing between the 11th and 12th floors. These vents together provide an area in excess of the 1m <sup>2</sup> required. In addition, the doorway from the stairway onto the uppermost open deck can be opened for additional ventilation if required. Although this is an unusual arrangement, it is considered acceptable by our assessor, after taking into account that the stairway is separated on each floor from the common lobby to the flats by an open deck and 2 x self-closing fire doors. It would be highly unlikely for any smoke from a flat fire that affects a common lobby, to be able to reach or enter the staircase, due to the layout. Additionally, the lift room accessed from the top of the stairs is separated by a fire door and a vertical ladder, giving access to a rooftop room, which again is ventilated directly to the outside. The final exit door at the base of the stairs also opens straight to the outside. |

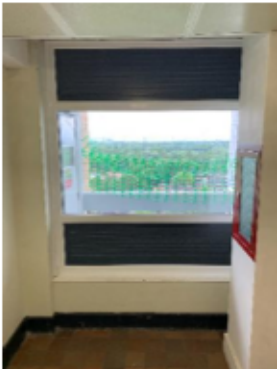
| Ref | COMMENTARY |
|---|---|
| 8.2 | The lobbies serving flats are provided with a permanently open vent on each floor, which would allow smoke from a fire to ventilate to fresh air and help keep conditions tenable within the lobbies. Additionally, the door leading to the stairs via the open deck could be opened to provide ventilation within the lift lobbies, allowing smoke to escape, as is the refuse cupboards. |

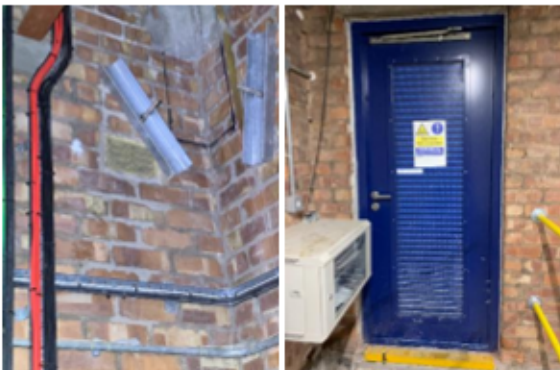
| Ref | COMMENTARY |
|---|---|
| 8.2 | Air bricks and a louvred door were observed for ventilation purposes in the lift motor room. Photos reused from previous fire risk assessments. |

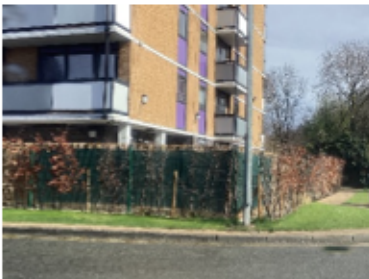
| Ref | COMMENTARY |
|---|---|
| 8.6 | Gardens at the back appear to be private to a tenant. These gates are padlocked. They are used only by the resident and they have a choice of direction as they can evacuate through their front door via the main block. |

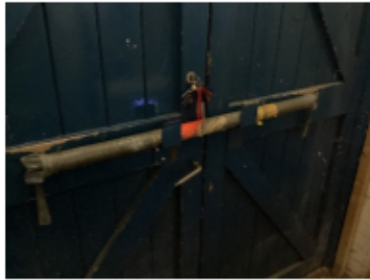
- 8.6 It was observed in the tank room the door had been locked. The door should remain unlocked with the bar in place so it can be used in the event of an evacuation. It has been confirmed that this room is seldom used and would only be used by authorised persons who should be informed that they should remove the bar and push to the door to open.

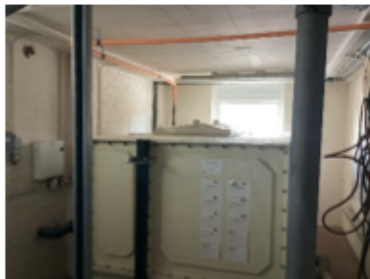
- 8.8-8.10 The water pump room could be classed as an inner room, however, the caretaker's/cleaner's area is only small and the corridor from the tank room to the common area lobby is only short, the corridor is also protected by smoke detection (which WCHG had previously confirmed to be audible in this area) and the water tank room is seldom used. These arrangements were found to be satisfactory by our consultant.

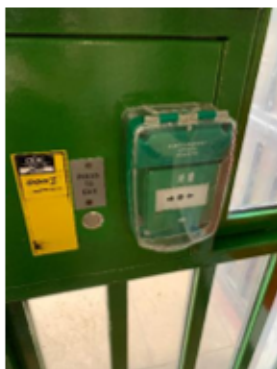
- 8.18-8.19 Where electromagnetically secured doors were observed as fitted on the premises (e.g. main entrance door/laundry corridor door), these were provided with suitable overrides on the escape side.

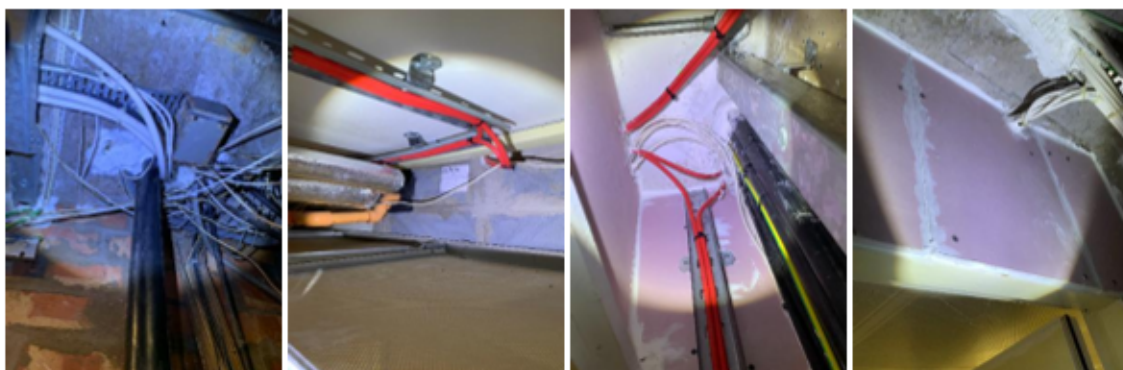
**2026 update** - No obvious breaches in compartmentation were observed at the time of the fire risk assessment.

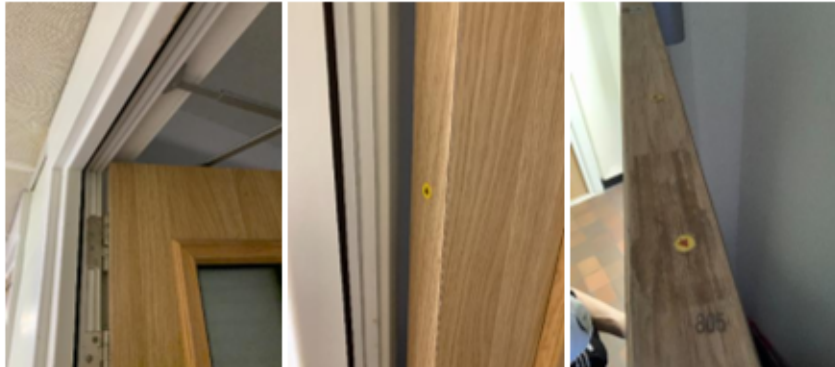
9.1, 9.5-9.6 **Retained for historical information:** WCHG had completed the programme of fire door replacement in this building, which has been ongoing during the course of previous fire risk assessments. Although some deficiencies relating to individual doors have been noted (see relevant findings) doors appeared to be of the same standard from a visual external inspection. From the sample accessed on this assessment, the doors were observed to be FD30s and fitted with combined intumescent fire and cold smoke seals, and self-closing devices. The doors had spring-loaded metal letterboxes fitted approximately midway down their length.

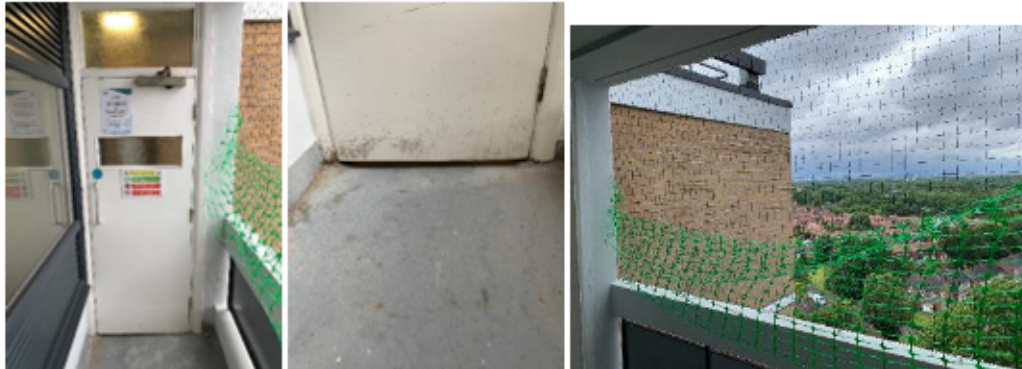
- 9.6 The refuse doors on each floor have large gaps at the foot of the doors. These doors are in place for smoke control to prevent smoke from affecting the balcony egress to the staircase should a fire occur in the bin chute areas. The refuse chute rooms have an open balcony which allows smoke to escape before it reaches the bottom of the doors, and the end of the refuse chute is protected by a fire shutter plate. With this in mind and the opinion of our assessor, the gaps at the foot of the doors are considered low risk. However, should future upgrades take place, the gaps at the foot of the doors should be reduced to a tolerable level.

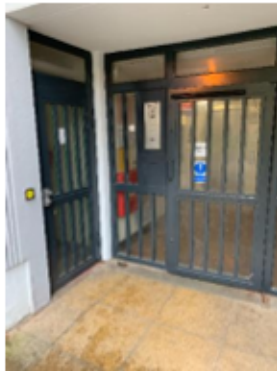
9.12-9.13 The 'main entrance' final exit from the lift lobby and the exit at the base of the staircase serving all floors discharge within 1.8m of each other and the surrounding glazing does not appear to be fire-resisting. Although this does not meet the requirements of current guidance, this has been accepted on the basis that robust control measures are in place to ensure these areas remain sterile at all times, therefore the probability of a fire beginning in either of these areas is negligible.

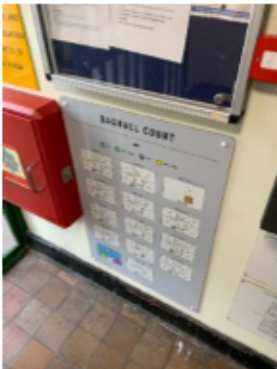
| Ref | FINDINGS |
|---|---|
| 10.14-10.16 | <p>A suitable alarm zone plan is provided adjacent to the alarm control panel in the entrance foyer. See appendix.</p> <div data-bbox="236 1606 513 1973"> </div> |

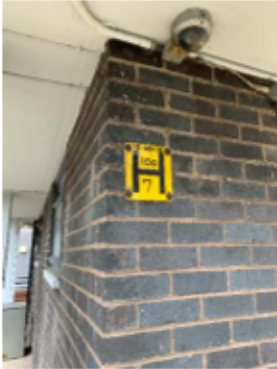
| Ref | COMMENTARY |
|---|---|
| 12.6 | Although not specific to the property, the assessor noted that there is a fire hydrant location around 6 metres away from the building. |

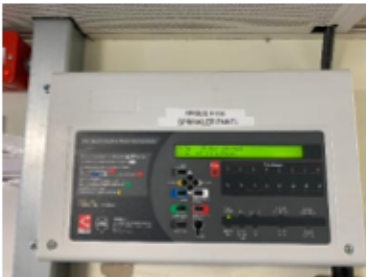
| Ref | COMMENTARY |
|---|---|
| 12.8-12.10 | A BS9251 sprinkler system has been installed. In each flat, there are concealed sprinkler heads located in the hallway, each bedroom, the living room, any enclosed balcony and the kitchen (essentially all rooms except the bathroom). In addition, there are also sprinkler heads located in the ground floor plant areas and the laundry. There are control valves on each floor located in a secure cupboard in each lift/flat lobby. A pump and water tank (Approximately 8000 litres) for the sprinkler system have been provided. The sprinkler panel is located by the fire alarm panel in the main entrance lift lobby and was displaying no faults at the time of the assessment. |

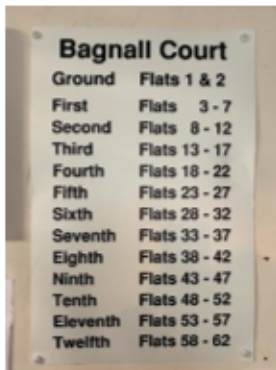
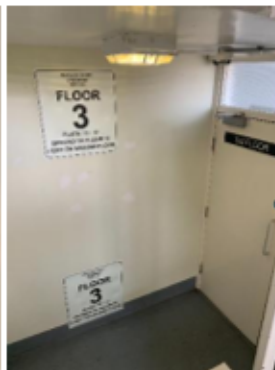
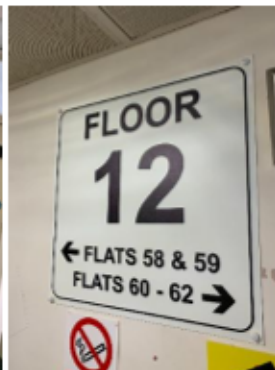
- 13.11 The premises is operating on a Stay Put policy, but if evacuation is necessary, an appropriate assembly point would initially be designated as outside the main car park.
- 13.12 'No Smoking' signage was observed on the premises, in the common areas.
- 13.15-13.16 Wayfinding signage that has the floor number and directional signage to the flats, including flat numbers, is displayed in the lift lobbies and on the stairway landings. They appear to be mounted at the recommended height as per ABD and are all visible and in good condition. Supplementary signage is also present, with signage outside the lift areas to show which flats are on each floor and which floors the two lifts access.

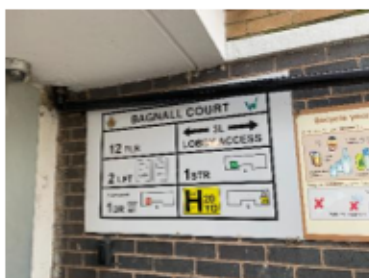
| Ref | FINDINGS |
|---|---|
| 14.11 | Signage indicating certain provisions of the building is displayed externally, which may be used to assist attending Fire and Rescue Service personnel. |
