# TOTAL FIRE GROUP LTD

## Fire Risk Assessment

1-58 Benchill Court  
Wythenshawe  
Manchester  
Greater Manchester  
M22 4GL

01 June 2026

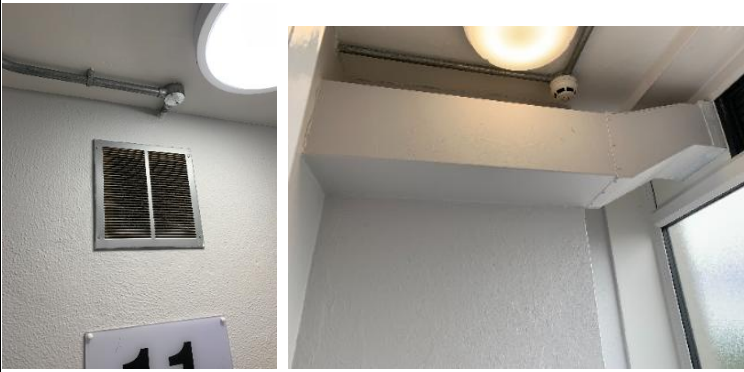
| Ref | COMMENTARY |
|---|---|
| 8.2 | <p>The below photographs show an example of the means of smoke ventilation in the stairway of the premises. The layout is the same on all floors from the first floor upwards. The vent on the stairs leads into the metal ducting which in turn vents direct to outside, passing through the refuse chute room on its way. The previous FRA confirmed that WCHG have engaged third parties to confirm that this method of smoke ventilation is adequate. Smoke modelling calculations have been provided by a fire engineer who concluded that provided new grilles were fitted and the ducting was cleaned that the existing provisions for smoke ventilation are satisfactory. Also previously advised is that in addition, the ducting has been inspected by another third party who confirmed that they were fit for purpose. Although not viewed on this assessment, it is understood that WCHG has documentary evidence available issued by the third parties.</p> <div data-bbox="236 443 983 813"> </div> |

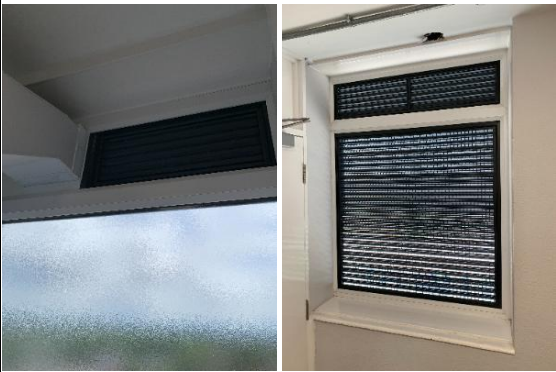
| Ref | COMMENTARY |
|---|---|
| 8.2 | <p>The corridor between the lobby serving flats and the staircase is provided with permanent ventilation, as is the refuse chute room.</p> <div data-bbox="236 891 794 1261"> </div> |

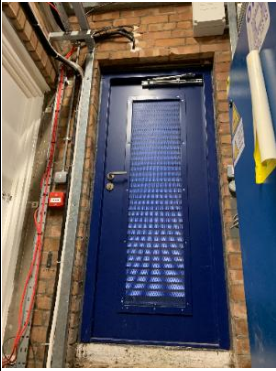
| Ref | COMMENTARY |
|---|---|
| 8.6 | <p>A louvred door provides a means of permanent ventilation to the lift motor room.</p> <div data-bbox="236 1317 512 1686"> </div> |

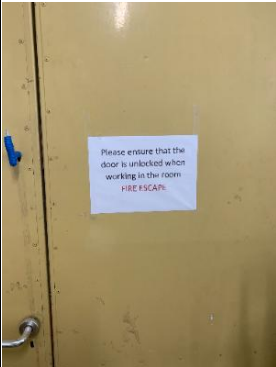
| 8.11 | <p>A previous assessment noted that the double doors from the plant room within the caretaker area were found key-locked shut. Although an alternative exit is available back through the building, this exit leads directly to open air and would be the preferred choice if evacuation were needed from this area.</p> <p><b>Note:</b> It was observed that there was now signage on the door that informed the occupant to unlock the doors when undertaking any work. This is deemed acceptable as the doors need to be secure (security risk).</p> |

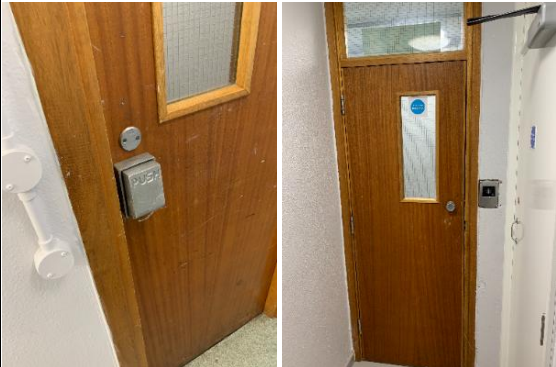
| 8.17 | <p>Electromechanically secured doors separate the staircase from the corridors serving flats and these require fob access in the direction towards the flats. In the direction of escape, a suitable push pad device is provided leading into the stairs.</p> |

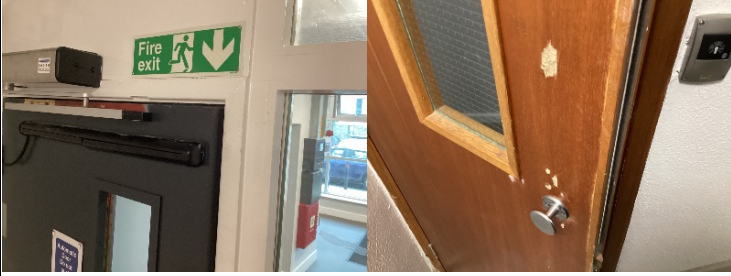
| 9.0 The Confinement of Fire: Finding(s) | |
|---|---|
| 9.1, 9.5, 9.8 | <p>There were deficiencies observed to communal doors at the time of the fire risk assessment:</p> <ul style="list-style-type: none"> <li>The door to the ground floor lobby area is not self closing fully and unaided, leaving a large gap to the top of the door.</li> <li>The door leading to the scooter/community room was not securing into its latch.</li> <li>There was slight surface damage observed to the staircase door on the 4th floor.</li> </ul> <p>Where fire doors do not self close fully or are damaged, this may allow for the spread of fire and products of combustion, placing persons at risk of harm.</p> |

| 9.0 The Confinement of Fire: Finding(s) | |
|---|---|
| 9.1, 9.5, 9.8 | It is recommended that the doors identified be repaired so that they are able to self-close fully and unaided into the frame. The damage to the door on the 4th floor staircase should be repaired. |

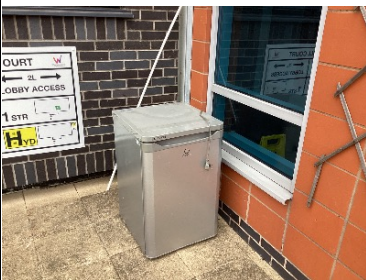
| 9.0 The Confinement of Fire: Finding(s) | |
|---|---|
| 9.16 | <p>There was a fridge stored outside against the side of the premises.</p> |

| 9.0 The Confinement of Fire: Finding(s) | |
|---|---|
| 9.16 | It is recommended that this item be removed. |

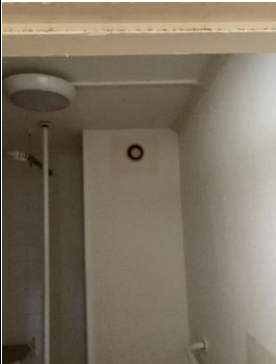
| 9.12 | <p>The previous FRA confirmed that WCHG has confirmed that Allied Protection Ltd has completed fire stopping and compartmentation works to prevent fire spread via the common bathroom and shower room extract shafts. They have also fitted fire-rated valves with an intumescent infill in the bathrooms which are connected to the ducting and shaft. Although these valves will not prevent smoke spread into the shaft in the early stages of a fire they are considered an acceptable method of preventing fire spread. Documentary and photographic evidence is available to evidence the works carried out by Allied Protection Ltd and are held by WCHG. These were not viewed during this assessment.</p> |

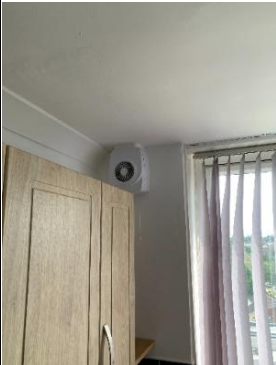
| 9.12 | <p>It was noted that the kitchen ventilation in the flats seen is extracted directly to the outside, via a powered fan, which was not common to any other flats. It is assumed that all the flats in the block have similar provisions installed.</p> |

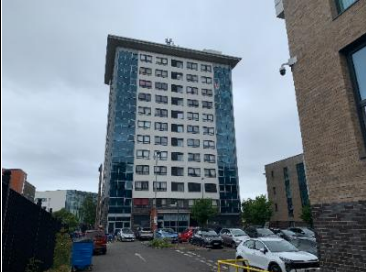
| 9.28-9.29 | <p><b>The previous FRA confirmed the below in relation to the external cladding system on the building. No changes have been advised:</b></p> <p>A product sheet certificate has been provided to our assessor for the external wall insulations (EWI) system fitted to the building. This is a TERMOK8 external wall insulating render system comprising mechanically fixed mineral wool dual density or mineral wool lamella insulation slabs, with supplementary adhesive, reinforced basecoat and either render or brick slip finishes. The product certification states a reaction to fire classification of A2-s1, d0 in accordance with EN 13501-1, which exceeds the minimum requirements for a building with a storey above 18m as detailed in Section 10.6 of Approved Document B Volume 1 (this minimum requirement is A2-s3, d2).</p> <p>In addition to the provision of this product sheet, WCHG provided our assessor with an external façade report for the building, carried out by 'High Rise Fire Safety' in 02/2018. This certification states on page 5 of the report that 'The cladding affixed to the external façade of the premises is made up of layers of materials that individually, and collectively, have limited or non-combustible fire ratings as defined in Appendix A (A6 &amp; A7) of Approved Document B of the Building Regulations'. The report then goes on to confirm that the cladding will not contribute to fire spread on the building.</p> <p>Previous fire risk assessments have confirmed that the enclosed balconies have curtain wall glazing which is aluminium framed with clear and opaque glazing throughout.</p> |

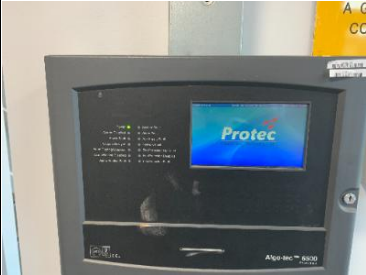
| Ref | COMMENTARY |
|---|---|
| 10.1, 10.4-10.6 | <p>The common area fire alarm and detection system incorporated smoke detection throughout commonly used areas (except the biomass boiler room - see another commentary 10.1, 10.4-10.6) and heat detection in the hallways of each resident flat. The fire alarm panel for the system is located at the ground floor level in the staircase enclosure. It was previously confirmed that the system is addressable. This may be confirmed within the installation and commissioning certificate issued at the time of installation. Further detail regarding the fire alarm system and its purpose within the building is provided in commentary 12.14.</p> |

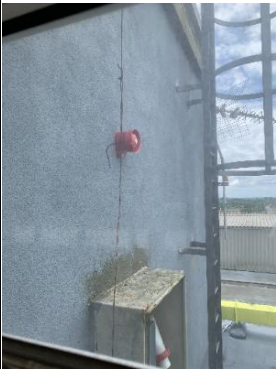
| Ref | COMMENTARY |
|---|---|
| 10.12 | <p><b>Extract from the previous fire risk assessment:</b> The previous FRA action has been signed off as complete on 16/09/2022 by Mike Holt. Although access was not gained to the roof on this assessment, the roof area was observed from the observation area with which a sounder was seen. Red cabling could also be seen penetrating the lift motor room walls to the roof area in this block indicating the fire alarm system extends to this area. Due to the action being signed off as complete, it is reasonable to assume that the sounder has been confirmed as audible as previously recommended.</p> |

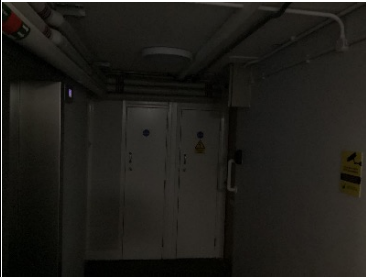
| Ref | FINDINGS |
|---|---|
| 11.7 | <p>It was observed that the lighting outside of flat 57/58 was not working at the time of the fire risk assessment. Where normal lighting is not working, residents may find it difficult to navigate the escape routes in the event of an evacuation, placing persons at risk of harm.</p> |

| Ref | FINDINGS |
|---|---|
| 11.7 | It is recommended that the lighting unit be repaired. |

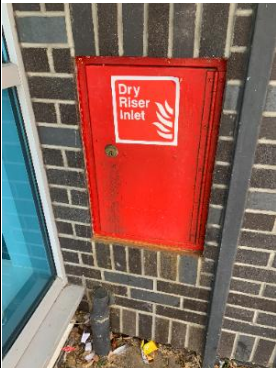
| Ref | COMMENTARY |
|---|---|
| 12.6 | <p>The dry riser inlet is located on the building's external façade.</p> |

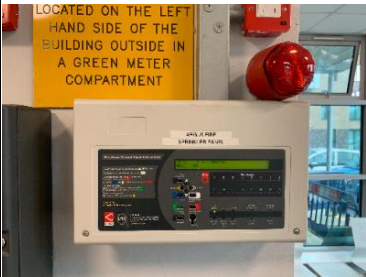
| Ref | COMMENTARY |
|---|---|
| 12.8 | <p><b>As noted on the previous FRA:</b></p> <p>A BS9251 sprinkler system has been installed. In each flat, there are concealed sprinkler heads located in the hallway, each bedroom, the lounge, and the kitchen. In addition, there are also sprinkler heads located in some ground floor plant and community areas. There are control valves for each floor in riser cupboards that adjoin the lift lobbies. A pump and water tank for the sprinkler system have been provided in the sprinkler tank room which is within the old caretaker's area. A sprinkler panel and plan are provided by the fire alarm panel in the staircase enclosure at the ground floor level. The previous FRA confirmed that the system is maintained and serviced by an approved contractor on a quarterly basis and contractors also attend weekly to visually check the sprinkler system.</p> |

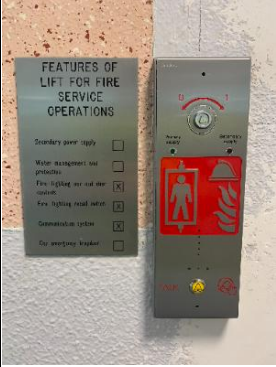
| 12.11-12.13 | <p>The previous fire risk assessment noted that the original 'Firemen's Switch' function for exclusive use by firefighters in an emergency was not confirmed. This action has been completed. The new lift has had the following alterations;</p> <ul style="list-style-type: none"> <li>• Fire-fighting car and door controls.</li> <li>• Fire-fighting recall switch.</li> <li>• Communication system.</li> </ul> <p>The function of the lift is noted on a metal plaque on the ground floor. WCHG have confirmed that the lifts will continue to be tested monthly. WCHG have confirmed that all information required and all keys will be provided to the Fire Service and will continue to be held in the SIB.</p> |

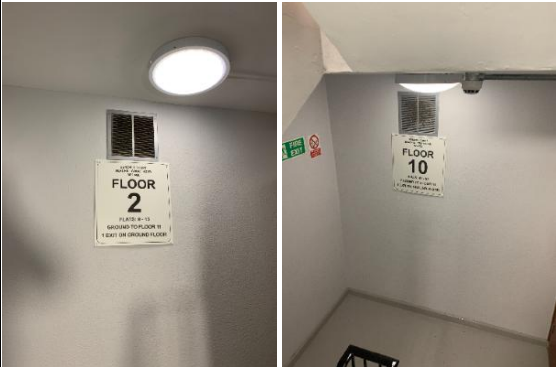
| 13.0 Fire Safety Signs and Notices: Finding(s) | |
|---|---|
| 13.15-13.16 | <p>Wayfinding signage that has the floor number and directional signage to the flats, including flat numbers, is displayed in the lift lobbies and on the stairway landings. They appear to be mounted at the recommended height as per ABD and are all visible and in good condition.</p> <p>Supplementary signage is also present, with signage outside the lift areas to show which flats are on each floor and which floors the two lifts access.</p> <p><b>Note:</b> Signage was not fully checked against the current guidance e.g. correct text sizes and font, but it is reasonable to assume the newer signage meets the requirements within the guidance.</p> |

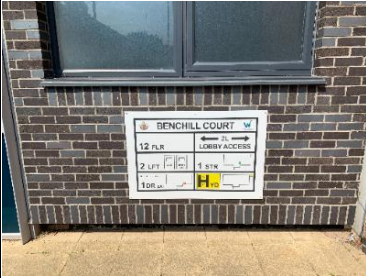
| Ref | FINDINGS |
|---|---|
| 14.12 | <p>A building information board showing key building facilities is present by the main entrance. This shows:</p> <ul style="list-style-type: none"> <li>• Number of floors.</li> <li>• Stating the 'lobby access' nature of the building.</li> <li>• Number of lifts.</li> <li>• Number of stairs.</li> <li>• Number of dry risers.</li> <li>• Location of nearest fire hydrant.</li> </ul> |
