## Fire Risk Assessment

Brookway Court  
Bideford Drive  
Wythenshawe  
Manchester  
M23 0GL

18 May 2026

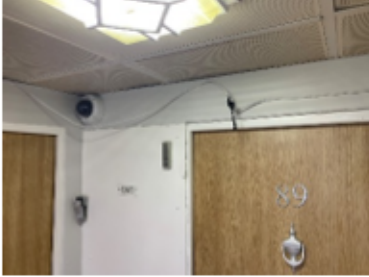
| Ref | FINDINGS |
|---|---|
| 6.14 | It was observed that there was a single cable hanging from the ceiling above the flat entrance door of flat 88. |

| Ref | FINDINGS |
|---|---|
| 6.14 | It is recommended that the cable be secured with appropriate fixtures. |

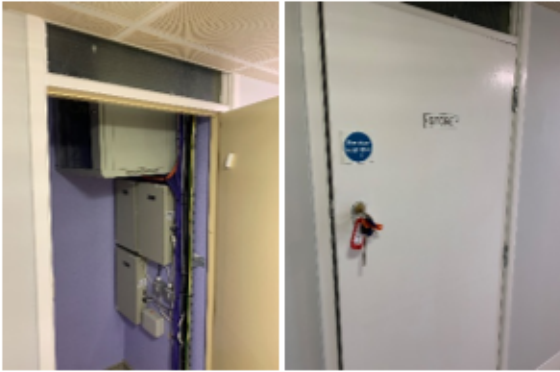
| Ref | FINDINGS |
|---|---|
| 6.16 | It was observed that some store cupboards have server boxes within and there is no electrical hazard signage on the doors. |

| Ref | FINDINGS |
|---|---|
| 6.16 | It is recommended that electrical hazard signage be fitted to these doors that house electrical equipment. |

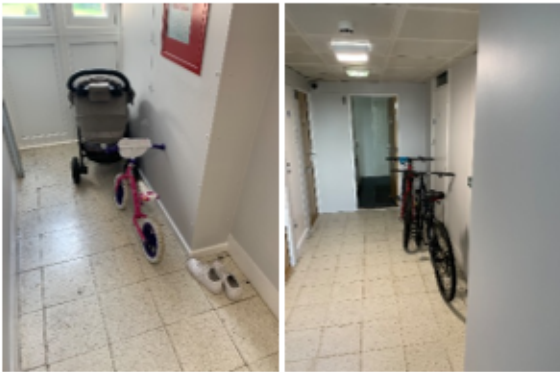
| Ref | FINDINGS |
|---|---|
| 8.7 | There were items outside flats 8 and 39. Where there are breaches of WCHG policy, this may encourage additional storage, introducing slip/trip hazards and placing persons at risk of harm. |

| Ref | FINDINGS |
|---|---|
| 8.7 | WCHG should arrange for the identified storage to be removed in line with their policy for items in the communal areas. |

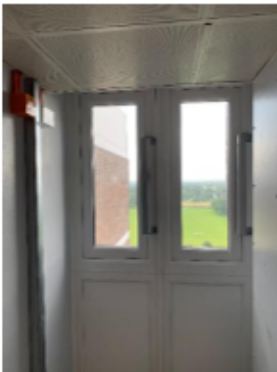
| Ref | COMMENTARY |
|---|---|
| 8.2 | Automatic openable vents are provided in the lobbies serving flats on each floor level. This AOV system vent will open automatically on the actuation of the smoke detector in the lobby. As part of WCHG's standard responses, they have confirmed that AOV systems are subjected to regular servicing and testing. |

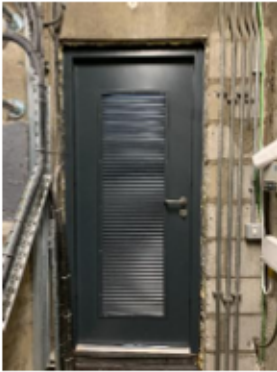
| Ref | COMMENTARY |
|---|---|
| 8.2, 8.6 | A door onto the roof of the building provides a means of permanent ventilation from the lift motor room. There are also some manually openable windows in the room. |

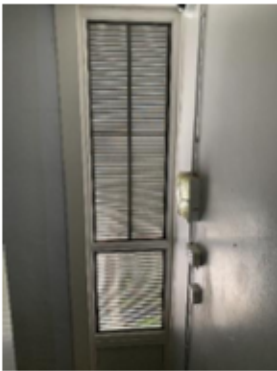
| Ref | COMMENTARY |
|---|---|
| 8.2, 8.6 | Permanent ventilation is provided at the absolute head of the staircase on the sixteenth floor. The previous FRA noted that the staircase was originally lobbied on the fifteenth floor before the AOV system was installed and that the door providing the lobby on the fifteenth floor has now been removed in line with recommendations and has been signed off by Building Control. It is the opinion of the assessor that this is acceptable. There is permanent ventilation to the staircase and automatic opening ventilation to both flat lobbies on each floor level. |

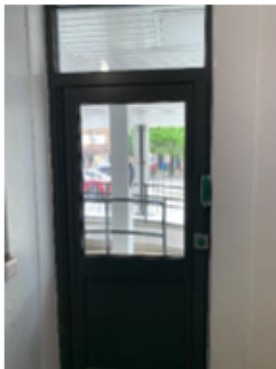
- 8.18-8.19 As part of WCHG's standard responses, they have confirmed that due to most FRAs raising a finding, WCHG had engaged with Tech Sol and confirmed that doors fail safe/open upon a fire alarm activation or loss of electricity, and that break glass points are installed as a back up should the push to exit button fail.
- 8.18-8.19 The exit from the staircase is provided with a push-to-exit button and also an emergency override.

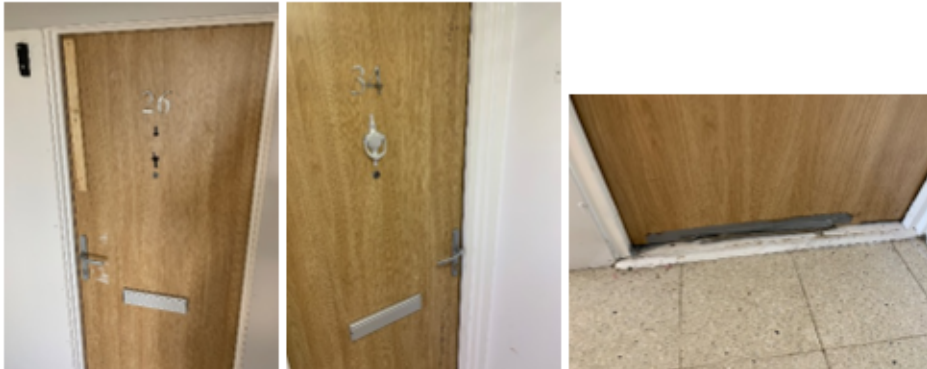
9.1, 9.5-9.6 It was observed that there were deficiencies to flat entrance doors at the time of the fire risk assessment:

- Damage was observed to the entrance door of flat 26.
- Damage was observed to the entrance door of flat 34.
- Damage was observed to the entrance door of flat 81.
- There is duct tape on the entrance door to flat 85 that may suggest that there is damage to the door.

Where there is damage to flat entrance doors they may not perform as expected in the event of a fire, placing persons at risk of harm.

9.1, 9.5-9.6 It is recommended that the doors identified be repaired/replaced with suitable FD30s doors.

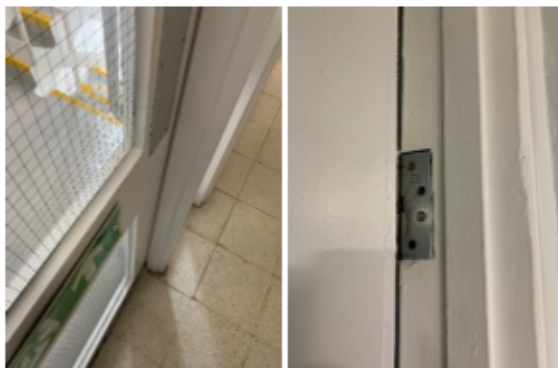
9.5 It was observed that the fire door to the staircase on the 5th floor is unable to self-close fully and unaided into the doorframe, the lobby door to the door leading to flat 27 was missing two screws in its top hinge. Where fire doors cannot self close or are missing components, they may allow for the spread of fire or not provide the required level of fire resistance, placing persons at risk of harm.

- 9.5 The door on the 5th floor leading to the staircase should be adjusted so that it can self-close fully and unaided into the doorframe. Suitable screws should be installed to the top hinge.

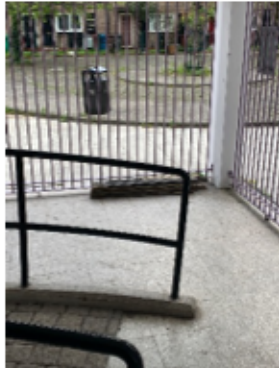
- 9.17 It was observed that there was a stack of timber stored by the front entrance.

- 9.17 It is recommended that this stack of timber be removed from this area.

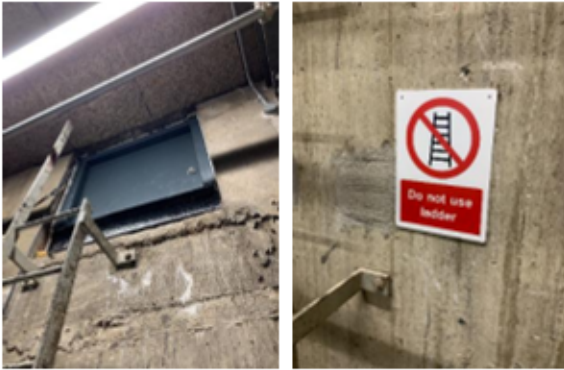
| Ref | COMMENTARY |
|---|---|
| 9.1 | <p>No access was gained into the high-level door within the lift motor room for safety reasons. However, the door appears to open into an area located adjacent to/above the staircase and potentially onto the roof area. No breaches were observed from within the staircase. The area is considered to be low-risk, as the door appears to be robust, sealed, and kept in a closed position to adequately separate the lift motor room from this area.</p> |

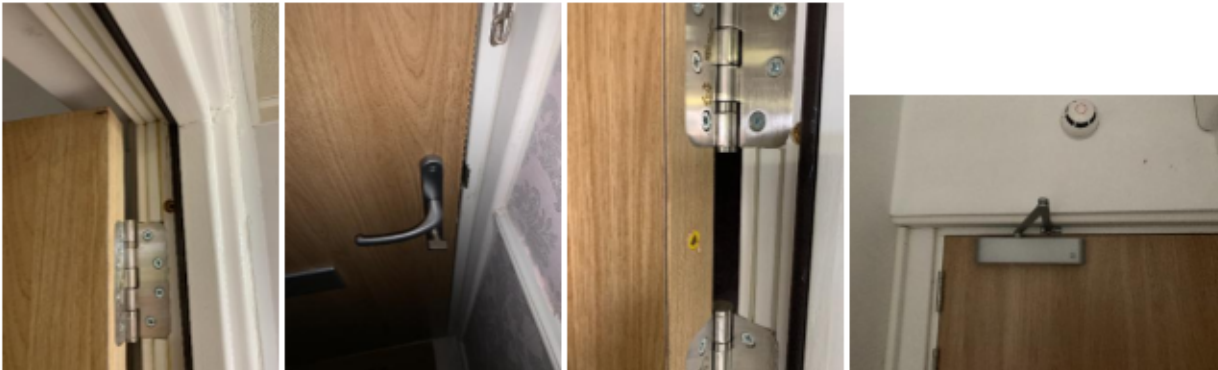
| Ref | COMMENTARY |
|---|---|
| 9.1, 9.5-9.6 | <p>From the sample of flat entrance doors accessed on this assessment, the doors were observed to be FD30s and fitted with combined intumescent fire and cold smoke seals, and self-closing devices. The doors had spring-loaded metal letterboxes fitted approximately midway down their length. The lounge doors within the flats appeared to be robust timber doors.</p> |

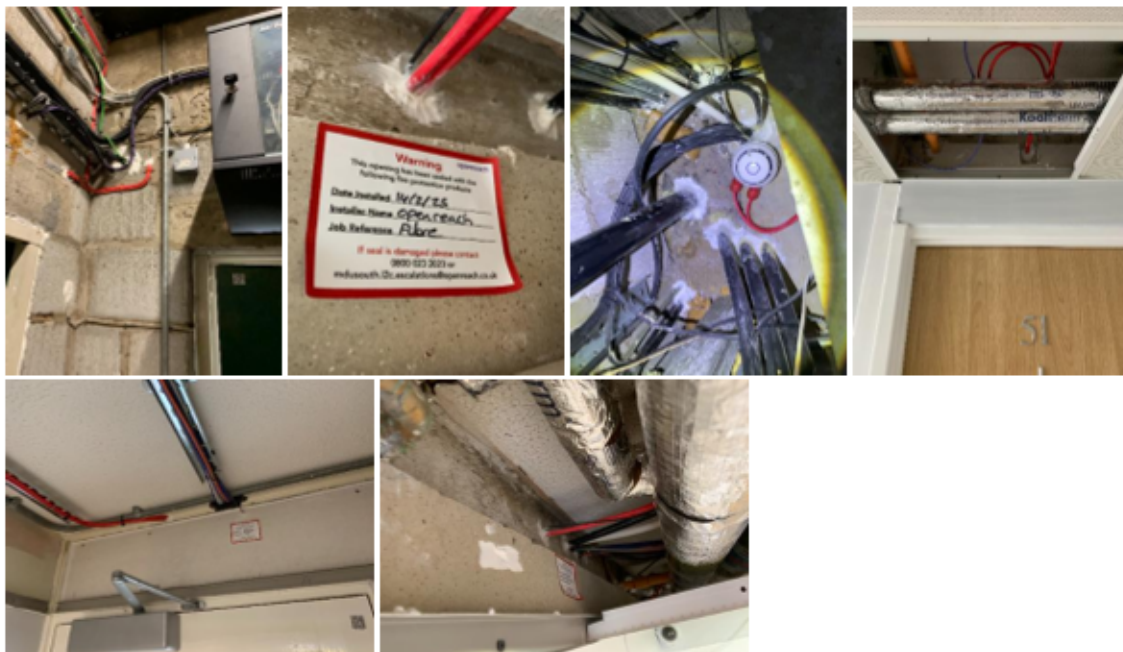
At the time of the fire risk assessment it was observed that fire stopping works had been carried out. From a sample of areas, and from sticker observed, the fire stopping was completed in February 2025. WCHG have also confirmed that this work has been completed by HG Maintenance and the due-to-be-completed dates and completion dates on Aurora are in line with the dates on the stickers adjacent to the fire stopping. Below are examples of fire stopping observed throughout the premises.

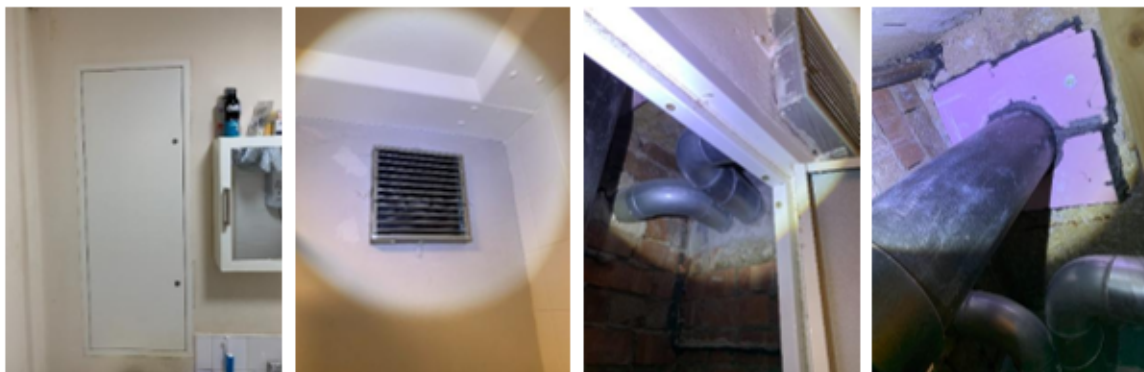
Two of the riser shafts within the flat bathrooms were accessed during the previous fire risk assessment, to find them adequately fire-stopped from within and vents connected to the ductwork as noted above. It is reasonable to assume the same in other flats. The vent ducting leads into a shaft shared with the soil stacks and appears to run into an adjacent enclosed shaft to which no access was gained.

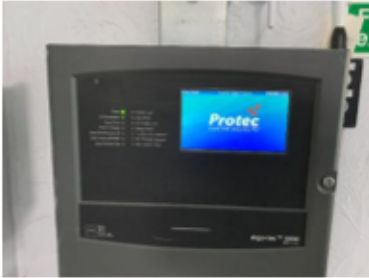
| Ref | COMMENTARY |
|---|---|
| 10.1-10.6, 10.8, 10.10 | <p>A common BS5839-1 fire alarm system is installed which incorporates the provision of automatic detection which appears to be to an L2 standard. The system also extends into flats in the form of a heat detector in flat entrance hallways. It is understood that the fire alarm system has been configured to be silent (in the main) and is monitored. It is also understood that the system has also been configured to act as a form of Evacuation Alert System (EAS), whereby it can be used by the Fire and Rescue Service to sound on a chosen floor and the floors above and below the chosen floor. WCHG had previously confirmed that the common fire alarm is audible in service/plant areas and on the roof, where contractors may be present and where immediate evacuation would be considered prudent.</p> |

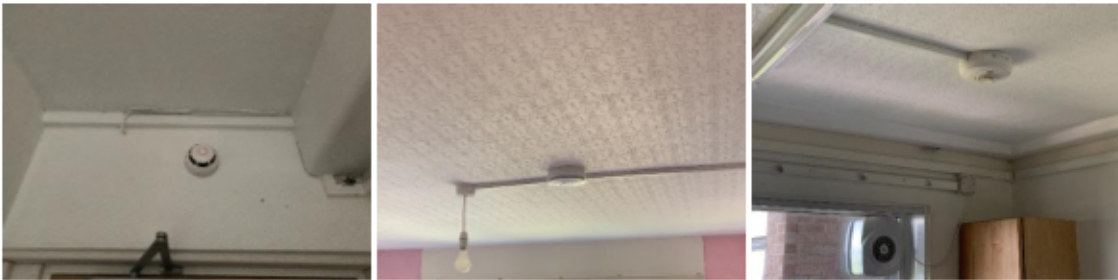
| Ref | COMMENTARY |
|---|---|
| 10.2-10.3 | <p>Adjudging by the provisions within those flats sampled at the time of the assessment, BS5839-6 Grade D LD1 fire alarm systems are installed in all rooms except bathrooms and cupboards, along with heat detection to the communal system in the flat hallways.</p> <p>As part of WCHG's standard responses, all alarms within flats are checked and the findings are recorded as part of the annual gas servicing.</p> <p>Due to the above process and physically seeing detection in flats accessed, it is reasonable to assume that this is representative of the remainder of the flats.</p> |

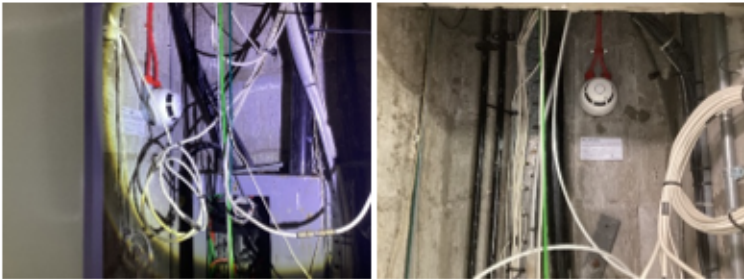
| Ref | COMMENTARY |
|---|---|
| 10.7 | <p>The BS5839-1 common heat detectors extending into riser cupboards are fitted horizontally to the walls. It should be noted that the minimum distance away from any walls or fixings should be 300mm.</p> |

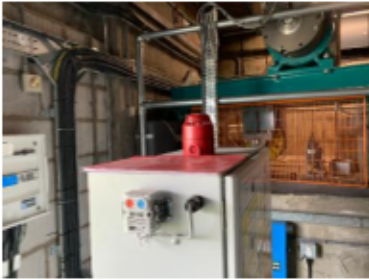
| Ref | COMMENTARY |
|---|---|
| 10.10 | <p><b>As confirmed on the previous FRA-</b> Only fire alarm sounders installed in the maintenance areas of the building including the roof are clearly audible and alert maintenance staff of the activation of the fire alarm system.</p> |

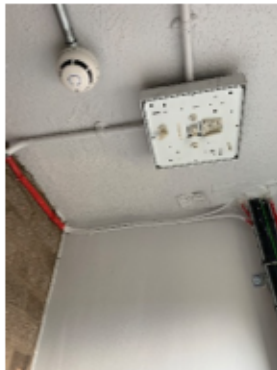
11.7 It was observed that the lighting unit within the 6th-floor bin room was not working at the time of the assessment.

11.7 The lighting unit should be repaired.

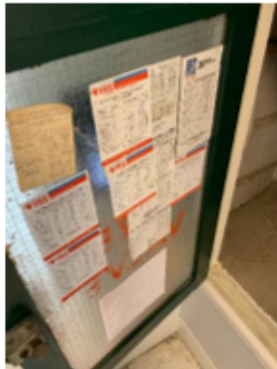
| Ref | COMMENTARY |
|---|---|
| 12.6-12.8, 12.10 | A dry-rising main is installed for use by the Fire and Rescue Service. The dry-rising main outlets are located in the lobbies on each floor that contain the lifts and are behind locked doors. The inlet is located adjacent to the main entrance, on the external facade. The dry rising main is visually inspected monthly and is also serviced annually as noted on the labels affixed to the inside of the riser outlet doors which indicated that the date of the last pressure test service was 04/2025. A visual check is also carried out. |

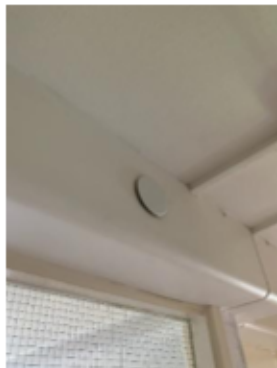
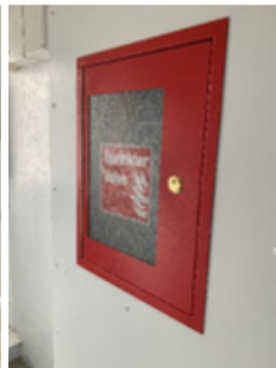
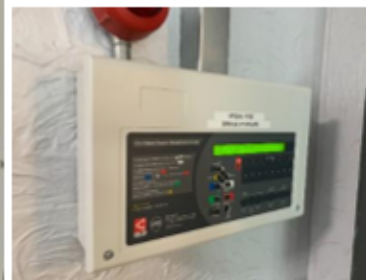
| 12.8-12.10 | A BS9251 fully functioning sprinkler system has been installed in each flat with concealed sprinkler heads located in the hallway, each bedroom, the lounge, the enclosed balcony and the kitchen. In addition, there are also sprinkler heads located in the ground floor entrance lobby, the laundry and parts of the old caretaker's area. There are control valves located in a secure cupboard on each landing. Water tanks are provided on the top floor, near to the lift motor room, and an additional tank with a pump system is located on the ground floor near the meter room. The sprinkler panel is located by the fire alarm panel in the main entrance lift lobby and was showing healthy at the time of the assessment. |

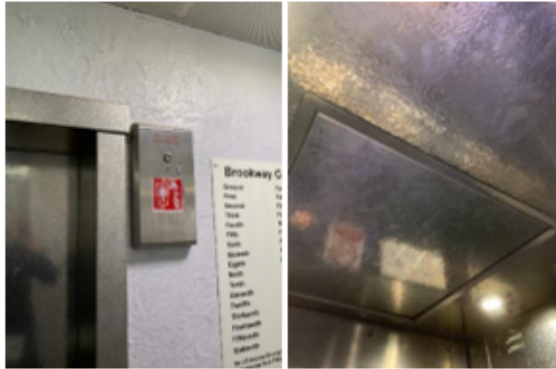
- 12.11-12.13 One of the lifts on the premises appears to be a standard passenger lift, whereas the other appears to be a firefighting lift. The firefighting lift has a switch to return the lift to the ground floor level and also an intercom for communications. Within the lift was a hatch in the ceiling. It is understood that the lift defaults to the ground floor on activation of the common fire alarm system and that the switch to manually return the lift to the ground floor is tested monthly in line with the Fire Safety (England) Regulations 2022. Records to evidence such testing are held centrally by WCHG and not viewed. It was previously communicated for another block that all keys required for the operation of the lifts have been provided to the Fire and Rescue Service and are also held in the SIB. It is understood that the firefighting lift can continue to be used by firefighters without having to reset the alarm if it sounds audible.

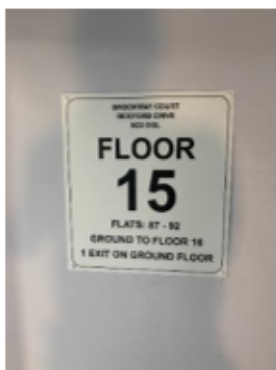
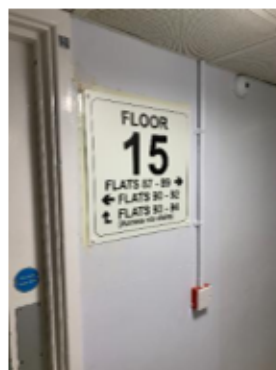
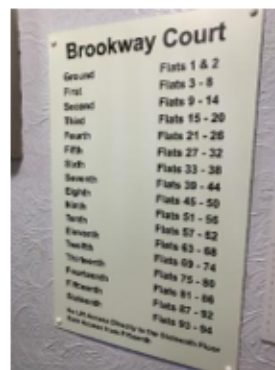
| Ref | FINDINGS |
|---|---|
| 13.15-13.16 | Wayfinding signage that has the floor number and directional signage to the flats, including flat numbers, is displayed in the lift lobbies and on the stairway landings. They appear to be mounted at the recommended height as per ABD and are all visible and in good condition.<br>Supplementary signage is also present, with signage outside the lift areas to show which flats are on each floor and which floors the two lifts access. |

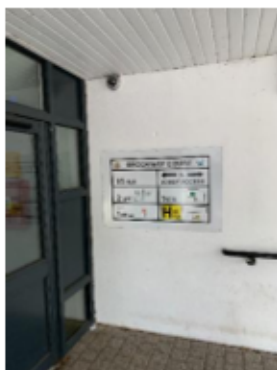
| Ref | FINDINGS |
|---|---|
| 14.11 | Signage indicating certain provisions of the building is displayed externally, which may be used to assist attending Fire and Rescue Service personnel. |
