TOTAL FIRE GROUP LTD

Fire Risk Assessment

Brookway Court
Bideford Drive
Wythenshawe
Manchester
M23 0GL

19 May 2025

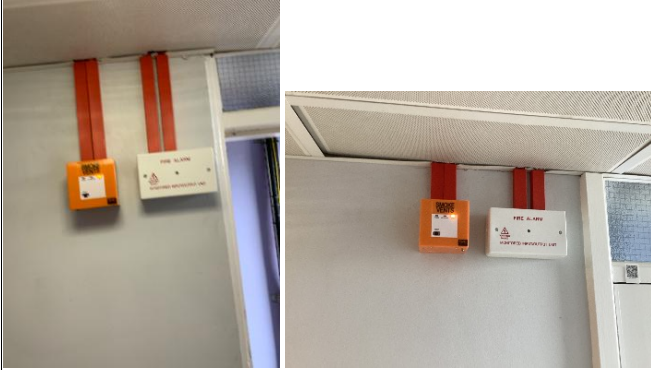
Ref	FINDINGS
	Observation
8.2	<p>It was observed at the time of the fire risk assessment that there were faults to the AOV override buttons on the majority of floors. (2 overrides per floor). Where there are faults on the AOV system, the overrides may not operate as expected in the event that they are needed, placing persons at risk of harm.</p>

Recommended Actions
8.2	The AOV overrides should be inspected by a competent engineer to determine, fix and remove the fault.
Ref	RECOMMENDATIONS
	None.

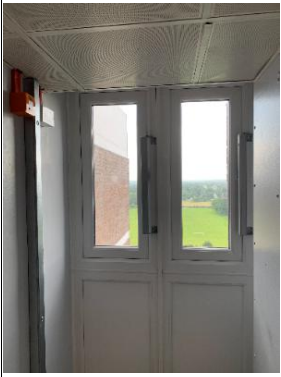
Ref	COMMENTARY
8.2	<p>Automatic openable vents are provided in the lobbies serving flats on each floor level. This AOV system vent will open automatically on the actuation of the smoke detector in the lobby. As part of WCHG's standard responses, they have confirmed that AOV systems are subjected to regular servicing and testing.</p>

8.2	<p>Article 17 of the Regulatory Reform (Fire Safety) Order 2005 requires the responsible person to provide a suitable system of maintenance for any facilities, equipment and devices so that they are maintained in good working order.</p>

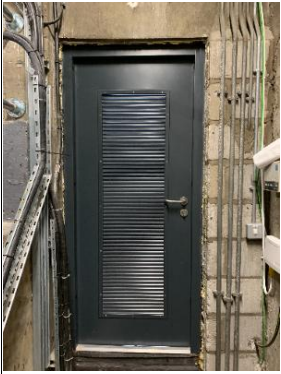
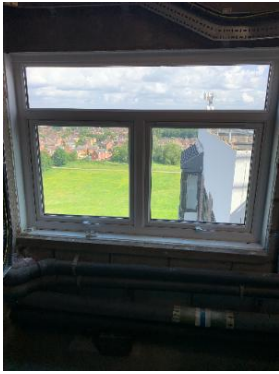
8.2, 8.6	<p>A door onto the roof of the building provides a means of permanent ventilation from the lift motor room. There are also some manually openable windows in the room.</p>

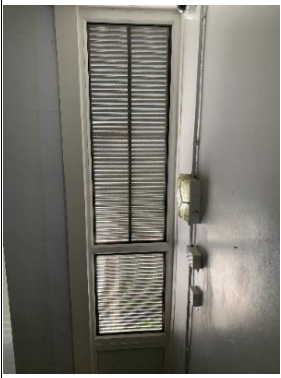
8.2, 8.6	<p>Permanent ventilation is provided at the absolute head of the staircase on the sixteenth floor. The previous FRA noted that the staircase was originally lobbied on the fifteenth floor before the AOV system was installed and that the door providing the lobby on the fifteenth floor has now been removed in line with recommendations and has been signed off by Building Control. It is the opinion of the assessor that this is acceptable. There is now permanent ventilation to the staircase and automatic opening ventilation to both flat lobbies on each floor level.</p>

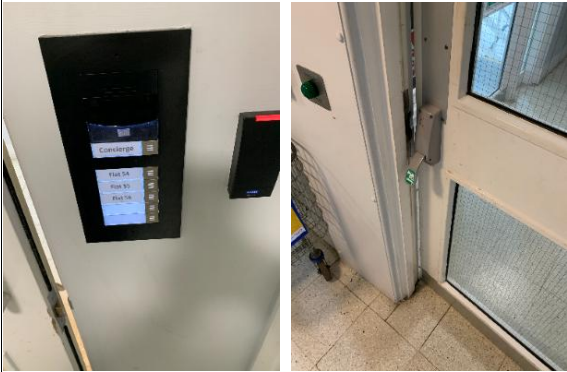
8.17-8.19	<p>At each floor level, access from the lift lobbies into the lobbies serving flats is via electromechanically secured doors. On the escape side (back into the lift lobbies) these doors are overridden via the use of push pads (push to exit buttons are also present with appropriate overrides).</p> <div data-bbox="236 286 805 656">

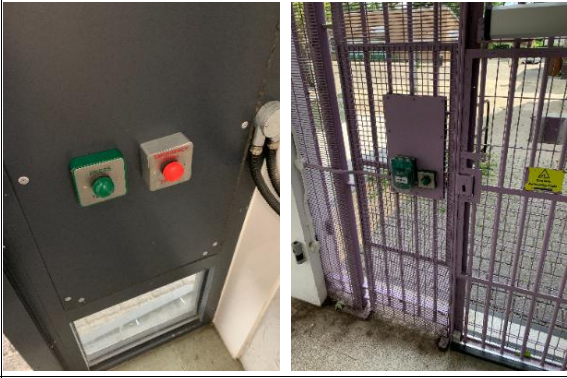
8.18-8.19	<p>Where electromagnetically secured doors are installed within the premises (e.g. final exits, external exit from the forecourt, laundry), these were observed to be accompanied by suitable green box emergency overrides.</p> <div data-bbox="236 739 805 1115">

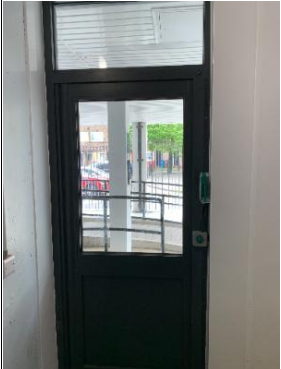
8.18-8.19	<p>The previous fire risk assessment raised an action that the final exit at the foot of the staircase is fitted with an electro-magnetic lock. To exit the premises a push button is located adjacent to the door but no emergency override is provided. At the time of the fire risk assessment it was observed that this action had been completed.</p> <div data-bbox="236 1299 517 1666">

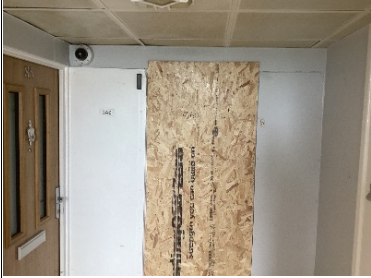
Ref	FINDINGS
	<p>Observation</p> <p>9.5 It was observed at the time of the fire risk assessment that the entrance door to flat 86 had been covered with a sheet of wood. Where there are potentially damaged fire doors, they may not perform as expected in the event of a fire, placing persons at risk of harm.</p> <p>Note: The risk rating has been reduced from substantial as it is assumed that the flat is currently void.</p>

<p>Recommended Actions</p> <p>9.5 It is recommended that the sheet of wood be replaced and the fire door be repaired/replaced. Prior to the flat being occupied.</p>
	<p>Observation</p> <p>9.5-9.6 There were deficiencies to communal doors observed at the time of the fire risk assessment;</p> <ul style="list-style-type: none"> • The riser on the 15th floor had a damaged smoke seal on the latch side and top of the door. • The riser on the 14th floor had a damaged smoke seal on the latch side of the door. • The lift lobby door leading to flats 87/88/89 was missing a smoke seal on the hinge side. • The door to the server room on the ground floor was not closing fully and unaided into its rebate. • A door within the caretakers area on the ground floor was wedged open. • The risers next to flats 42/45/75 could not be locked. • There is damage to the base of the doorframe of the riser door next to flat 42. <p>Where fire doors are missing seals, not self-closing fully into rebates, wedged open or damaged, they may not provide the expected level of fire resistance in the event of a fire, placing persons at risk of harm.</p>

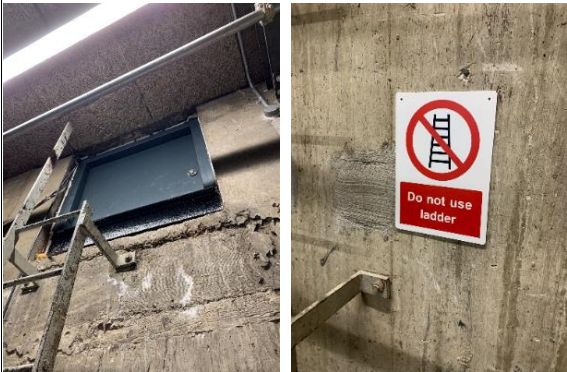
Ref	COMMENTARY
9.1	<p>No access was gained into the high-level door within the lift motor room for safety reasons. However, the door appears to open into an area located adjacent to/above the staircase and potentially onto the roof area. No breaches were observed from within the staircase. The area is considered to be low-risk, as the door appears to be robust, sealed, and kept in a closed position to adequately separate the lift motor room from this area.</p> <div data-bbox="236 342 805 712">

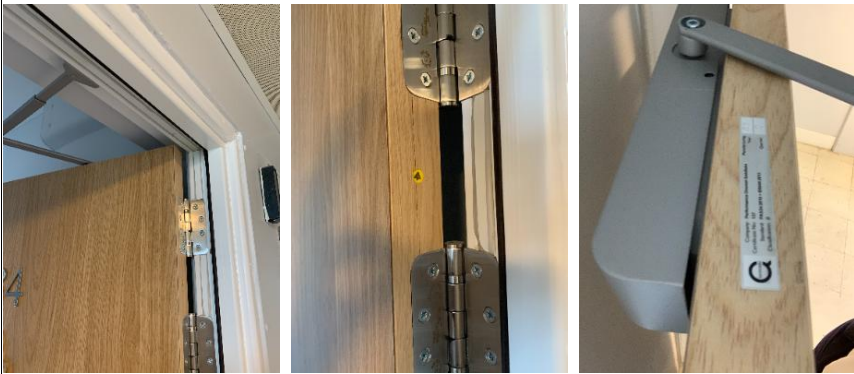
9.1-9.2	<p>There is no roof void compartmentation to consider as the building has a flat roof as seen via Google Maps, and as advised.</p>
9.1, 9.5-9.6	<p>From the sample of flat entrance doors accessed on this assessment, the doors were observed to be FD30s and fitted with combined intumescent fire and cold smoke seals, and self-closing devices. The doors had spring-loaded metal letterboxes fitted approximately midway down their length. The lounge doors within the flats appeared to be robust timber doors.</p> <div data-bbox="236 929 1094 1301">

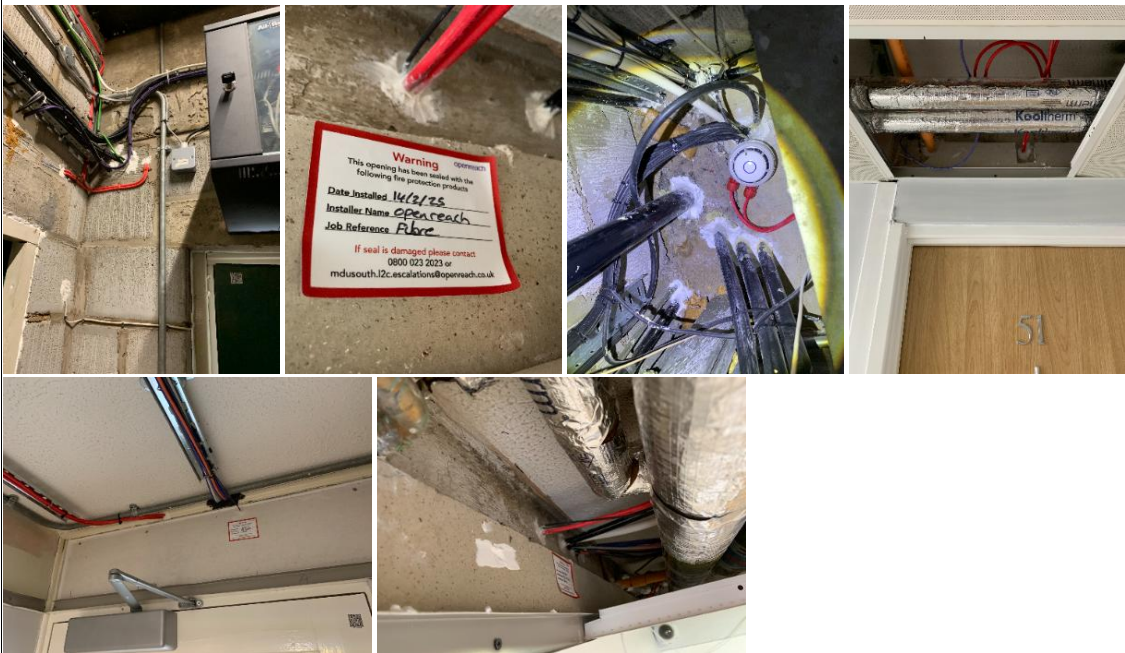
9.8	<p>The previous fire risk assessment noted that there were a number of penetrations in the compartmentation that did not appear to be adequately protected to maintain the fire resistance of the compartment floors/walls. Inadequate fire stopping include:</p> <ul style="list-style-type: none"> Red cabling is not sealed within the riser cupboard to flats 87-89. Cable penetrations not sealed above the 'lift 2' area on the 15th floor above the false ceiling to the floor slab to the 16th floor. The riser cupboard on the 15th floor was not sealed around the door frame. Opposite flats 87-89. The cable penetration in the tank room on the top floor to the communal area is not sealed. Cable penetrations in the 12th-floor riser cupboard leading to flats. The area above flat 35 had damaged block work that may need sealing. The area above the 3rd-floor flats had damaged block work that may need sealing. Cable penetrations are not sealed above the false ceiling above flat 32. The 4th-floor boxed-in section is not sealed near the sprinkler valve cupboard above the false ceiling. Pipe penetrations were not adequately sealed above the void space on the ground floor to the floor slab above. Previously raised and outstanding - Small gaps appeared to be present at the top of the service riser cupboards by flats 93/94 (sixteenth). <p>At the time of the fire risk assessment it was observed that fire stopping works had been carried out. From a sample of areas, and from sticker observed, the fire stopping was completed in February 2025. WCHG have also confirmed that this work has been completed by HG Maintenance and the due-to-be-completed dates and completion dates on Aurora are in line with the dates on the stickers adjacent to the fire stopping. Below are examples of fire stopping observed throughout the premises.</p> <div data-bbox="236 1357 1366 2007">

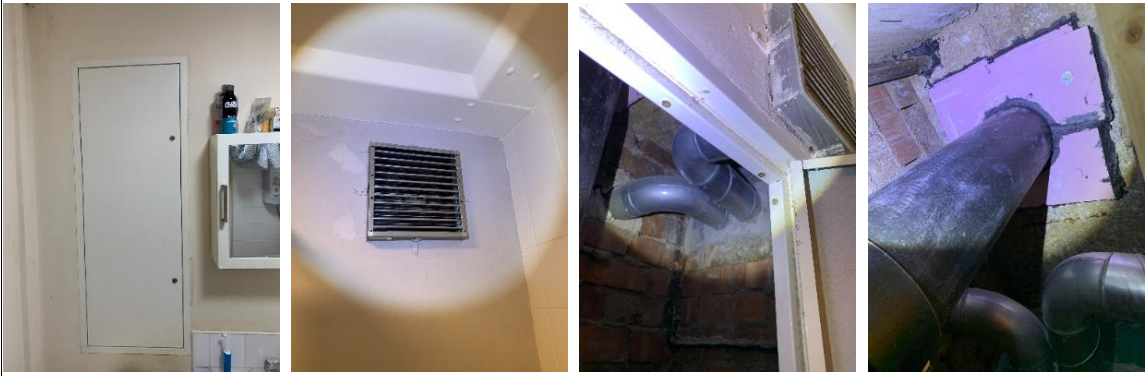
9.11	<p>Retained for historical information: WCHG have previously confirmed that Allied Protection Ltd has completed fire-stopping and compartmentation works to prevent fire spread via the common bathroom extract shafts. They have also fitted fire-rated valves with an intumescent infill in the bathrooms which are connected to the ducting and shaft. Although these valves will not prevent initial smoke spread into the shaft they are an acceptable method of preventing fire spread in bathrooms. Documentary and photographic evidence is available and is held by WCHG.</p> <p>Two of the riser shafts within the flat bathrooms were accessed during the previous fire risk assessment, to find them adequately fire-stopped from within and vents connected to the ductwork as noted above. It is reasonable to assume the same in other flats. The vent ducting leads into a shaft shared with the soil stacks and appears to run into an adjacent enclosed shaft to which no access was gained.</p> <div data-bbox="236 1368 1386 1742">

<p>The block contains four photographs. The first shows a white door in a bathroom. The second shows a square ceiling vent with horizontal slats. The third shows a close-up of a grey duct pipe with a fire-rated valve. The fourth shows a close-up of a grey duct pipe with a fire-rated valve.</p> </div>

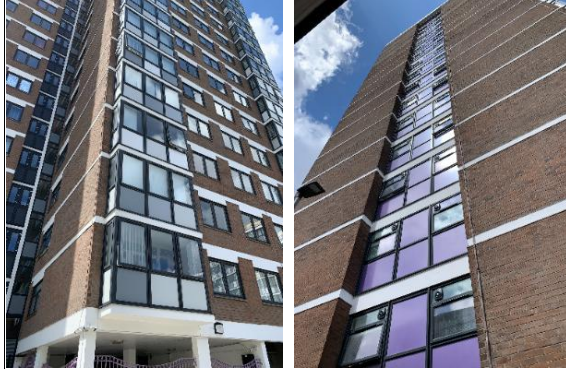
The window spandrel panels on the outside of the building have been replaced with 'Proteus SP' material produced by 'Proteus Facades'. This is a polyester powder-coated steel/ceramic powder-coated aluminium/glass-faced spandrel panel with a Rockwool insulated core structurally bonded to a lightweight metal rear skin to be used within a curtain wall system. Warrington Fire Testing and Certification Limited have classified the material in relation to their reaction to fire behaviour as A2, S1, d0.

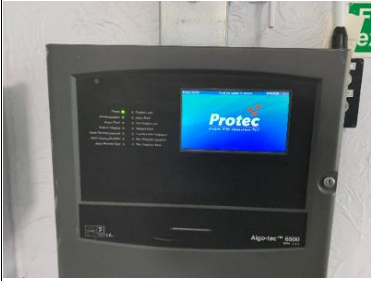
Ref	COMMENTARY
10.1-10.6, 10.8, 10.10	<p>A common BS5839-1 fire alarm system is installed which incorporates the provision of automatic detection which appears to be to an L2 standard. The system also extends into flats in the form of a heat detector in flat entrance hallways. It is understood that the fire alarm system has been configured to be silent (in the main) and is monitored. It is also understood that the system has also been configured to act as a form of Evacuation Alert System (EAS), whereby it can be used by the Fire and Rescue Service to sound on a chosen floor and the floors above and below the chosen floor. WCHG had previously confirmed that the common fire alarm is audible in service/plant areas and on the roof, where contractors may be present and where immediate evacuation would be considered prudent.</p>

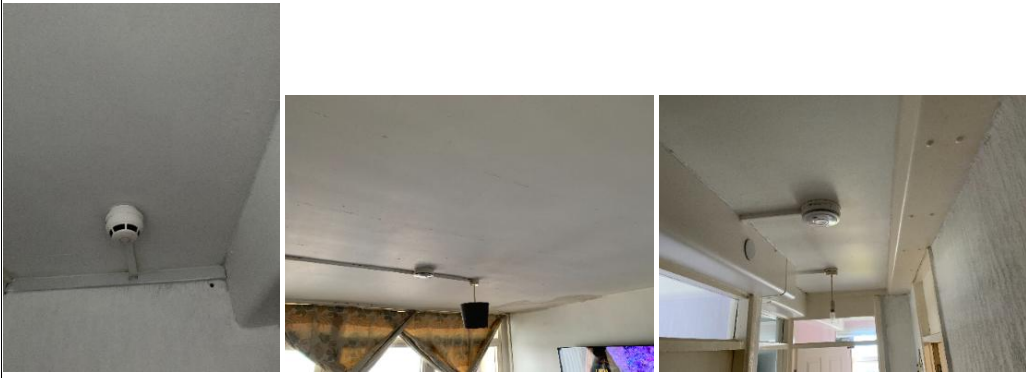
10.2-10.3	<p>Adjudging by the provisions within those flats sampled at the time of the assessment, BS5839-6 Grade D LD1 fire alarm systems are installed in all rooms except bathrooms and cupboards, along with heat detection to the communal system in the flat hallways.</p> <p>As part of WCHG's standard responses, all alarms within flats are checked and the findings are recorded as part of the annual gas servicing.</p> <p>Due to the above process and physically seeing detection in flats accessed, it is reasonable to assume that this is representative of the remainder of the flats.</p>

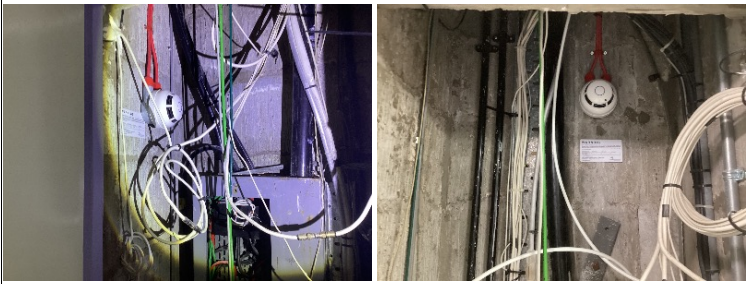
10.7	<p>The BS5839-1 common heat detectors extending into riser cupboards are fitted horizontally to the walls. It should be noted that the minimum distance away from any walls or fixings should be 300mm.</p>

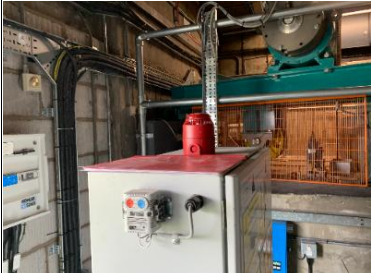
10.10	<p>As confirmed on the previous FRA- Only fire alarm sounders installed in the maintenance areas of the building including the roof are clearly audible and alert maintenance staff of the activation of the fire alarm system.</p>

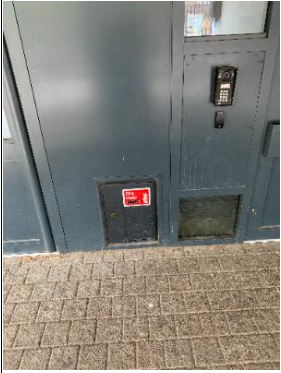
13.0 Fire Safety Signs and Notices: Finding(s)	
Ref	FINDINGS
	None.
Ref	RECOMMENDATIONS
	Observation
13.9	<p>It was observed at the time of the fire risk assessment that the dry riser inlet at the main entrance has been provided with incorrect signage, it has been edited with a permanent marker, however it is not suitable.</p>

Recommended Actions
13.9	Correct Dry Riser Inlet signage should be displayed.

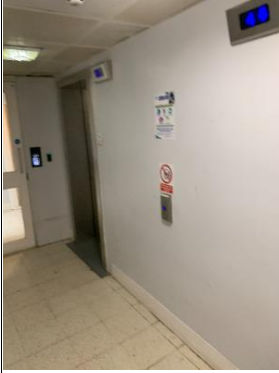
Ref	COMMENTARY
13.0	<p>The previous fire risk assessment noted that the area outside the lift on floor 15 was missing a 'Do Not Use Lift In The Event of Fire' sign. If residents use the lift in a fire situation they may become trapped, putting them at risk of harm. At the time of the fire risk assessment it was observed that this action had been completed.</p>

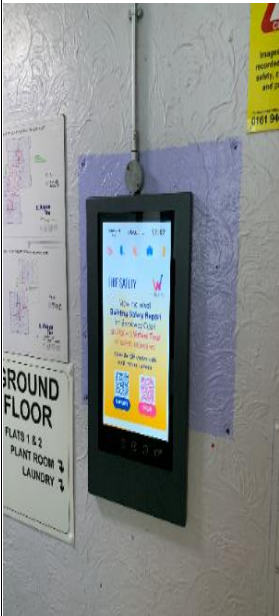
13.0	Suitable 'Do Not Use in the Event of a Fire' signage was observed by the lifts.
13.0	<p>An information tablet has been installed, this gives residents access to all details regarding their building, from fire risk assessments, to building safety reports.</p>

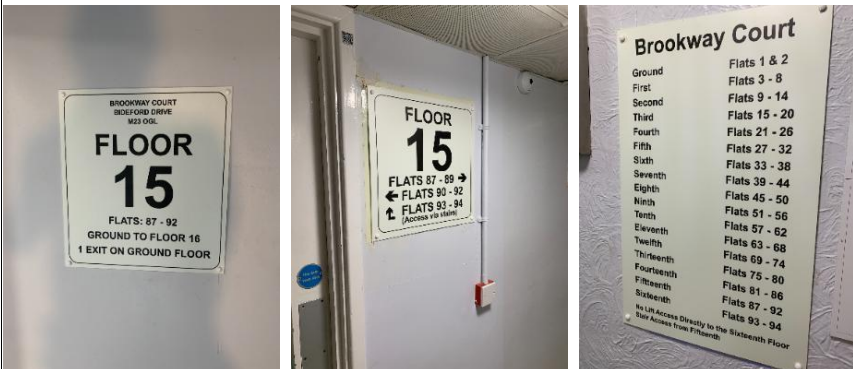
13.12	'No Smoking' signage was observed on the premises, in the common areas.
13.15-13.16	<p>Wayfinding signage that has the floor number and directional signage to the flats, including flat numbers, is displayed in the lift lobbies and on the stairway landings. They appear to be mounted at the recommended height as per ABD and are all visible and in good condition.</p> <p>Supplementary signage is also present, with signage outside the lift areas to show which flats are on each floor and which floors the two lifts access.</p>

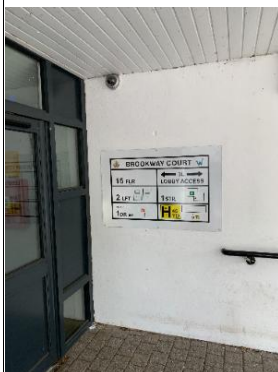
14.11	The previous FRA noted that the Fire Service had been provided with access fobs for all WCHG high-rise blocks.
14.11	Signage indicating certain provisions of the building is displayed externally, which may be used to assist attending Fire and Rescue Service personnel.

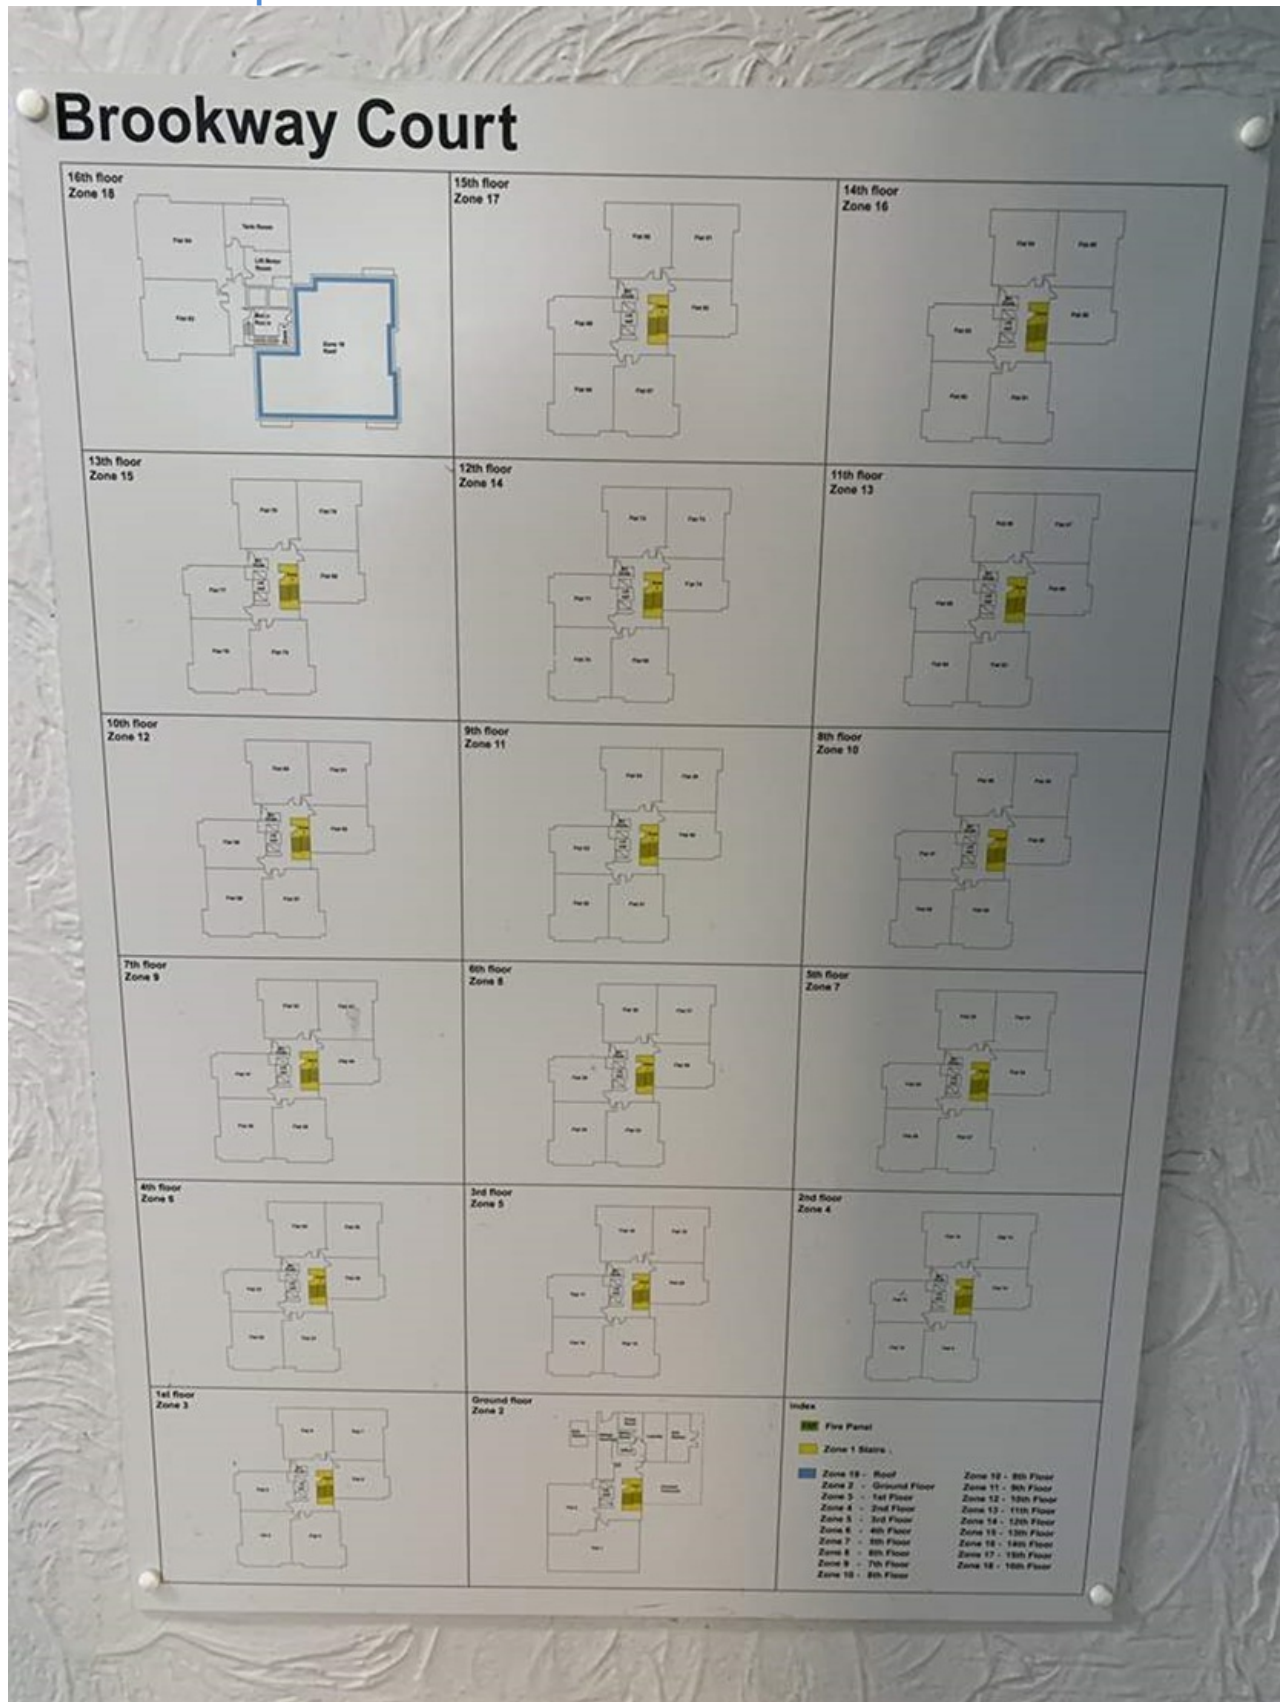
Fire alarm zone plan

10.13	A suitable building and zone plan is provided adjacent to the fire alarm panel. See appendix.
10.14-10.16	As part of their standard responses, WCHG ensures that the fire alarm/emergency alert systems are tested weekly, with tests, faults, and maintenance schedules recorded. Also confirmed in their standard responses is that the maintenance of such systems is carried out regularly by an approved contractor. Records were not observed on this assessment. Records were not observed at the time of the fire risk assessment.
