TOTAL FIRE GROUP LTD

Fire Risk Assessment

West View Court
West View Road
Wythenshawe
Manchester
M22 4LQ

04 March 2025

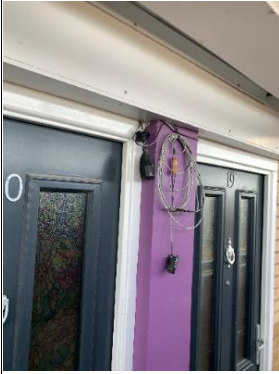
6.0 Heating and Electrical Appliances: Finding(s)	
Ref	FINDINGS
	None.
Ref	RECOMMENDATIONS
	Observation
6.14	<p>There was a bundle of cables hanging above flat 20.</p> <p>Note: The number of cables hanging from ceilings on the open deck has been reduced since the previous fire risk assessment.</p>

6.14	Cables which have become loose over the open deck should be re-affixed.
Ref	COMMENTARY
6.0	The main gas and electric isolation valve is housed inside the water tank/pump room on the ground floor, which is externally accessed. Signage indicating the location of the gas cut off is displayed by signage in the main entrance lift lobby.

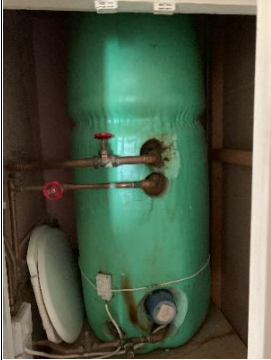
6.20	<p>WCHG have confirmed to TFG that gas boiler systems are on an annual servicing programme with a competent contractor, with records to evidence this practice held centrally by WCHG. Heating vessels are provided to individual flats.</p>

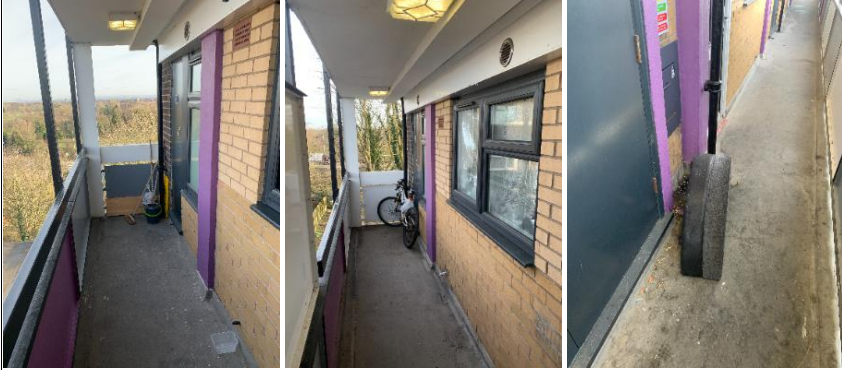
Ref	FINDINGS
	Observation
8.7	<p>As highlighted in the previous fire risk assessment there were combustibles/items stored within the communal area, that would provide fuel for a fire and they are also an obstruction/trip hazard for persons evacuating the premises and for the fire service attending an incident. Items left in the common areas place persons at risk of harm.</p>

Recommended Actions
8.7	WCHG should continue to manage the storage, including removals, in line with their policy. Residents should be reminded to not store personal items or refuse in the communal areas.
Ref	RECOMMENDATIONS
	None.

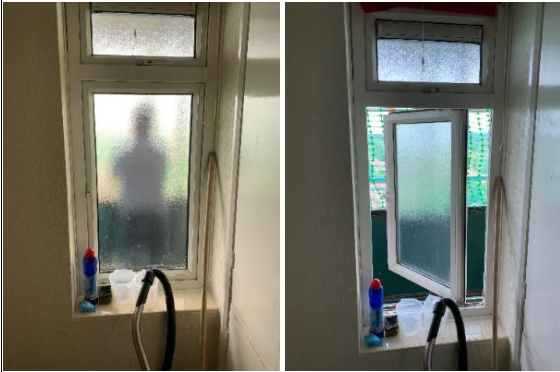
8.6	The layout of flats is such that by normal means residents would have to pass from their bedroom through the living room and past the kitchen to reach the flat entrance door. An alternative has been provided in the bathroom, where escape windows have been installed. This alternative provides a means by which, from a bedroom, the resident could enter the bathroom and use the escape window as opposed to passing through the living room and by the kitchen.

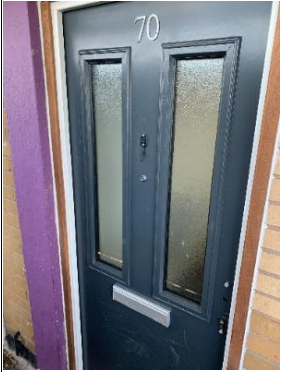
9.0 The Confinement of Fire: Finding(s)	
Ref	FINDINGS
	Observation
9.1, 9.5	<p>It was observed at the time of the fire risk assessment that the entrance door to flat 70 was missing a handle. Where fire doors are missing components they may not perform as expected in the event of a fire, in this case the interior handle may not function/be present, placing persons at risk of harm.</p>

9.1, 9.5	It is recommended that the handle to flat 70 be replaced.
	Observation
9.1, 9.5, 9.8	<p>The riser door next to flat 66 cannot be secured and has sustained damage. Where fire doors do not close fully into the frame and are damaged, fire and products of combustion have the potential to spread from the compartment of origin and to the escape routes, placing persons at risk of harm.</p>

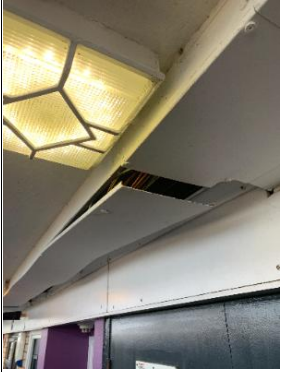
Ref	RECOMMENDATIONS
	Observation
9.1, 9.8	<p>At the time of the fire risk assessment, it was observed that the Metal trunking was open on the 3rd floor.</p> <p>Note: The majority of metal trunking that was observed to be open during the last assessment has been sealed.</p>

9.1, 9.8	The metal trunking should be closed and secured to prevent access and tampering.
	Observation
9.17-9.18	<p>It was observed at the time of the fire risk assessment that there was a breach in the ceiling above the side exit (with the padlocked gate). This leaves the building exposed to external fires and arson as the internal structure of the building is exposed. Due to this being a type 3 non-invasive assessment, there is potential that there could be breaches within the structure of the premises that would allow a fire to spread throughout.</p>

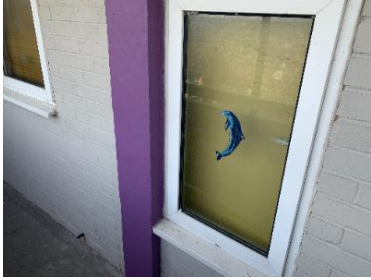
9.1	<p>The bathroom windows from some residential flats are non-fire resisting and are not fixed, with them opening below a height of 1.1m. Although non-fire resisting and non-fixed windows are not usually accepted on single-direction open decks below a height of 1.1m, this arrangement has been accepted due to:</p> <ul style="list-style-type: none"> • Sprinklers are installed throughout each residential flat. • The common monitored fire alarm system extends into the flats. • The bathrooms are low-risk rooms in which it is very unlikely a fire would begin.

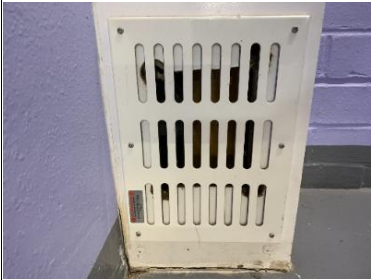
9.1	<p>There is a boxed-in section of conduit/trunking which runs the full height of the stairs, in the corner of each landing. This has vents cut into it, but its purpose could not be determined. However, the stairs are well ventilated and the vents are covered with intumescent grills. These arrangements were found to be acceptable to our consultant.</p>

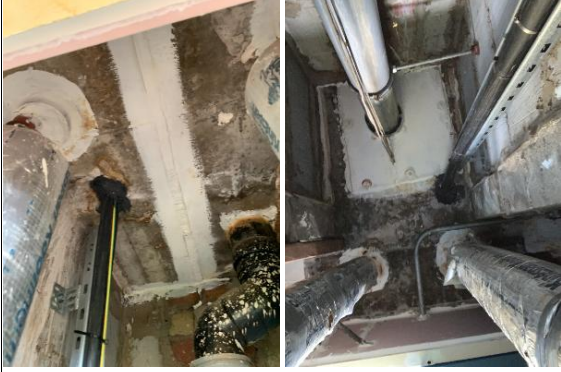
9.1, 9.8	<p>Extract from previous fire risk assessment: It has been highlighted in previous Fire Risk Assessments that compartmentation works have been carried out throughout the premises by Allied Protection Ltd (circa July 2017). They are an accredited passive fire protection contractor and they have provided WCHG with documentary/photographic evidence of their work. Following the installation of the common fire alarm system, further fire-stopping was required. This was carried out by Flame Hold Ltd, another accredited passive fire protection contractor who has also provided WCHG with documentary/photographic evidence of their work.</p> <p>Additionally, it was noted during the course of this FRA that remedial fire stopping and compartmentation works have been carried out by Alpha Fire Solutions, accredited contractors (during April 2022) following the installation of the sprinklers and new flat entrance doors. It is indicated by labelling that the extent of the fire-stopping works incorporates spaces such as behind sprinkler trunking, however, this was not confirmed due to this fire risk assessment being non-destructive.</p> <p>Note: WCHG has implemented annual compartmentation inspections by an accredited passive fire protection contractor.</p>

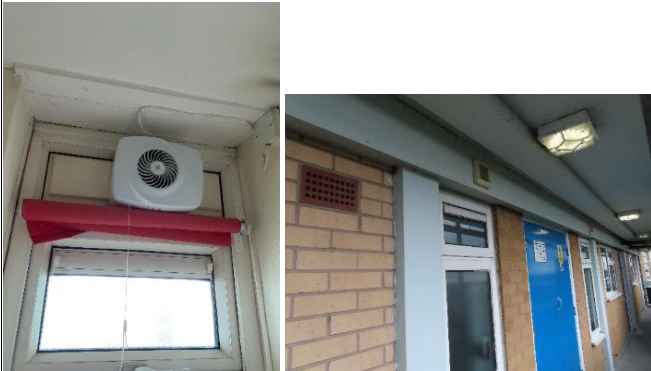
9.11	<p>Kitchen/Bathroom Extraction:</p> <p>It was noted that the kitchen and bathroom ventilation in the flats seen is extracted directly to the outside via powered fans installed within the walls above the windows of the flats and which were not common to any other flats. The extraction was at a height of above 1.1m. It is reasonable to assume that all the flats in the block have similar provisions installed.</p> <div data-bbox="236 1104 890 1473">

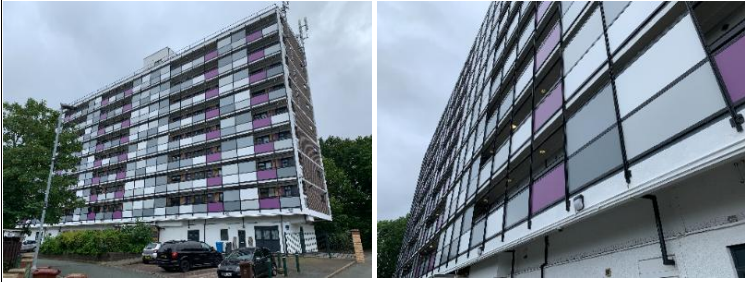
9.27-9.29	<p>The balcony panels and the spandrel panels have been replaced. WCHG provided the previous assessor with information and relevant certification showing that the materials are to be replaced with the following:</p> <p>Window spandrels - Replaced with 'Proteus SP' material produced by 'Proteus Facades'. This is a polyester powder-coated steel/ceramic powder-coated aluminium/glass-faced spandrel panel with a Rockwool insulated core structurally bonded to a lightweight metal rear skin to be used within a curtain wall system. Warrington Fire Testing and Certification Limited have classified the material in relation to their reaction to fire behaviour as A2, S1, d0.</p> <p>Balcony panel - Replaced with '3mm aluminium panels coated on both sides'.</p> <p>Work to identify the unsuitability of the panels and spandrels was detailed in a report carried out by Tenos fire engineers for a similar building and this information has also been applied to this site.</p> <p>Note: This information was communicated to the GMFRS through the online portal on the 6th of June 2024.</p> <div data-bbox="236 499 984 779">

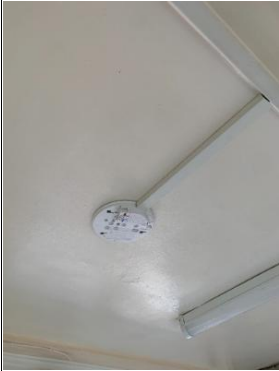
10.0 Automatic Fire Detection: Finding(s)	
Ref	FINDINGS
	None.
Ref	RECOMMENDATIONS
	Observation
10.2	<p>Although flats are outside of the scope of The Regulatory Reform Fire Safety Order 2005; The heat detector within the kitchen of flat 36 had been removed. Where detection is not present, it will not notify residents of a fire, placing them at risk of harm.</p>

10.2	It is recommended that a heat detector be reinstated within the kitchen of the flat.
Ref	COMMENTARY
10.1, 10.4-10.6, 10.8, 10.10	<p>A common BS5839-1 fire alarm system is installed which incorporates the provision of automatic detection to L2 standard. The fire alarm panel for this system is located in the lift lobby at ground floor level. The system also extends into flats in the form of a heat detector in flat entrance hallways. The fire alarm system has been configured to be silent (in the main) and is monitored. The system has also been configured to act as a form of Evacuation Alert System (EAS), whereby it can be used by the Fire and Rescue Service to sound on a chosen floor and the floors above and below the chosen floor. WCHG have confirmed to our assessor that the common fire alarm is audible in service/plant areas and on the roof, where contractors may be present and where immediate evacuation would be considered prudent. This system also extends into the community room where a repeater panel is located in the entrance lobby, and it was confirmed that the common fire alarm system is audible in the community room. The fire alarm system appeared healthy at the time of the fire risk assessment and displayed no faults.</p>

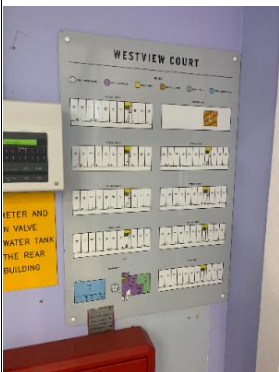
10.3	WCHG have confirmed that all alarms are checked and the findings recorded as part of the annual gas servicing.
10.13	<p>A suitable zone plan was observed by the common fire alarm panel in the ground floor lift lobby, which also displayed the building layout.</p>

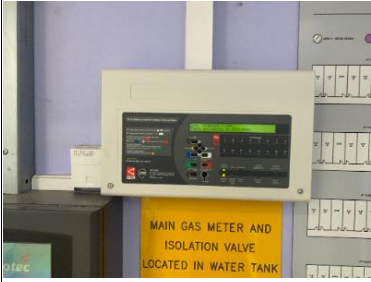
12.0 Fire Fighting Equipment, Facilities, Systems & Fixed Installations: Finding(s)	
Ref	FINDINGS
	Observation
12.7	<p>It was observed at the time of the fire risk assessment that there was a fault in zone 9 on the sprinkler control panel. Where sprinkler control systems display faults they may not perform as expected in the event that they are needed, potentially placing persons at risk of harm.</p>

Recommended Actions
12.7	It is recommended that the system be inspected and the fault is rectified and removed.
Ref	RECOMMENDATIONS
	None.

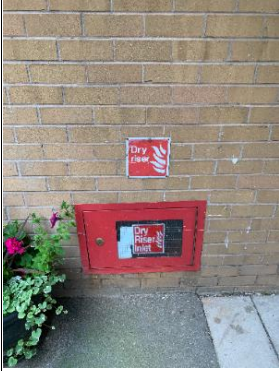
12.6-12.8	<p>A dry-rising main is installed for use by the Fire and Rescue Service. The dry-rising main outlets are located on each level of the staircase and are behind locked doors. The inlet is located adjacent to the main entrance, on the external façade. The dry rising main is visually inspected annually and is also serviced annually, with 6-month periods in between each of these inspections/services.</p>

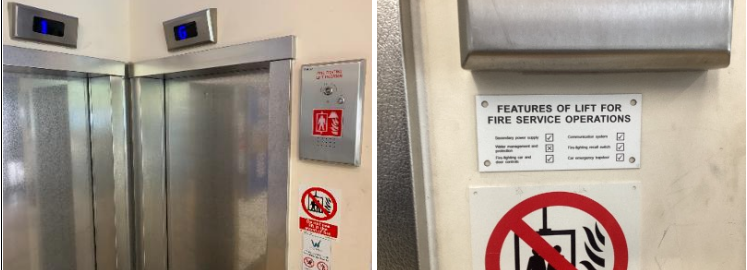
12.10-12.11	<p>One of the lifts on the premises appears to be a standard passenger lift, whereas the other appears to be a firefighting lift. The firefighting lift has a switch to return the lift to the ground floor level and also an intercom for communications. Within the lift was a hatch in the ceiling. It was confirmed to our assessor that the lift defaults to the ground floor on activation of the common fire alarm system and that the switch to manually return the lift to the ground floor is tested monthly in line with the Fire Safety (England) Regulations 2022. Records to evidence such testing are held centrally by WCHG. It was communicated that all keys required for the operation of the lift have been provided to the Fire and Rescue Service and are also held in the SIB. It was also communicated that the firefighting lift could continue to be used by firefighters without having to reset the alarm if sounding audibly.</p>

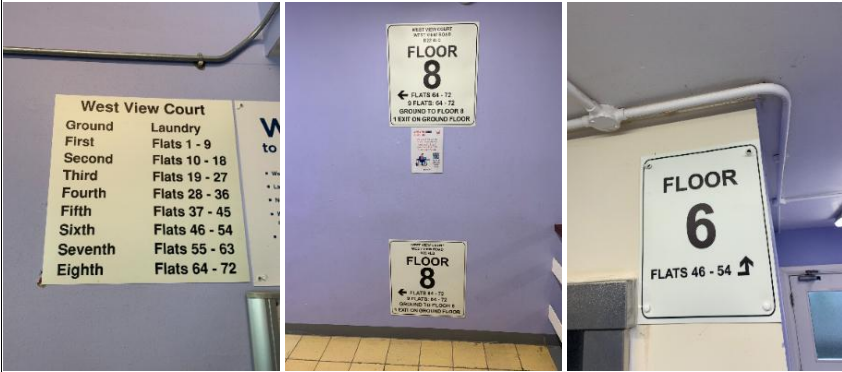
13.12	'No Smoking' signage was observed on the premises, in the common areas.
13.15	Wayfinding signage was observed on the staircase landings and on the open decks which indicated the floor level and the flats on that floor. Such signage was also observed in the lift lobby at ground floor level.

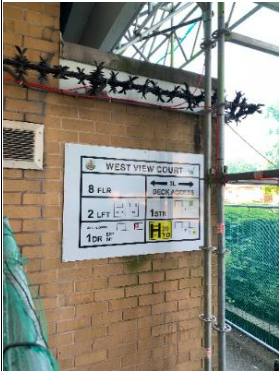
14.11	The previous fire risk assessment confirmed that the Fire Service has been provided with access fobs for all WCHG high-rise blocks.
14.11	Signage indicating certain provisions of the building is displayed externally, which may be used to assist attending Fire and Rescue Service personnel. (Photo used from previous fire risk assessment).
